Consultancy Services for the Plant Audit in various Pump Stations and Reservoirs (OP18REFCS03)

Technical Report for PACCOR Pump Station
reference: OP18REFCS03-GHD-PAG-REP-G001A

Title:
Preliminary Report for Pagcor Pump Station

Theme:
Plant Audit and Asset Management

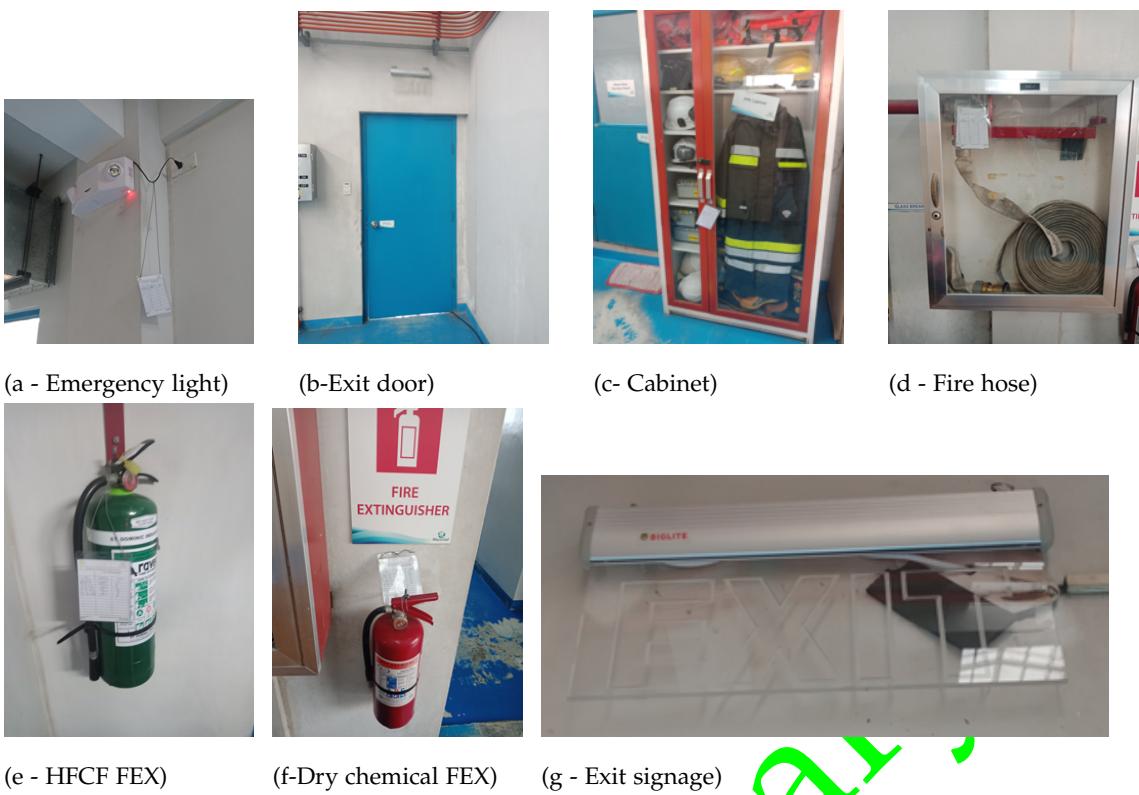
Figure 4.19: Existing safety devices

No.	Assets	CS	IT	Facts	Remarks
1	Exit light 01 (Fig. 4.19-g)	0	4	Not function No light indication	Unsafe risk to the safety of people in the event of power a power outage
2	Exit light 02 (Fig. 4.21-h)	0	4	Not function No light indication	Unsafe risk to the safety of people in the event of power a power outage
3	Exit light 03 (Fig. 4.19-b)	0	4		Unsafe risk to the safety of people in the event of power a power outage
4	Exit light 04 (Fig. 4.21-i)	0	4		Unsafe risk to the safety of people in the event of power a power outage
5	Exit light 05 (Fig. 4.21-j)	0	4		Unsafe risk to the safety of people in the event of power a power outage
6	Emergency light tag 01 (Fig. 4.19-a)	0	4	No updated Last update is 30/Aug/2018	Unsafe Failure to inspect emergency light can make it ineffective
7	Emergency light tag 02 (Fig. 4.21-a)	0	4	No tag	Unsafe Failure to inspect emergency light can make it ineffective
8	Emergency light tag 03 (Fig. 4.21-b)	0	4	No tag	Unsafe Failure to inspect emergency light can make it ineffective

9	MCP#1 (Fig. 4.20-g)	0	4	No updated	Unsafe Failure to inspect manual call point can make it ineffective in case of fire
10	Fire extinguisher 01 (Fig. 4.21-c)	0	4	Missing	Unsafe Failure to replace or locate fire extinguisher can delay response to
11	Fire extinguisher 02 (Fig. 4.21-d)	0	4	Missing	Unsafe Failure to replace or locate fire extinguisher can delay response to
12	Fire extinguisher 03 (Fig. 4.21-e)	0	4	Missing	Unsafe Failure to replace or locate fire extinguisher can delay response to
13	Fire extinguisher 04 (Fig. 4.21-f)	0	4	No inspection tag	Unsafe Failure to inspect fire extinguisher can make it ineffective in case of fire.
14	PPE cabinet tag (Fig. 4.21-g)	0	4	Not updated Last update is 7-30-2018	Unsafe Failure to inspect PPE cabinet may not ensure completeness of content and PPE may have damage that can make these equipment ineffective

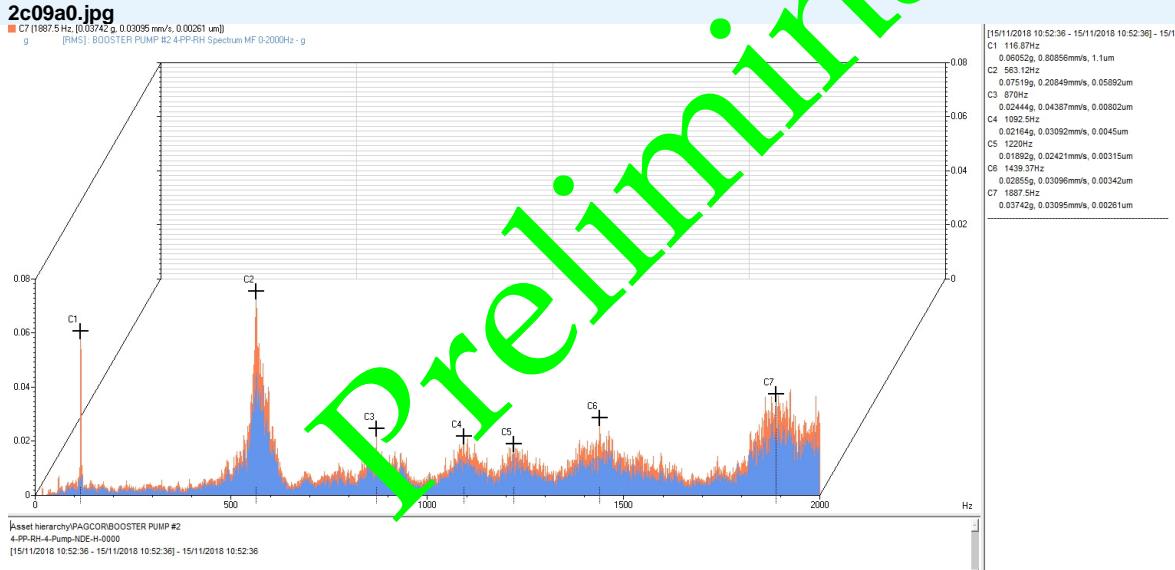
Noise generated at High frequencies due to lubrications problem

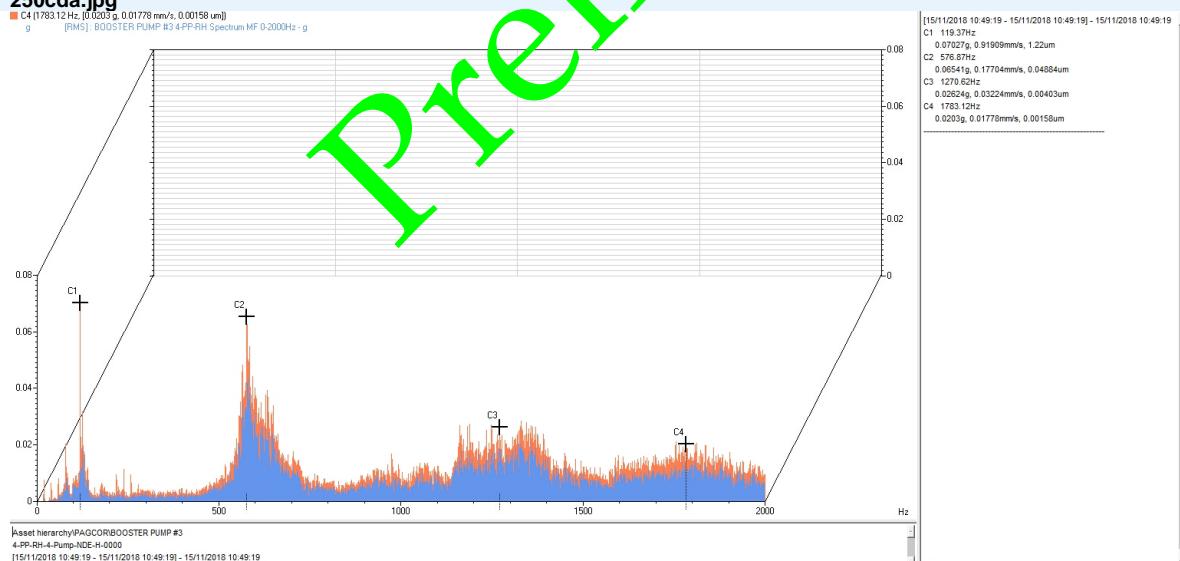
1x Blade Passing Frequency peak and elevated base or humps are an indications of pump cavitations Fault
2709f6.jpg
