Consultancy Services for the Plant Audit in various Pump Stations and Reservoirs (OP18REFCS03)

Technical Report for Noveleta (NVL) Pump Station
reference: OP18REFCS03-GHD-NVL-REP-G001A

Title:
Preliminary Report for Noveleta (NVL) Pump Station

Theme:
Plant Audit and Asset Management

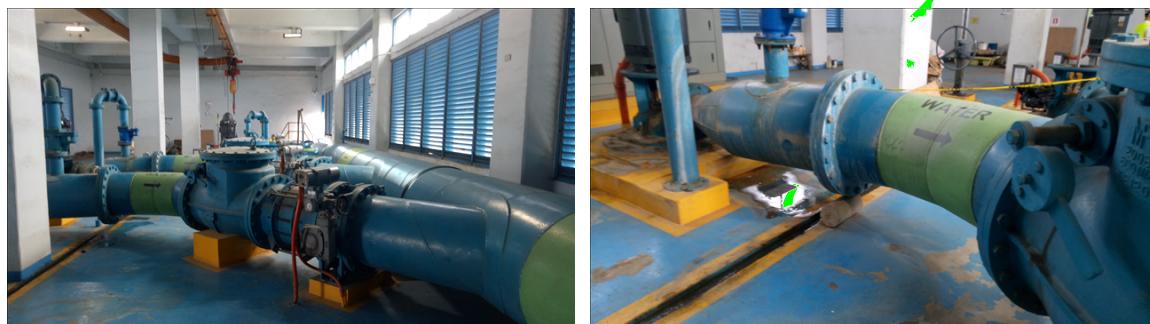
The pipes join the main discharge header on Y-type connection (Figure 4.3 - a). This helps to avoid higher head loss and strong water thrust that could develop if T junctions were used. However, the area allotted for the placement of the MCC, pumps, pipes and fittings was rather small. Necessary fittings such as the valves and STC's were installed and thereby only a small portion of straight pipe is left.

The discharge header then elbows down (Figure 4.3 - b) leading the pipe underground to join the supply line. This turn however may result to strong hydraulic thrust as water passes thru and the abrupt change in direction of a considerable volume of water will lead to losses and turbulence. The surface erosion on the elbow may need to check in the future.

a - Discharge header and joining lines

b - Discharge header continued

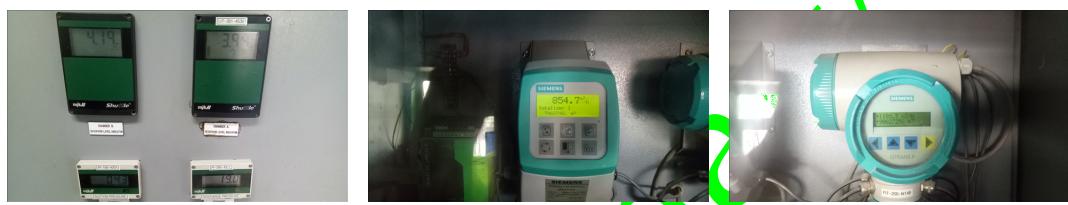
The water level inside the reservoir partitions are displayed in two separate meters. The inflow and outflow are also likewise displayed by two other meters. (Figures 4.8 - a, b and c)

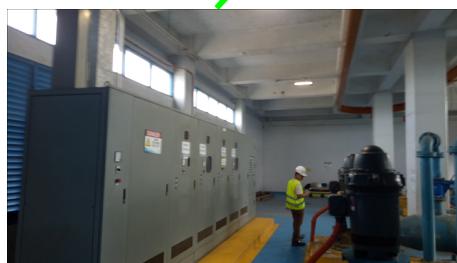
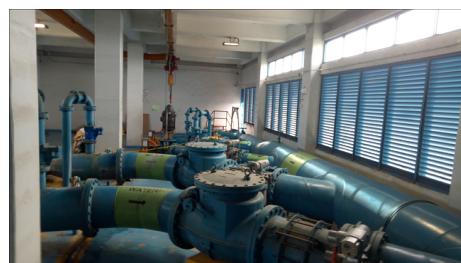
Figure 4.11: Pump room illumination

The illuminations recorded are well above the standard's minimum values. These mean the illumination inside and outside the pump room is suitable for inspections, and repairs. Considerable natural lighting come from the room windows (Figure 4.11 - a and Figure 4.11 - b) during the day. During evenings artificial lighting provides illumination inside the pump room and is also sufficient for inspections and repairs.

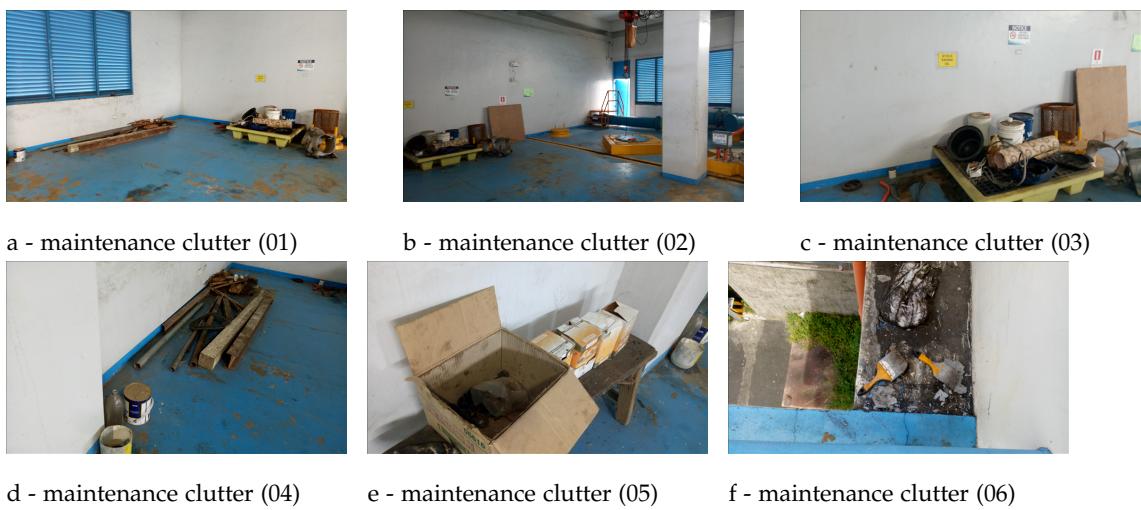
A minor observation that still needs to be addressed are lack of appropriate storage. Racks or cabinets could be placed to store miscellaneous items such as cleaning materials, repair tools, assembly parts and/or spares such as those observed during inspection as shown in Figure 4.13.

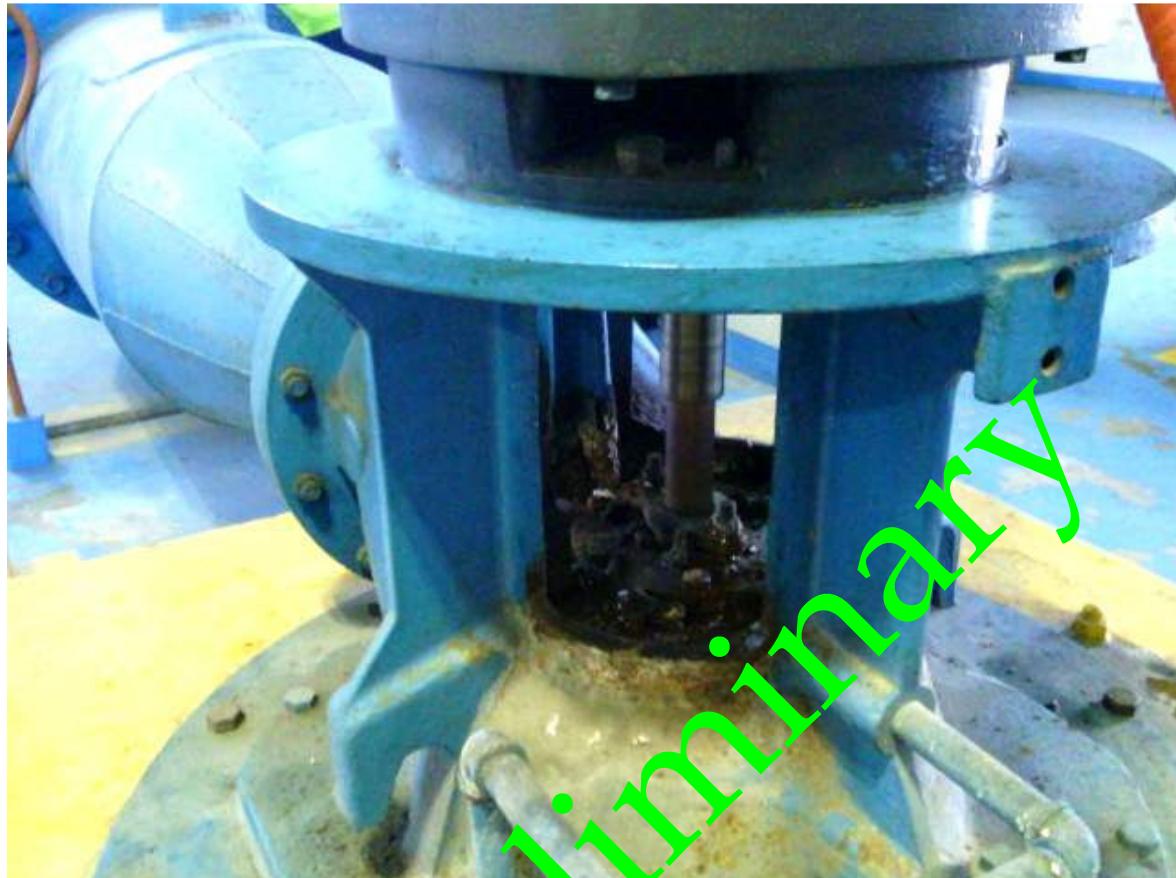
IP1.jpg

dirty

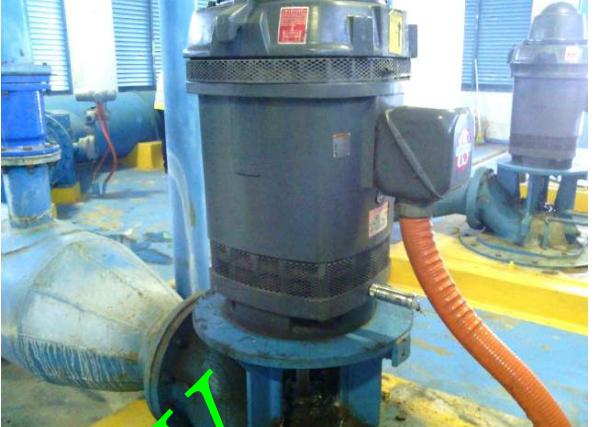
IP2.jpg

Designation	NOVELETA PUMP STATION					
Equipment	BOOSTER PUMP UNIT 2					
Designation						
Abbreviation	BP#2					
Serial No						
Model						
Periodicity (d)	Normal 60	Alarm 15				
Previous Advice	Condition	Rotation Speed				
Date	FAIR		Speed 50 Hz / 1795 rpm			
15/02/2019 09:15:13	Health is not acceptable for a long time service.		Author u1			
Condition	DfCnd		System Serial FALCON - 11407			
Diagnosis & Recommendation			Parameters sheet			
Diagnosis						
Slight Unbalance Motor Fan						
Overall state still acceptable for the component 'Electric motor'.						
Slight Unbalance Motor Fan						
Recommendations						
Monitor Slight Unbalance Motor Fan						
Monitor Slight Unbalance Motor Fan. Clean up on next PM or remove built up dirt on blades

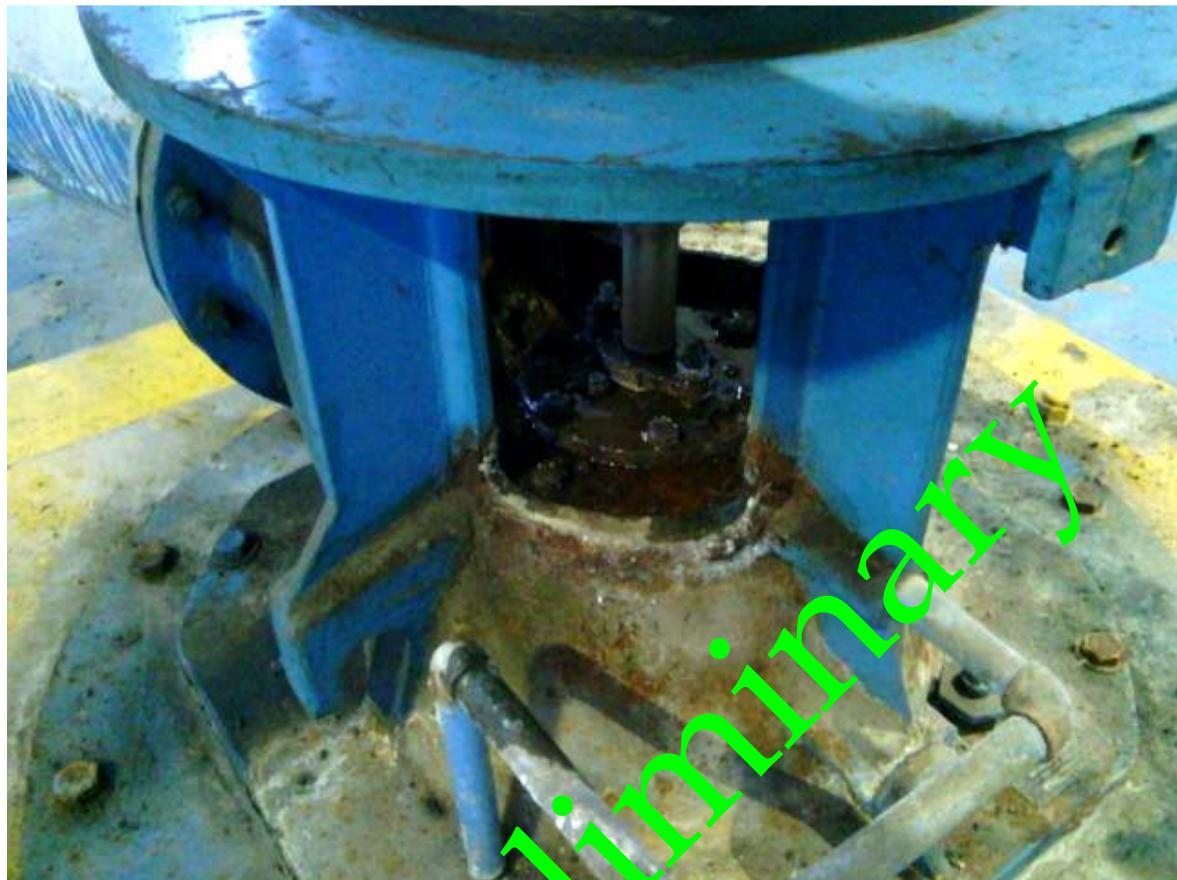
dirty
IP3.jpg

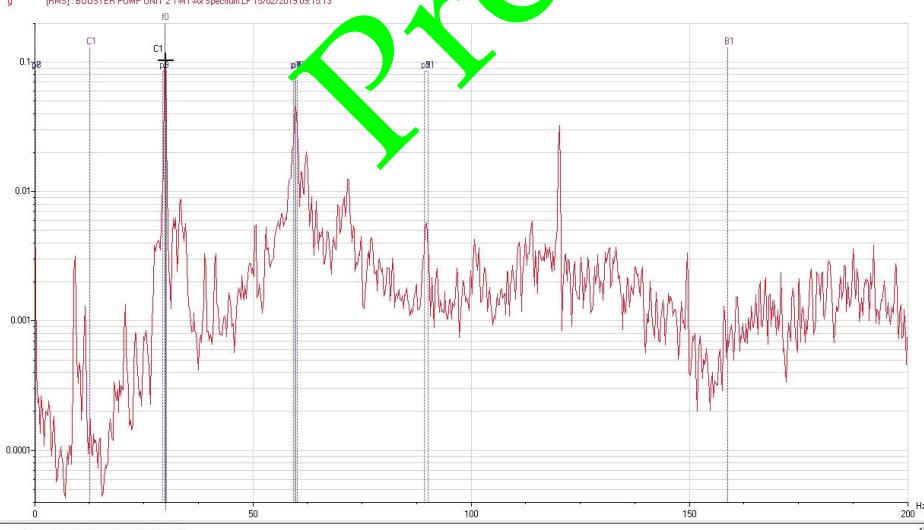
C1 (30 Hz) [0.1031 g, 5.36 mm/s, 28.46 um]
g [RMS] BOOSTER PUMP UNIT 2 1-MT-Ax Spectrum LF 15/02/2019 09:15:13

BOOSTER PUMP UNIT 2 1-MT-Ax Spectrum LF 15/02/2019 {
C1 30Hz
U: 0.1031 g, 5.36 mm/s, 28.46um
10 Rot Speed 29.92Hz
7222899 (SKF) I:273.16Hz E:1205.55Hz
B1 158.87Hz C1:12.56Hz
p0:ND-0007 29.92Hz [+/- 0.5Hz]
p1:ND-0008 59.84Hz [+/- 0.25Hz]
p2:ND-0009 89.76Hz [+/- 0.5Hz]
p3:ND-0010 119.68Hz [+/- 0.5Hz]
p4:ND-0011 59.84Hz [+/- 0.25Hz]
p5:ND-0012 89.76Hz [+/- 0.5Hz]
p6:ND-0013 0Hz [+/- 0.5Hz]
p7:ND-0014 0Hz [+/- 0.5Hz]
p8:ND-0015 0Hz [+/- 0.5Hz]
p9:1x 29.92Hz [+/- 0.5Hz]
p10:2x 59.84Hz [+/- 0.5Hz]
p11:3x 89.76Hz [+/- 0.5Hz]
