# **Consultancy Services for the Plant Audit in various Pump Stations and Reservoirs (OP18REFCS03)**

Technical Report for Ayala South Vale (ASV) Pump Station  
(Mechanical and WEM)

reference: OP18REFCS03-GHD-ASV-REP-G001B

**Title:**  
Preliminary Report for Ayala South Vale (ASV)  
Pump Station

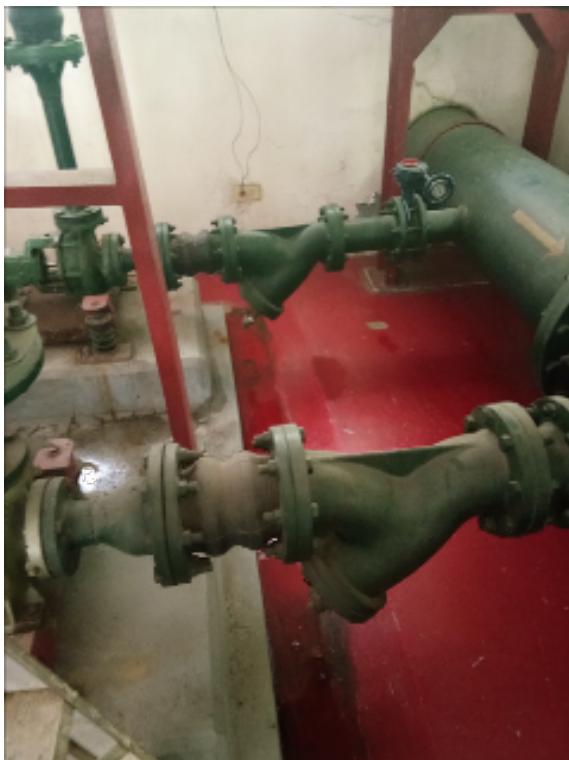
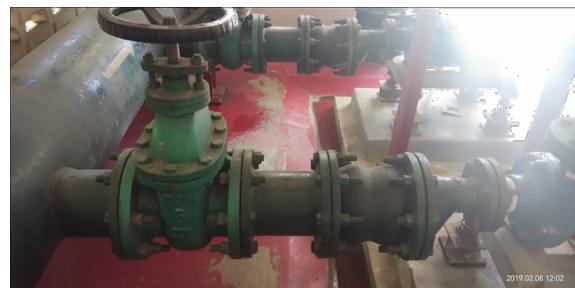
**Figure 3.4:** Suction side

Pipe design and flow profile Fittings neary the pump intake will cause flow disturbances and turbulence (Figure 3.4)

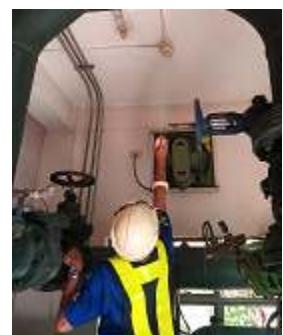
Testing of Smoke Detector

Testing At pump area SD#5,6,7

ITEM	DESCRIPTION	YES	NO	Findings During Testing	Test Results
1.	Smoke Detector #1		X	-With dust inside and outside -Spray Smoke Detector Maximum 3 times	-No response on smoke tester -Repeat spray again but no response in the device -Repeat clean -After 3x spray no response on smoke tester
<b>Analysis:</b> After spraying of smoke tester, removal of the device from base to Reset contact point and cleaning did not show any improvement on the device. Hence device is declared not functioning and there is communication failure between device and FACP panel.

- The smoke detectors are not stand alone type and is dependent on the Fire Alarm control panel for proper operation;
- The FACP, though still have input voltage has no output voltage and is recommended for replacement together with all the devices. All devices in the system should be compatible to be able to operate. Replacement of FACP alone does not guarantee that the existing smoke detectors will operate;
- After replacement of battery, push test/ "hush" button. This will decrease the sensitivity for approximately 8 minutes. During this time, the RED LED will flush every 10 seconds. This will indicate that the device is functioning;
- Owing to the years, the wires and other auxiliaries have deteriorated and must be replaced by a new FDAS system.
