# **Consultancy Services for the Plant Audit in various Pump Stations and Reservoirs (OP18REFCS03)**

Technical Report for Cherry<sup>®</sup>-inline Pump Station  
reference: OP18REFCS03-GHD-CHE-REP-G001A

**Title:**  
Preliminary Report for Cherry-Inline Pump Station

**Theme:**  
Plant Audit and Asset Management

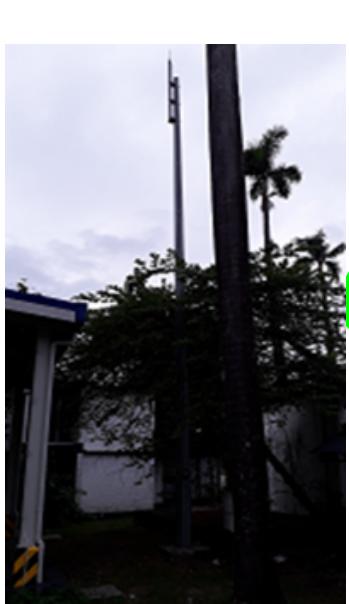
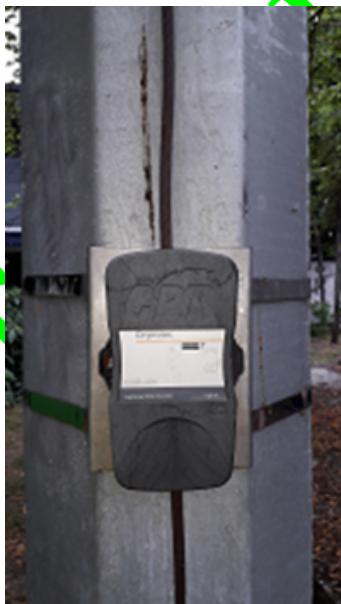
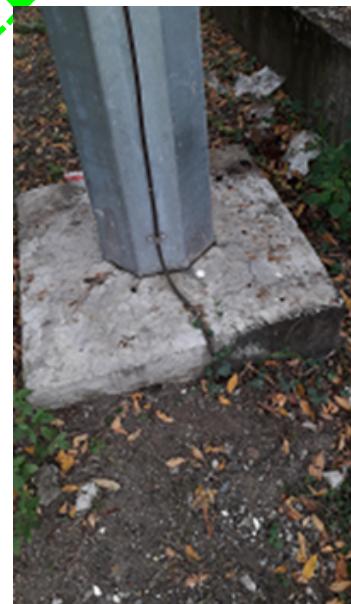
**Figure 1.1: Protective devices.**

There is a lightning protection system installed for this in line booster. The strike counter has not registered a single strike. The bare copper wire connecting the lightning arrester to the ground is already dark and corroded.

a - Lightning arrester rod

b - Strike counter

c - Bare copper wire

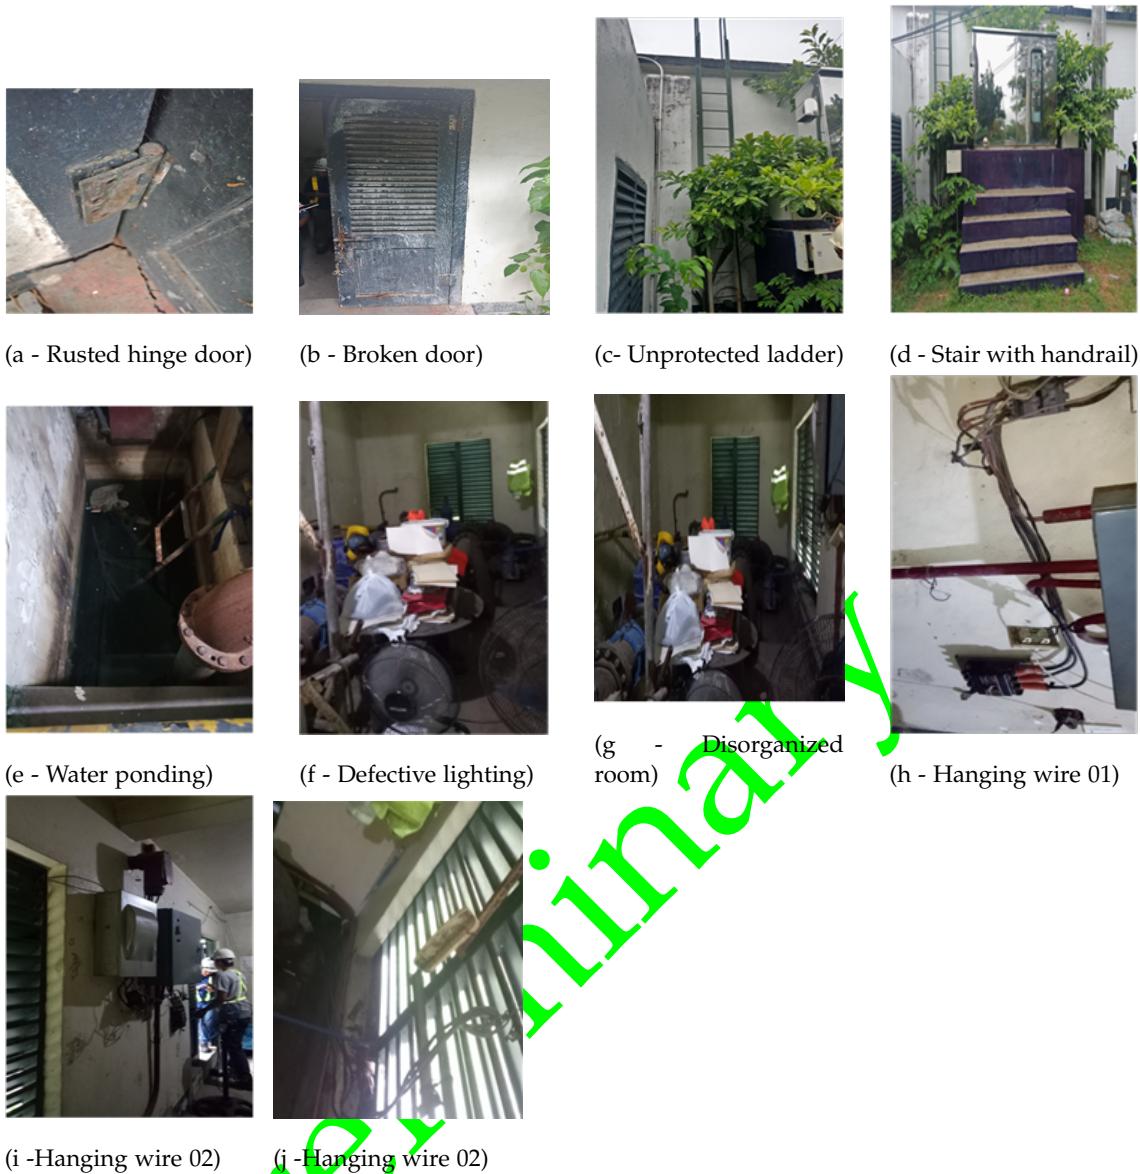
Figure 1.2: Electrical safety

The pump room is only manned by one person. The old pump room was not maintained and not organized. Staying inside the pump room poses danger to the operator because of the open wiring and exposed live parts. There is only entrance and exit.

Facts obtained from inspection are presented in Table 1.1 with indicative figures for each devices presented in Figure 1.2.

Item	Visual Check	Status	Remarks
1	Evacuation Plan	0	
2	Fire Extinguishers	0	Pump Station Is Not Equipped With All Of The Standard Safety Features And Equipment
3	Fire Exits	0	
4	Fire Hose Cabinet	0	
5	Fire Sprinkler System	0	
6	Emergency Exit Signages	0	
7	Emergency Lights	0	
8	PPE Cabinet	0

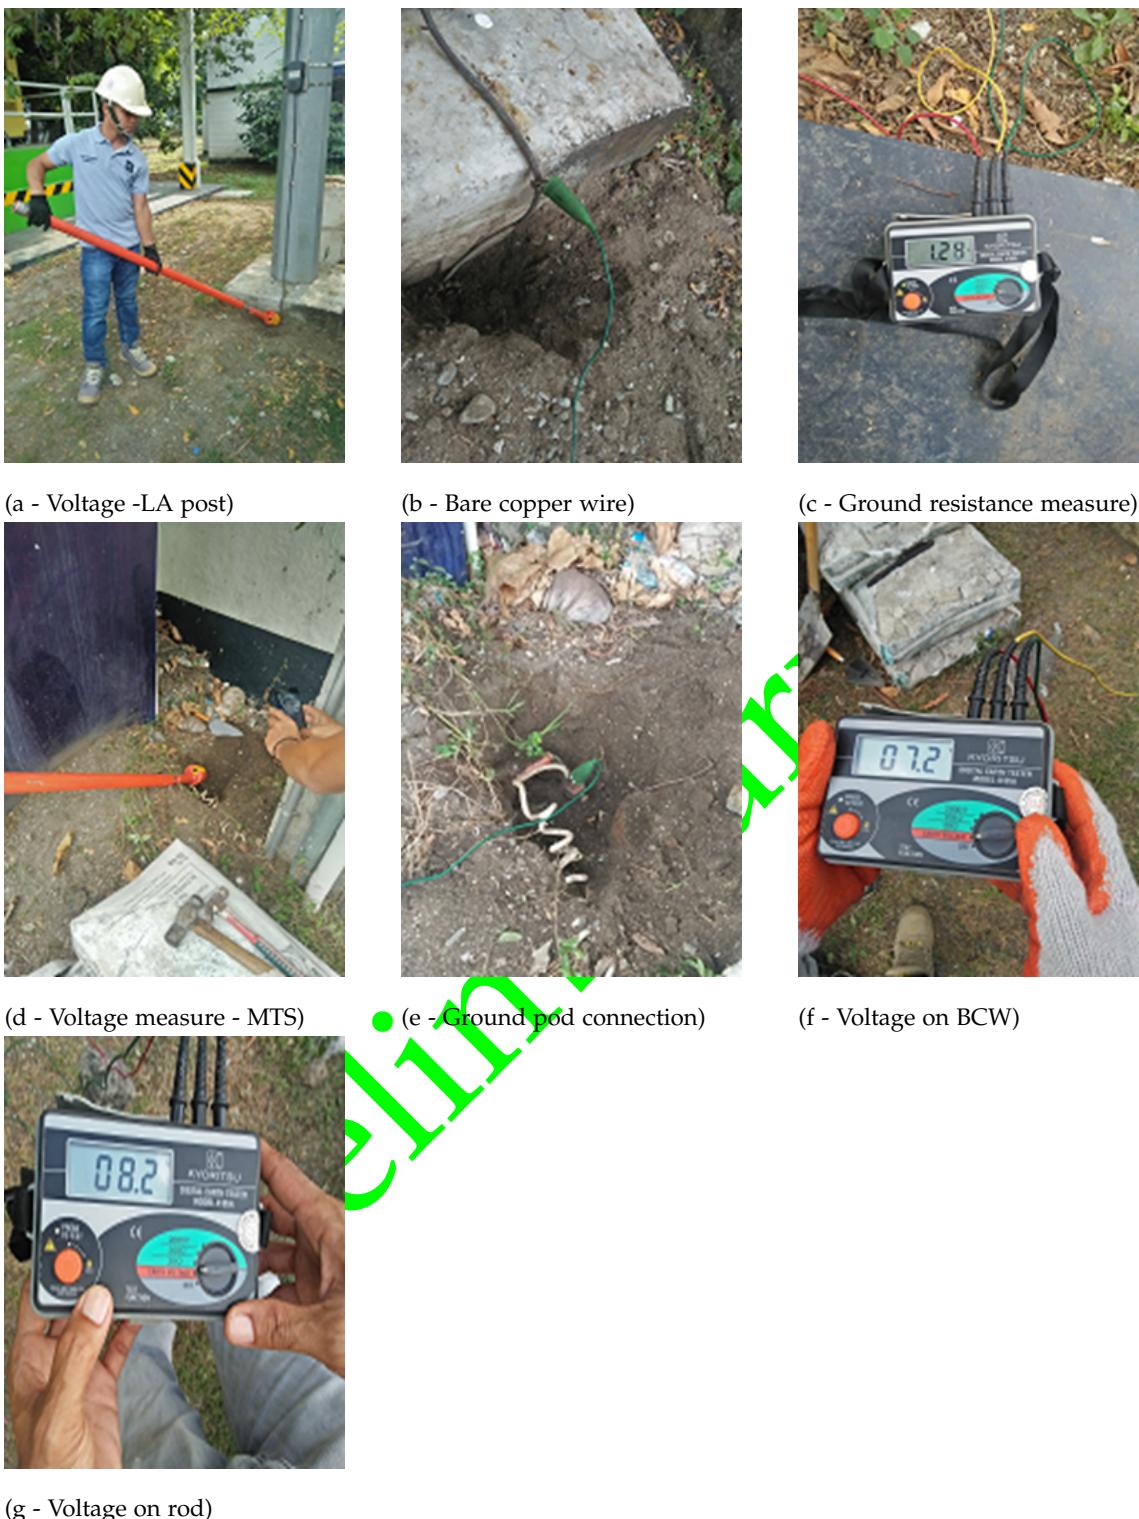
**Figure 1.21:** Grounding system measurement

Locations	Asset/Room	Resistance	Findings	Recommendations	Effects	Risks
Lightning Arrestor Post	Test Point 1 Bare Copper Wire	1.24 Ω	Within The 5 Ω Limit As Per Nfpa And Ieee Standards	(1)Check Tightness Of Connection Of Bcw To Ground Rod  (2) Grounding System Electrical And Mechanical Connections Should Be Free Of Corrosion. (3) Replace Bcw For Better Conductivity.	None	None
Mts Equipment Ground	Test Point 2 Bare Copper Wire	7.2 V	Measured Voltage In The Bare Copper Wire	Check And Trace Where The Voltage Is Coming From And Correct The Connection	Danger To Personnel And Damage To Equipment If Not Immediately Corrected	Health And Safety Risks For Facilities And Personnel And Damage To Equipment Or Accessories
Mts Equipment Ground	Test Point 2 Ground Rod	8.2 V	Same As Mts Equipment	Same As Mts Equipment	Same As Mts Equipment	Same As Mts Equipment
Genset	Test Point 3 Bare Copper Wire	NA	Connected To Grounding Busbar Of Mts	Same As Mts Equipment	(1) Unwanted Voltage Maybe Present On Non-Current Carrying Metal Objects (2) Equipment Might Be Damaged During A Fault Condition	(1) Incorrect Operation Of Overcurrent Device With Ground Fault Protection  (2) Health And Safety Risks For Facilities And Personnel
