Consultancy Services for the Plant Audit in various Pump Stations and Reservoirs (OP18REFCS03)

Technical Report for VILLAMOR Pump Station (Excluding Electrical Testing)
reference: OP18REFCS03-GHD-VIL-REP-G001A

Title:
Preliminary Report for Villamor Pump Station

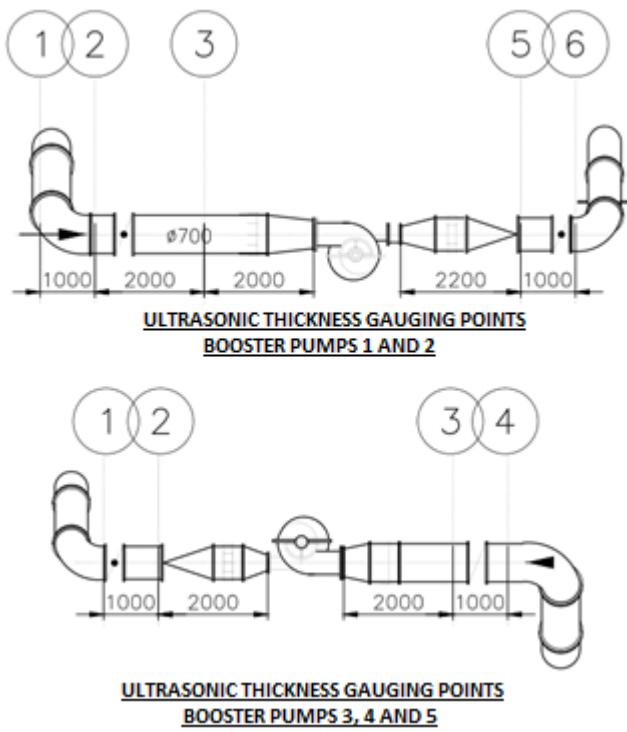
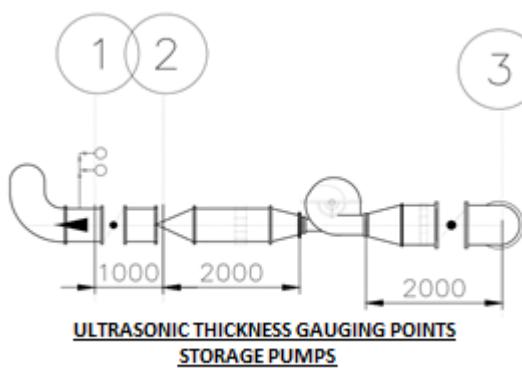
Figure 4.1: Positions and distances of UTG - Booster Pump

- Mean value of thickness is above 4.6 mm;
- Mean and median values are close, inferring a confidence on having less heterogeneity, i.e. distribution of thickness around the pipe is more or less homogeneous;

- Thickness at elbow is less than that of the straight line;
- Thickness of storage line is likely to be higher than that of the discharge line;
- BP1 has a value of 3.92 as min at the elbow, which requires attention from time to time.

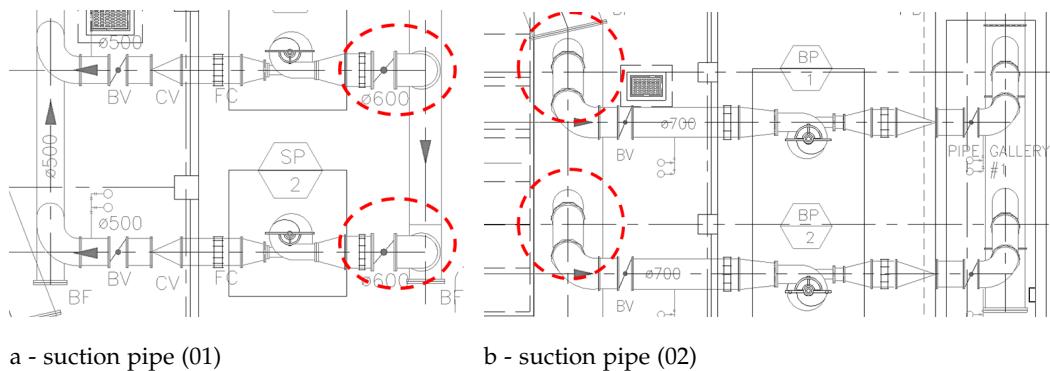
**Figure 4.5:** Piping design and alignment

The suction pipe design for the BPs resembles that of double elbow at two separate planes. The second elbow branches of the header at 45 degrees followed by a short straight pipe then connecting to the pump intake via a concentric reducer (refer to Figure 4.5-a and Figure 4.5-b).

flow is high and fluid momentum is great. However, from the visual inspection of the concrete support for check valves and how the valve seats on it, the supports function like anchors (fixed).

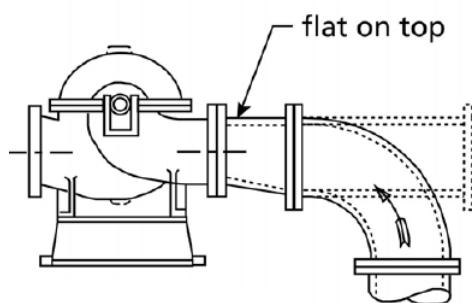
**Figure 4.6:** Eccentric reducer

Furthermore, common practice to avoid air pockets building up at the suction side of the pump is to use flat-on-top eccentric reducer before the pump suction (Figure 4.18). This is applicable for piping coming from below or straight ahead.

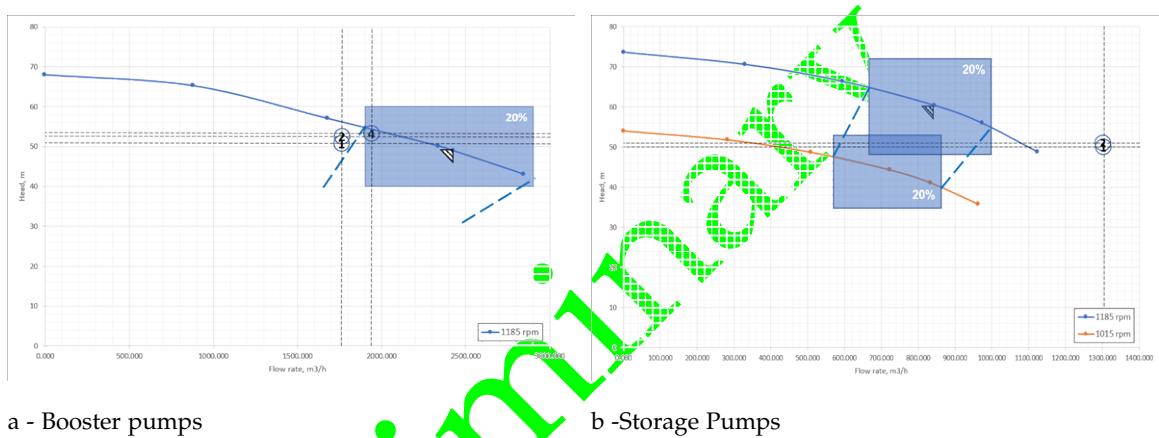
**Figure 4.10:** Efficiency curves

pumps have been operated inappropriately pursuant to their design specifications, a case that could be associated to VFD operated pumps, aside from the fact that the viable measuring points of the flow is near the elbow at the discharge side. With that, the operation of the pumps might not be the optimum and as a result incurred more power than they should be.

As shown in Figure 4.10-b, the storage pumps operate at an overflow condition and are beyond the tolerance of 20% Best Efficiency Point (BEP). Both pumps only run at 1015 rpm at the time of testing, but deliver an overflow and so deviate greatly from the curve. In this operating condition, the pump might incur higher power consumption aside from the increase of deterioration rate of its components. Specifically, it will produce high cavitation and high vibration thus associated to the so called operate-to-destruction. This is similar to underflow as it will increase the temperature rise rate and produce noisy operations, cavitation surge and even high vibration scenarios.

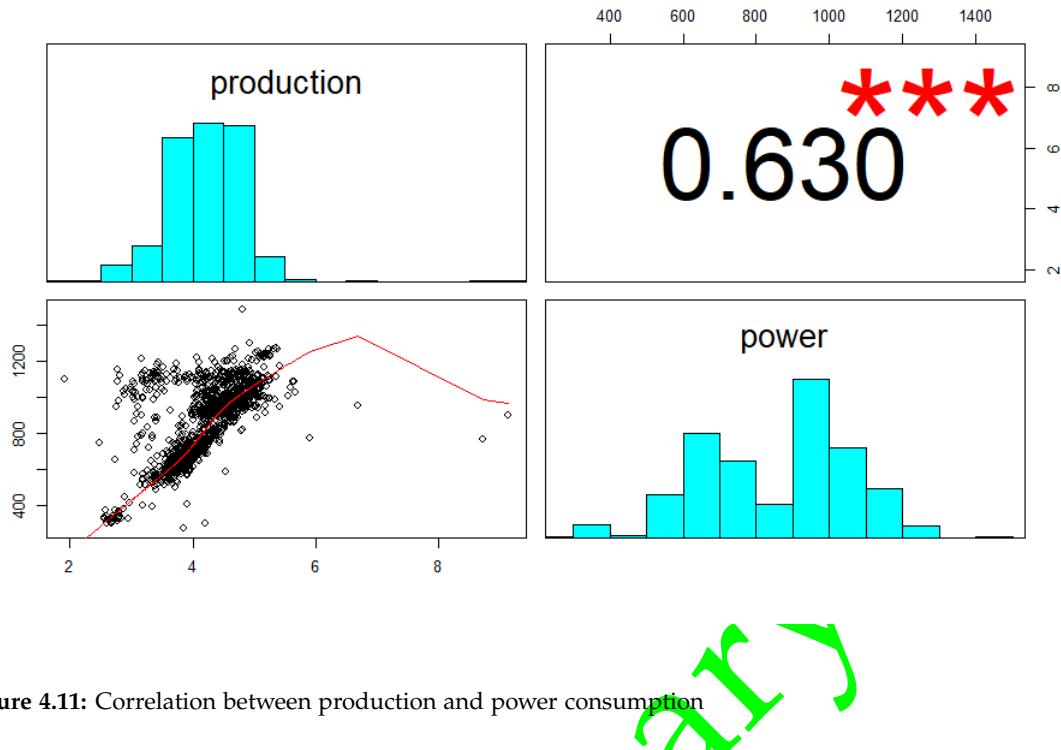
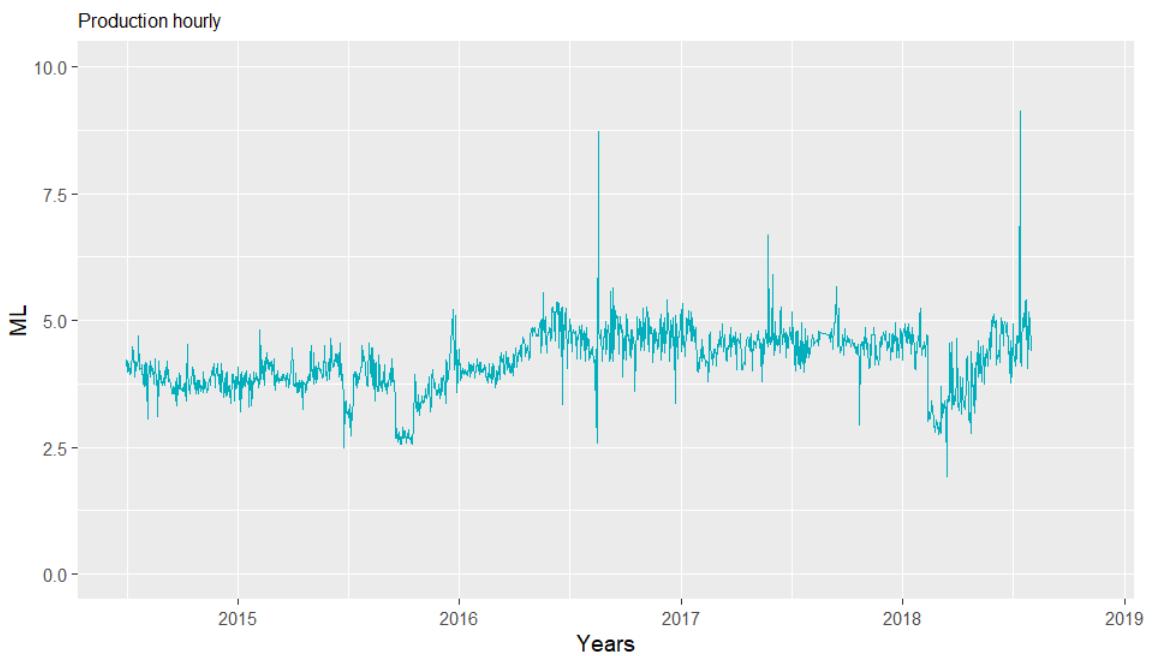
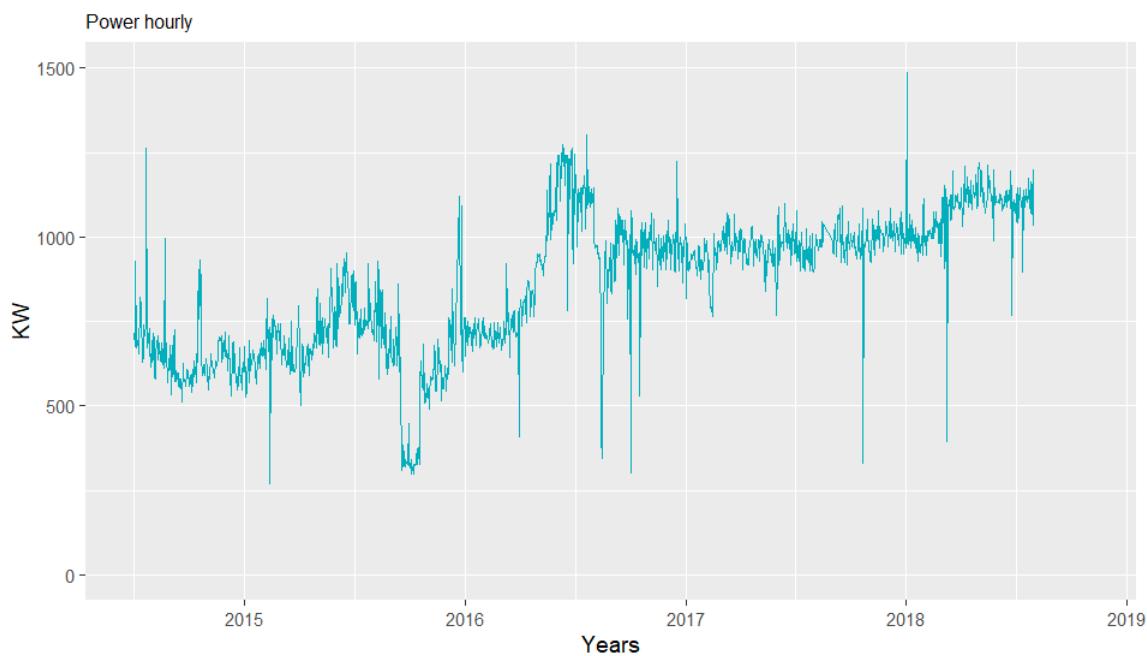
- There is a relatively strong correlation between the production and power, inferring that there has been less breakdown in this station;

- There has been a few number of peaks at which the ratio between power and production were significantly high compared to average value. These peaks seem to be repeated at least one in a year. The reason causing that peaks are unknown;
- There are a number of outliers which should not be an actual cases;
- There was a high peak in ratio in the first quarter of 2018. The ratio has reached between 300 and 400 for 3 months period, inferring an abnormal operation.

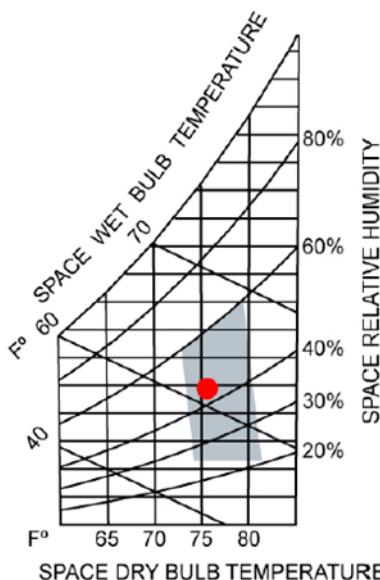
Figure 4.15: ASHRAE standard 55 : Summer Comfort Zone

As a matter of fact, temperature and humidity is highly correlated and as per ASHRAE standard 55 under summer comfort zone, the recommended combination of temperature and humidity shall be within the comfortable zone as shown in Figure 4.15.

In order to reduce the negative impacts from high temperature, particularly inside the pump house, the Client shall consider

- Establishing a good daily monitoring, exercise, and management considering ergonomic and health and occupational activities (e.g. appropriate time window for break in designated resting area);

- Execute physical intervention to reduce temperature can be with improving ventilation system by natural mean (e.g. installation of weather proofed louvers). This will be reflected in the conceptual design in Chapter 5.

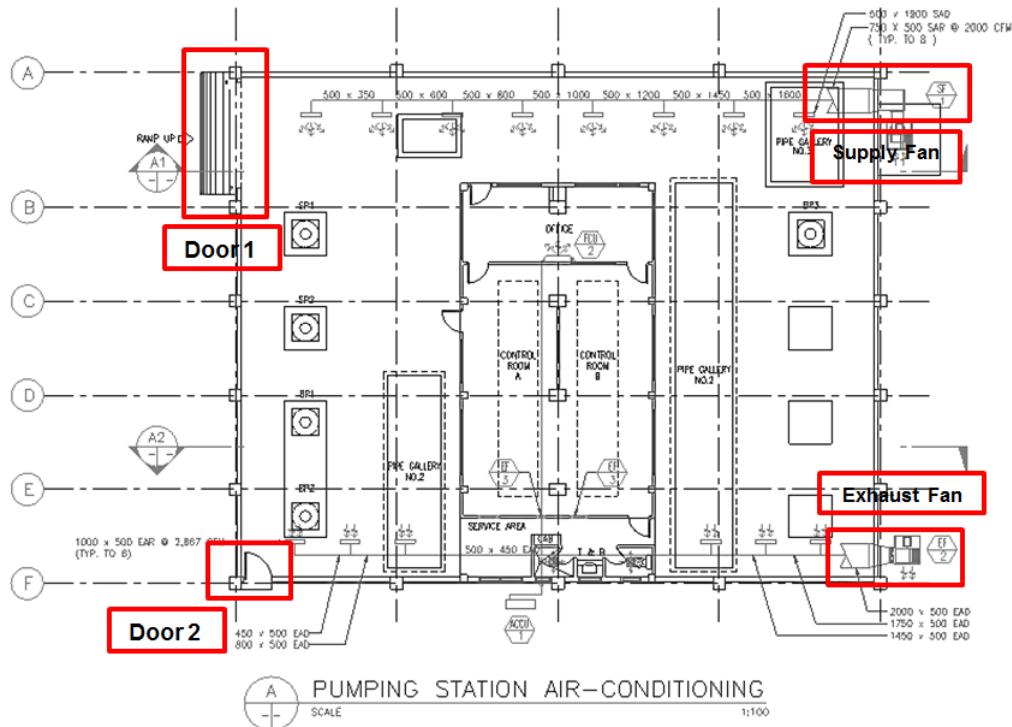
Figure 4.16: Existing ventilation layout

Natural ventilation through Door 1 and Door 2 is not sufficient to attain the minimum Air Changes requirement of the Pump House and so Mechanical Ventilation is utilized most of the time.

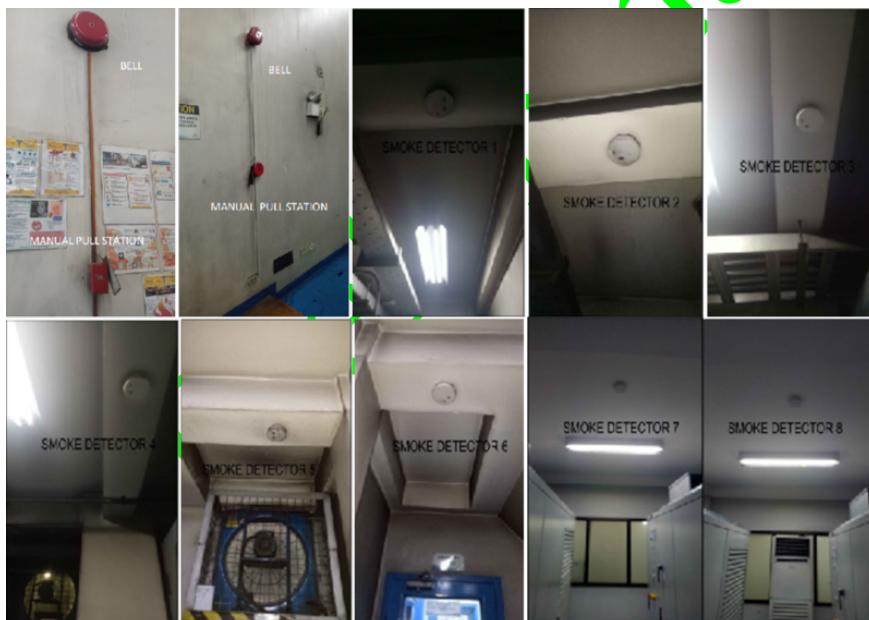
**Figure 4.17:** As-found devices and panels

- **Smoke Detectors 01/02/04/05/06/07/08:** Battery operated smoke detector should have audible chirping sound to indicate that device needs battery replacement. However, since there was no response from SD to the tests conducted, this means that the battery is already drained. Removal of device from base for cleaning did not show any improvement on the device. Hence device is declared not functioning;
- **Manual Call Point 01:** Manual call point should have an audible alarm response after pulling the cover. Hence this device is declared functioning;
- **Manual Call Point 02:** Manual call point did not respond with an audible alarm after

pushing the button. Hence this device is declared not functioning;

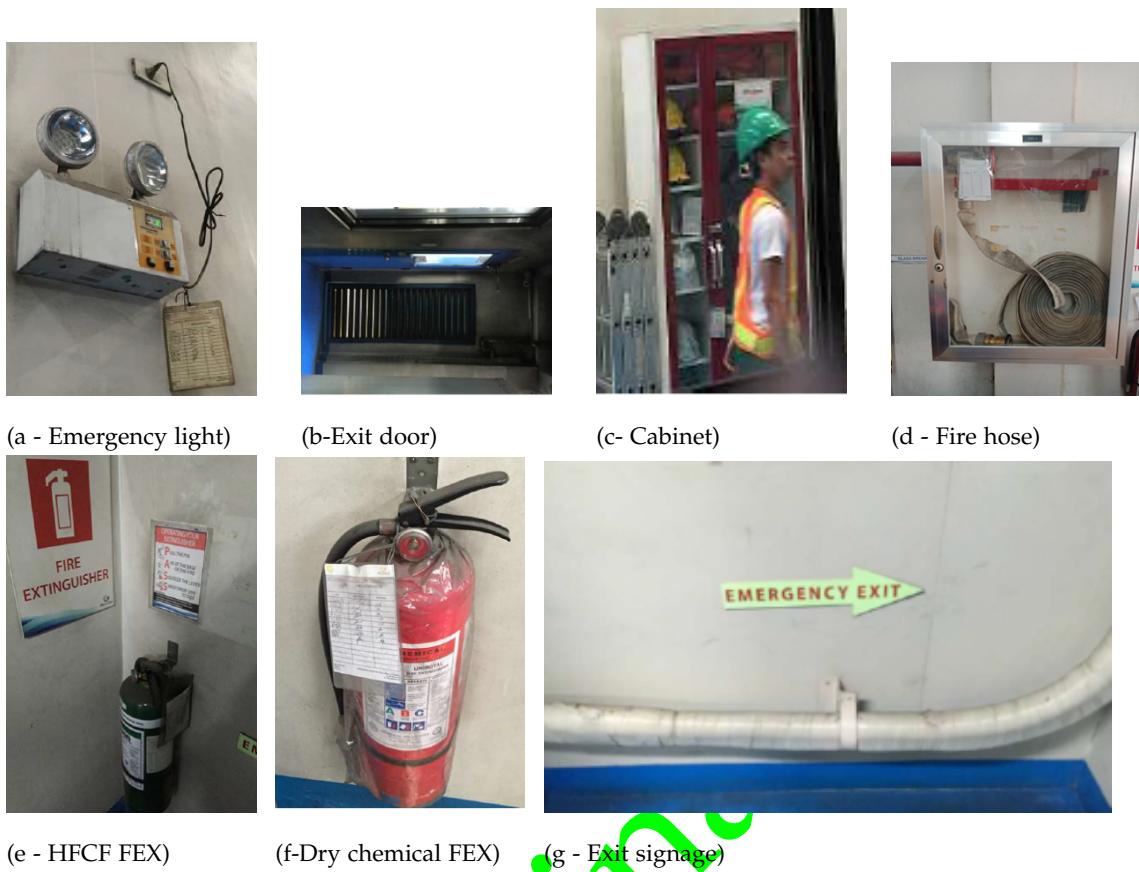
**Figure 4.19:** Existing safety devices**Table 4.27:** FDAS analysis.

- Most of the smoke detector devices, manual call point, buzzer and the FACP were not functioning. These were established during the conducted testing of FDAS and devices;

- Test the batteries for voltage output;

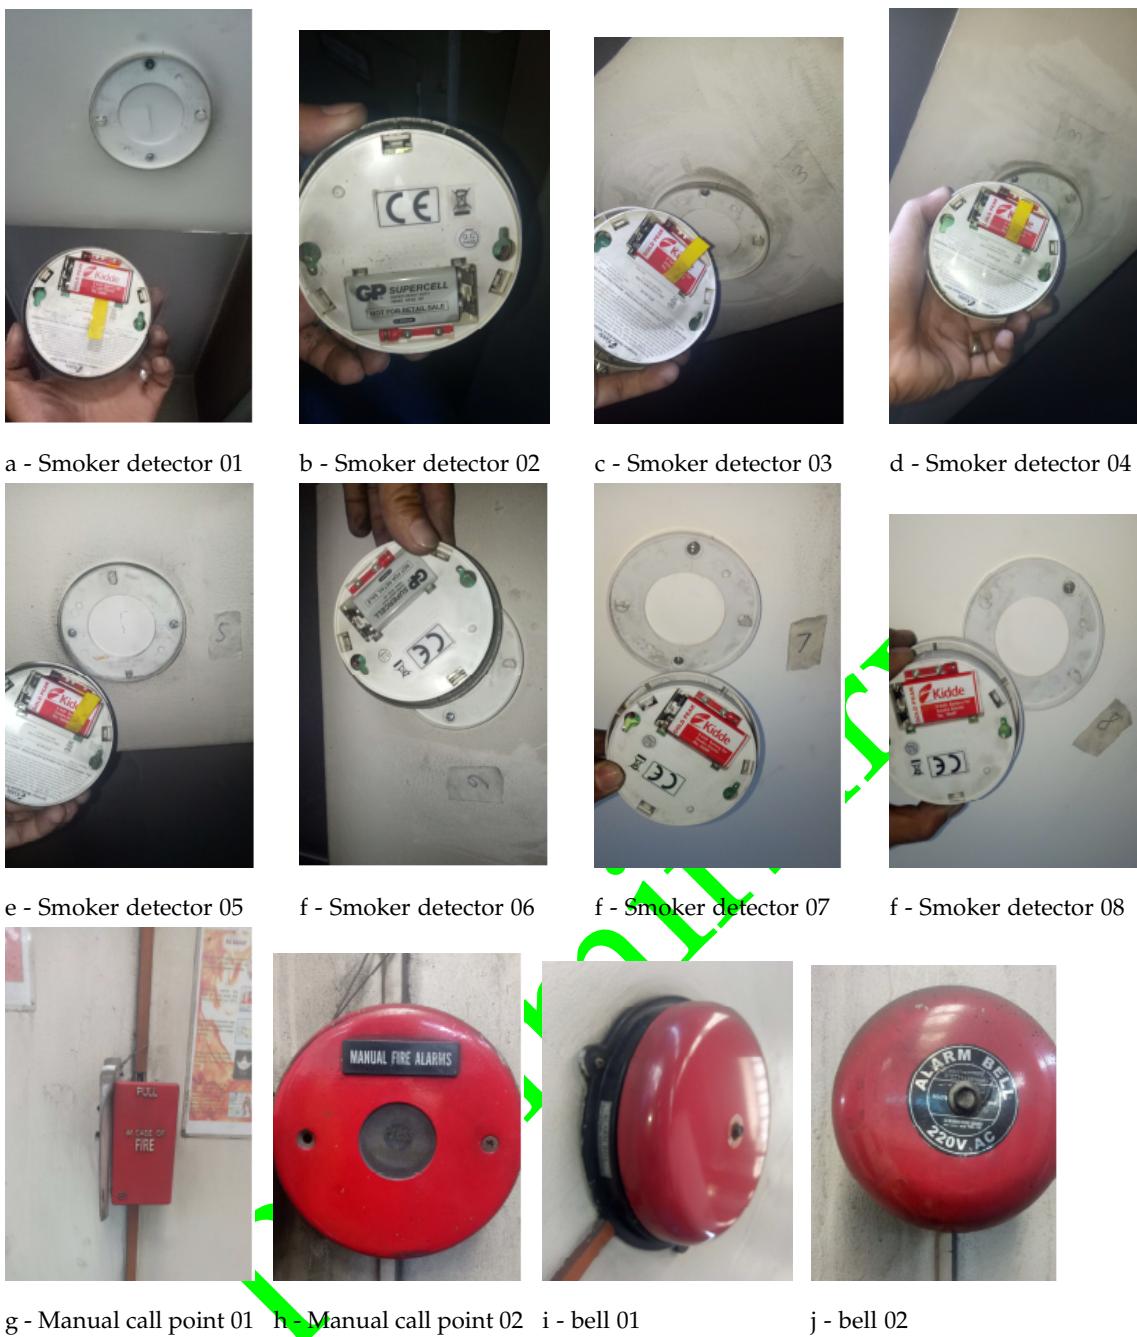
Figure 4.20: FDAS assets

No.	Assets	CS	IT	Facts	Remarks
1	SM 01	0	4	dust inside and outside no chirping sound indicating that the battery does not provide adequate LOS Perform push and hold to test Spray Max 3 times	No response to push and hold test Repeat clean After 3x sprays, still no response
2	SM 02	0	4	Same as SM01	Same as SM 01
3	SM 03	1	1	dust inside and outside With chirping sound. This indicates that battery needs replacement Perform push and hold to test Spray Max 3 times	With audible alarm response to Push and hold test Repeat clean 3X Repeat spray with audible alarm response in the device
4	SM 04	0	4	Same as SM01	Same as SM 01
4	SM 05	0	4	Same as SM01	Same as SM 01
6	SM 06	0	4	Same as SM01	Same as SM 01
7	SM 07	0	4	Same as SM01 (No light signal indication (orange color maintained light))	Same as SM01
8	SM 08	0	4	Same as SM01 (No light signal indication (orange color maintained light))	Same as SM01
7	MCP 01	1	1	Pull the MCP cover	Alarm response audible after pulling the cover

- Replace existing batteries for smoke detectors that are not functioning with fresh 9V Battery super heavy duty (Carbon-zinc type or Alkaline) with 0% Mercury;
- After replacement of battery, push test/ “hush” button. This will decrease the sensitivity for approximately 8 minutes. During this time, the RED LED will flush every 10 seconds. This will indicate that the device is functioning;
- Dust can clog your smoke alarms. Battery-powered smoke alarms should be cleaned by opening the cover of the alarm and gently vacuuming the inside with a soft bristle brush;
- Maintain smoke detectors by testing and manual push to ascertain functionality every week as per instruction on the device by the manufacturer.

- ✓ Replace the system with newer and addressable type FACP to determine exact location of fire as it happens;
- ✓ Additional smoke detector devices are required in engineer's office, guardhouse, pump area;
- ✓ Additional heat detector devices are required in pantry, genset room, substation room;
- ✓ Additional strobe with sounder and call point at the genset and substation room since these rooms are located in separate buildings and for safety reasons for sounding alarm at the instant that there is fire;
- ✓ Annual Inspection, Testing and Maintenance;
- ✓ Replace existing bell to strobe light with sounder and call point at the booster pump area and additional strobe light with sounder and call point at genset room. Genset room is located in separate building and for safety reasons for sounding alarm at the instant that there is fire;

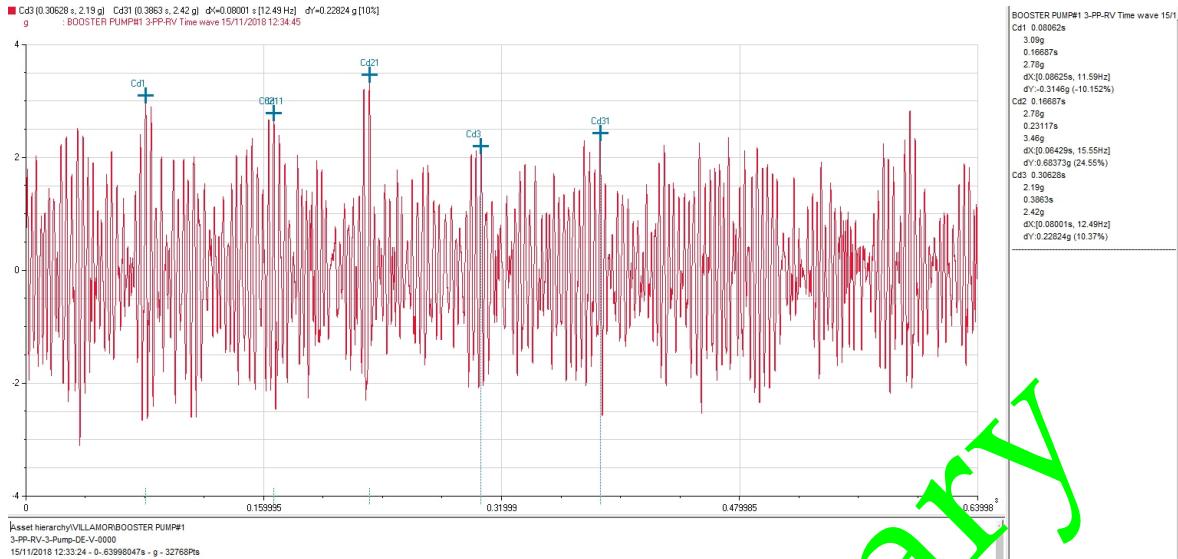
280aba.jpg

Non-periodic pulsation due to pump cavitations

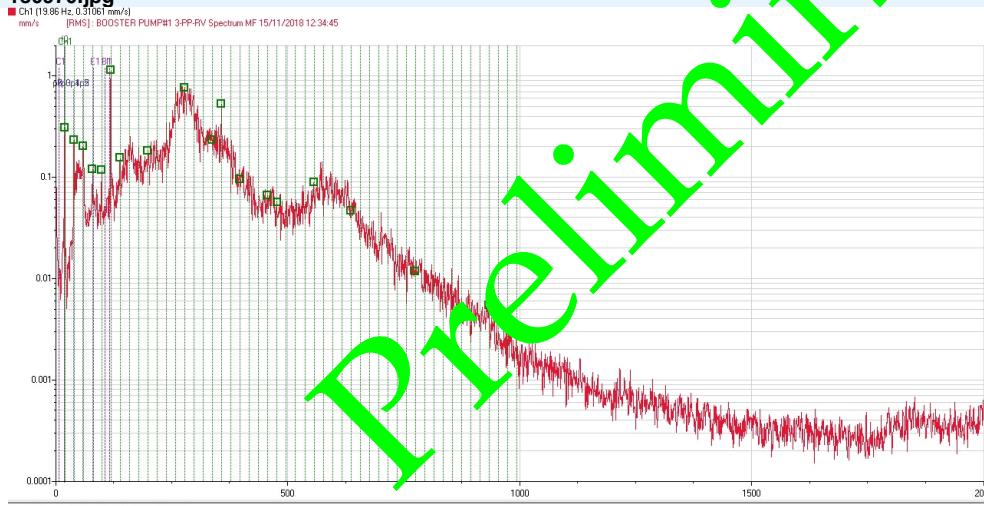
180970.jpg

FFT clearly shows haystack/humps or elevated base at high frequencies and 1x peak at Blade Passing Frequency - an indication of induced Pump Cavitations

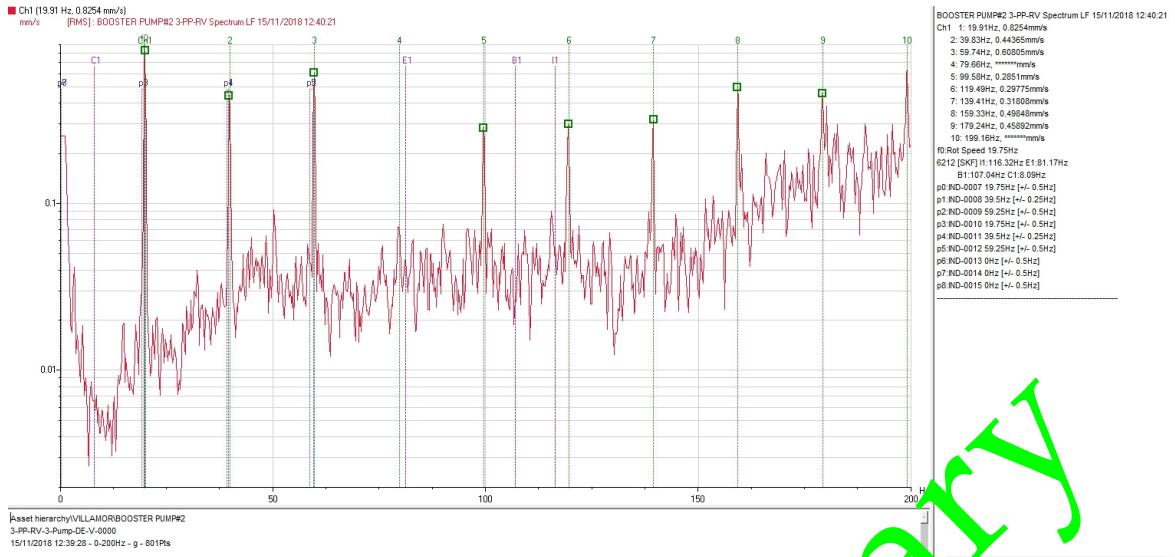
140abe.jpg

Highest vibrations measured at Pump IB Bearing Vertical with Overall Velocity of 0.7mm/s and dominant peak at 1x Blade Passing Frequency (119.25Hz) caused by Pump Cavitation.

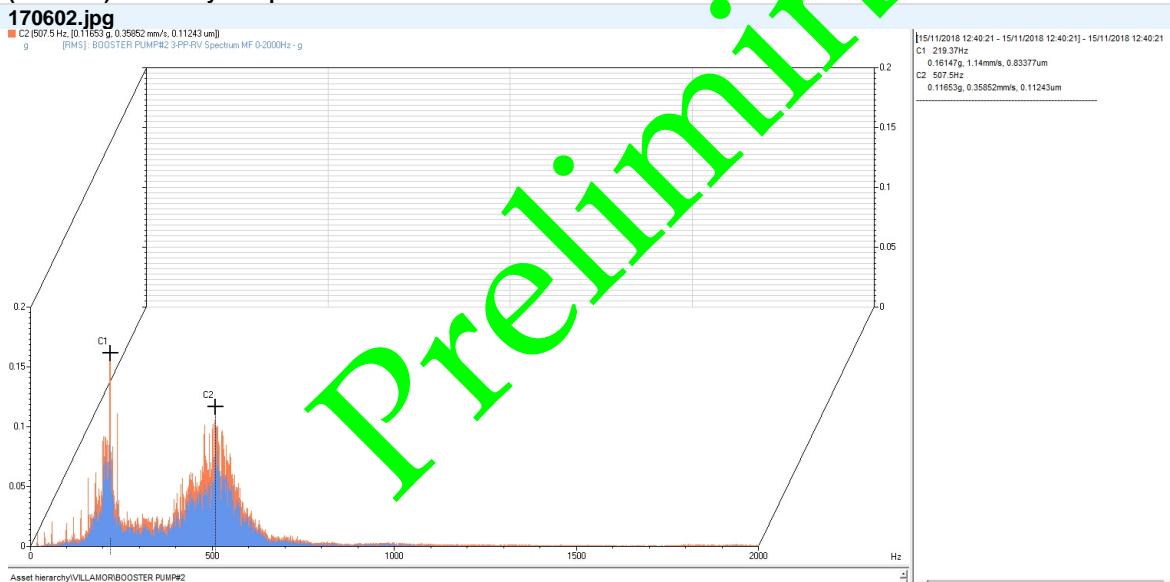
Elevated Base of Spectrum at high frequency range is an indication of Pump Cavitations
b0648.jpg

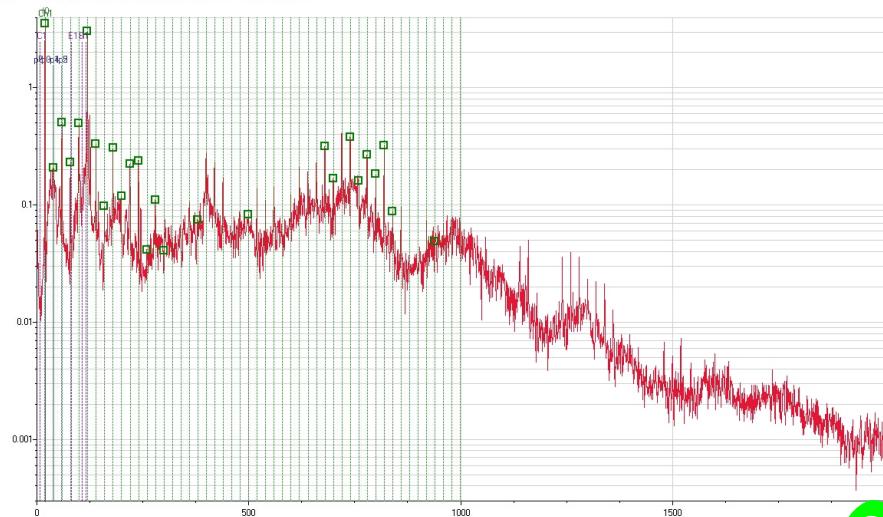
BOOSTER PUMP#4 3-PP-Ax Spectrum MF 15/11/2018 12:50:45

Ch1: 19.97Hz, 3.56mm/s
2: 39.95Hz, 0.2051mm/s
3: 59.93Hz, 0.5038mm/s
4: 79.91Hz, 0.231mm/s
5: 99.90Hz, 0.1901mm/s
6: 119.88Hz, 0.36mm/s
7: 139.84Hz, 0.3231mm/s

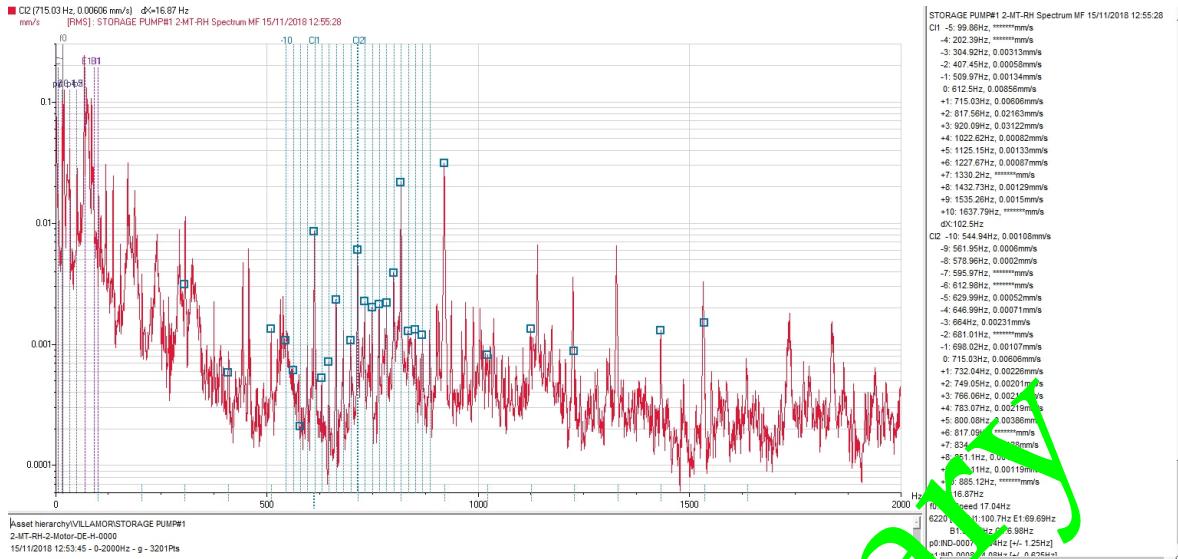
f09a0.jpg

Early Stage Motor DE Bearing Defect

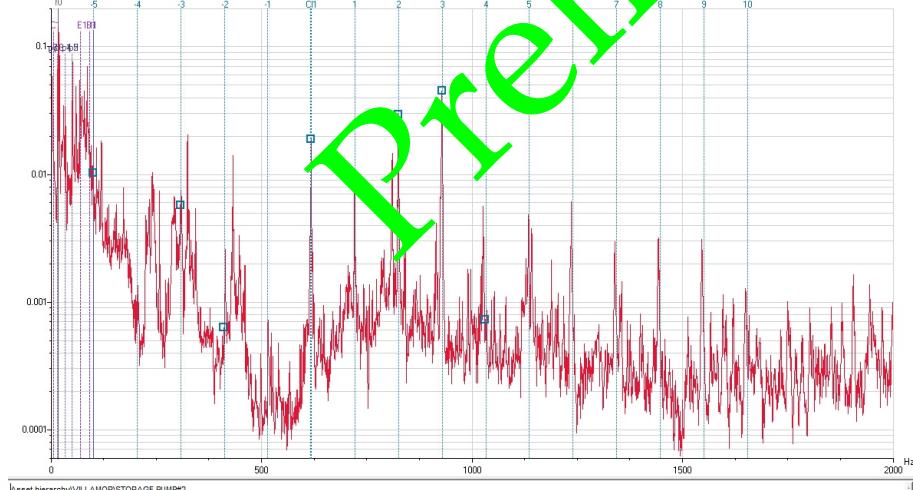
STORAGE PUMP#2 2-MT-RH Spectrum MF 15/11/2018 12:44:29

CII (617.94 Hz, 0.01883 mm/s) dX=103.12 Hz
