Consultancy Services for the Plant Audit in various Pump Stations and Reservoirs (OP18REFCS03)

Technical Report for VILLAMOR Pump Station (Excluding Electrical Testing)
reference: OP18REFCS03-GHD-VIL-REP-G001B

Title:
Final Report for Villamor Pump Station

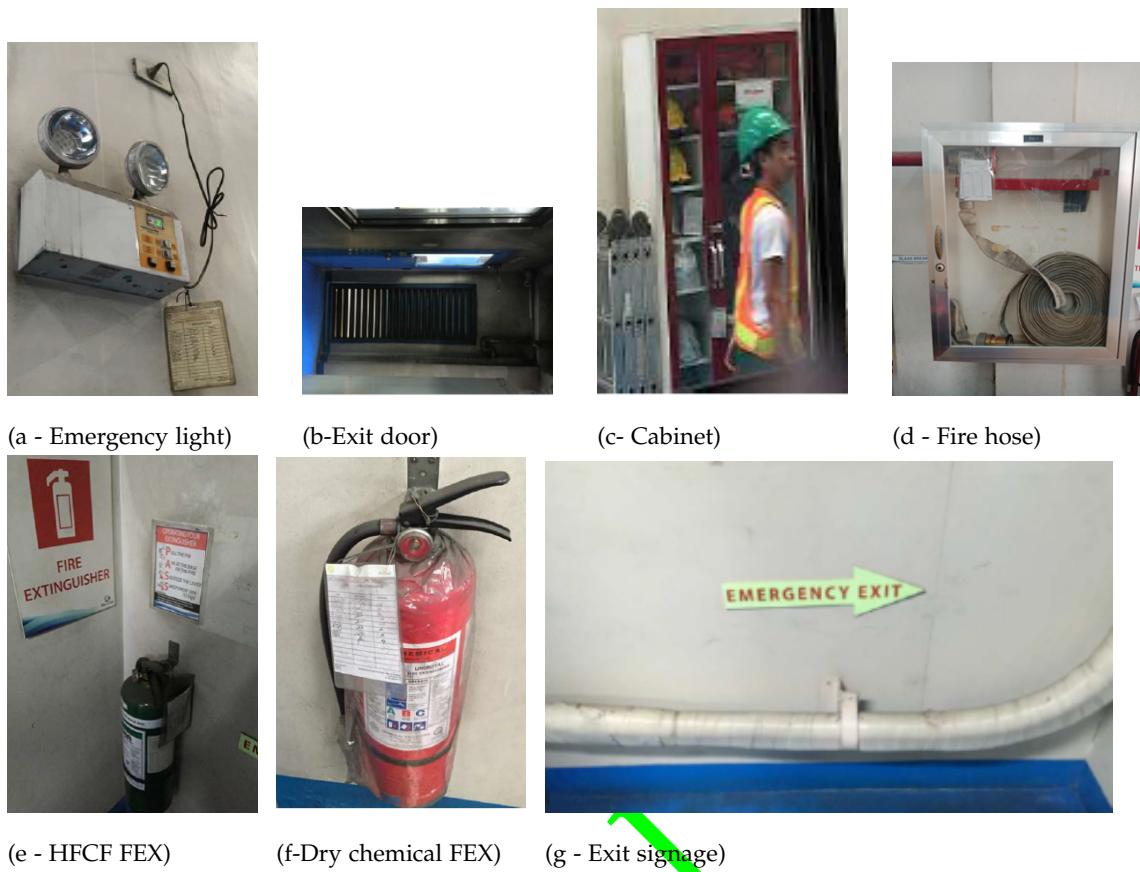
**Figure 4.19:** Existing safety devices**Table 4.27:** FDAS analysis.

- Most of the smoke detector devices, manual call point, buzzer and the FACP were not functioning. These were established during the conducted testing of FDAS and devices;
