Consultancy Services for the Plant Audit in various Pump Stations and Reservoirs (OP18REFCS03)

Technical Report for Noveleta (NVL) Pump Station
reference: OP18REFCS03-GHD-NVL-REP-G001B

Title:
Preliminary Report for Noveleta (NVL) Pump Station

Theme:
Plant Audit and Asset Management

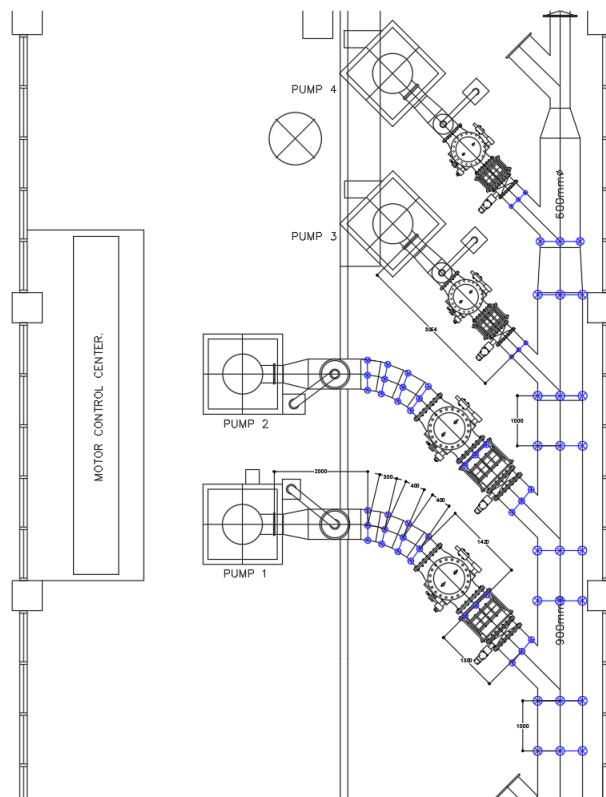
**Figure 4.1:** Test points and distances of UTG – Booster Pumps Discharge Side

Thickness data on discharge pipes of pumps is presented in Table 4.1 and refer to Figure 4.1 for the positions and the distances for the Ultrasonic Thickness Gauging (UTG).

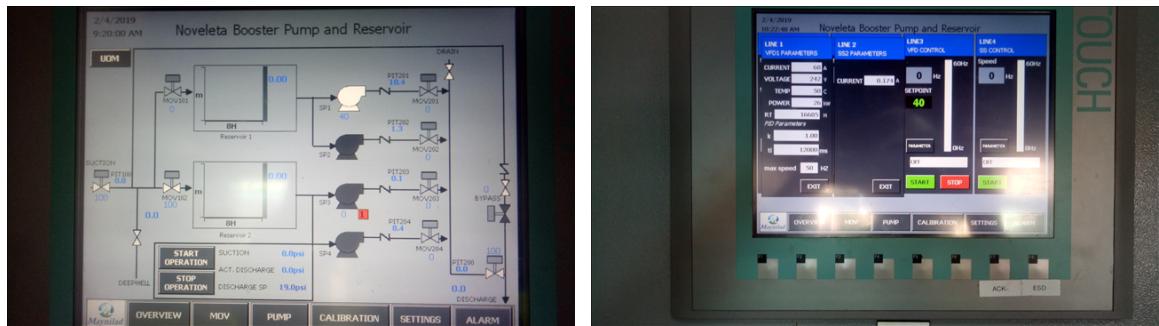
Figure 4.5: Discharge side piping

The PLC needs to checks and fixed to give complete and accurate readings which as important for consistent plant monitoring. Many values found in the display are either zero (Figure

4.5 - a and Figure 4.5 - b) and do not help the operator at all.

a - PLC overview

b - PLC parameters

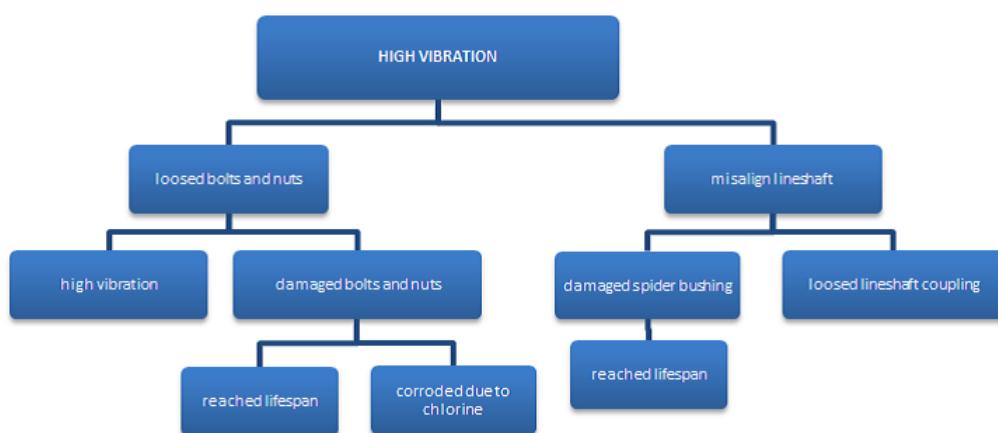
Figure 4.7: CI - Root Cause Analysis

This may prove significance in improving CI effectiveness. Consider the following possible root cause as presented in a CI report (Figure 4.7).

It can be seen that monitoring devices such as those for vibration are important to easily detect disturbances and immediately call for diagnosis of looseness or mis-alignments to avoid such to escalate to major problems requiring major overhaul and/or replacement.

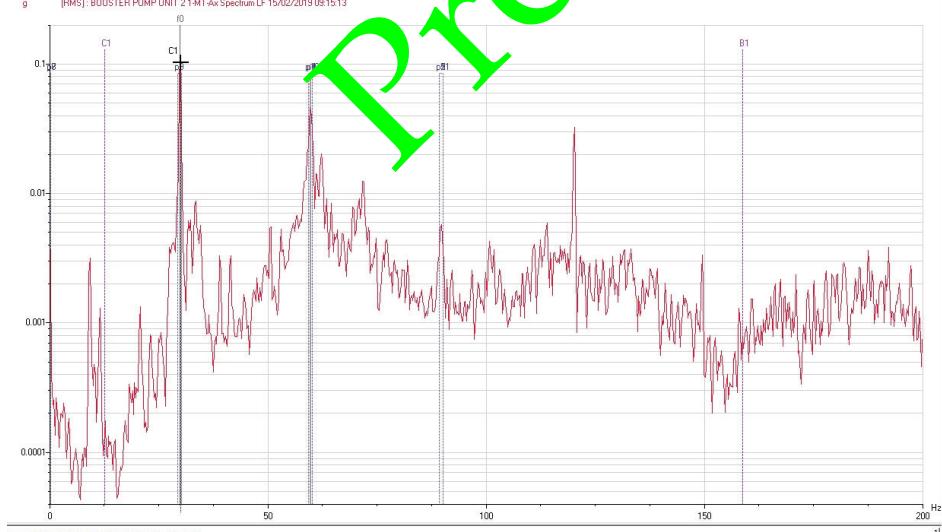
C1 (30 Hz) [0.1031 g, 5.36 mm/s, 28.46 um]
g [RMS] BOOSTER PUMP UNIT 2 1-MT-Ax Spectrum LF 15/02/2019 09:15:13

BOOSTER PUMP UNIT 2 1-MT-Ax Spectrum LF 15/02/2019 {
C1 30Hz
I0 100Hz, 5.36mm/s, 28.46um
p1 Rot Speed 29.92Hz [+- 0.5Hz]
722289P (SKF) H1273.16Hz E1205.55Hz
B1 158.87Hz C1:12.56Hz
p0:ND-0007 29.92Hz [+/- 0.5Hz]
p1:ND-0008 59.84Hz [+/- 0.25Hz]
p2:ND-0009 89.76Hz [+/- 0.5Hz]
p3:ND-0010 119.68Hz [+/- 0.5Hz]
p4:ND-0011 59.84Hz [+/- 0.25Hz]
p5:ND-0012 89.76Hz [+/- 0.5Hz]
p6:ND-0013 0Hz [+/- 0.5Hz]
p7:ND-0014 0Hz [+/- 0.5Hz]
p8:ND-0015 0Hz [+/- 0.5Hz]
p9:1x 29.92Hz [+/- 0.5Hz]
p10:2x 59.84Hz [+/- 0.5Hz]
p11:3x 89.76Hz [+/- 0.5Hz]

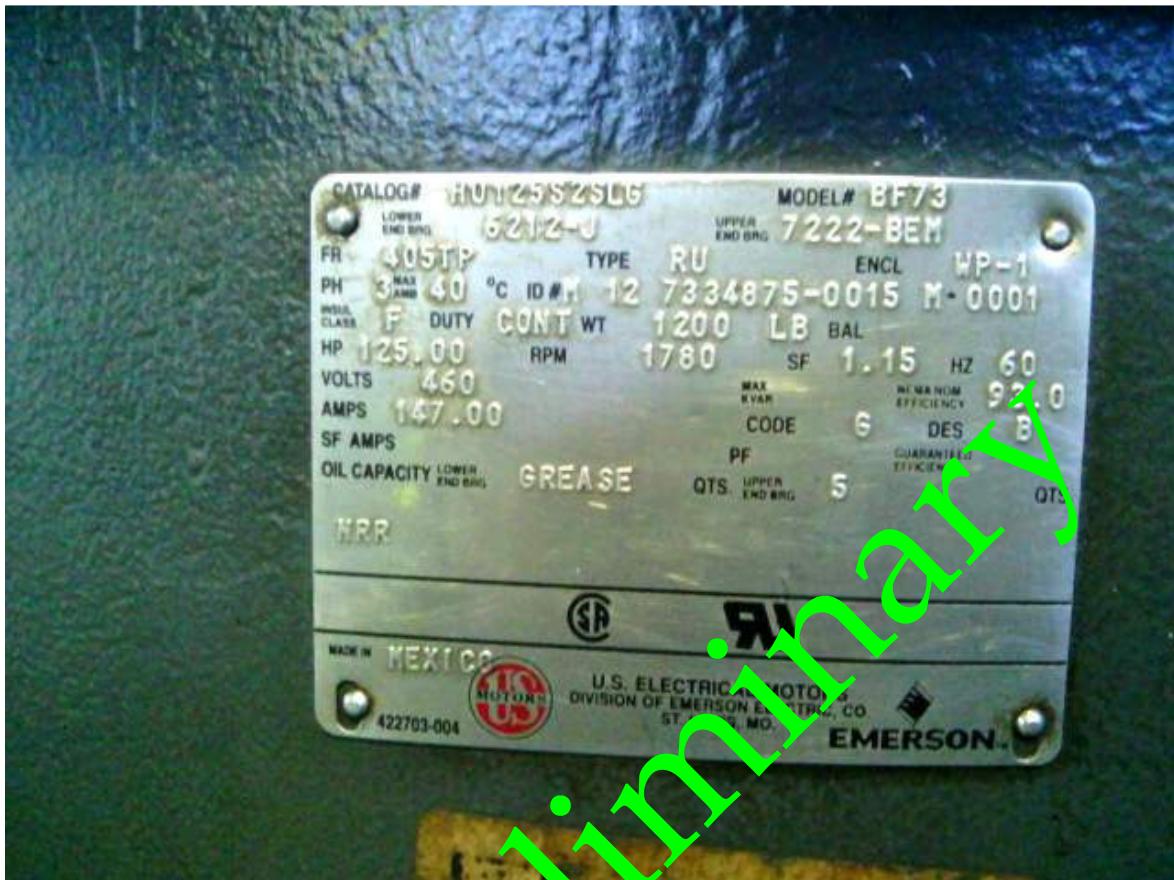
IP4.jpg

Location	NOVELETA\					
Designation	NOVELETA PUMP STATION					
Equipment	BOOSTER PUMP UNIT 4					
Designation						
Abbreviation	BP#4					
Serial No						
Model						
Periodicity (d)	Normal 60	Alarm 15				
Previous Advice		Condition	Rotation Speed			
Date	GOOD 15/02/2019 09:19:08		Health is good for a long time service without restriction. Speed 29.9 Hz / 1791 rpm Author u1 System - Serial FALCON - 11407 Sensor _____ Connector _____			
Condition	DfCnd					
Diagnosis & Recommendation	Parameters sheet					
Diagnosis						
Vibrations are within acceptable levels						
Overall state still acceptable for the component 'Electric motor'.						
Recommendations						
Continue monitor vibrations periodically						
Continue monitor vibrations periodically
