Technical Bulletins Sorted By Bulletin Number
Generated 03/06/92

DATE: January 16, 1985
REVISION DATE: February 13, 1985
BULLETIN NO.: 6000:1
PRODUCT: 26-6021/2 (Tandy 6000)
 26-6014 (8 MHz CPU upgrade kit)
SUBASSEMBLY: 8 MHz 68000 CPU board

PURPOSE: To correct data setup time to memory board during a write cycle.

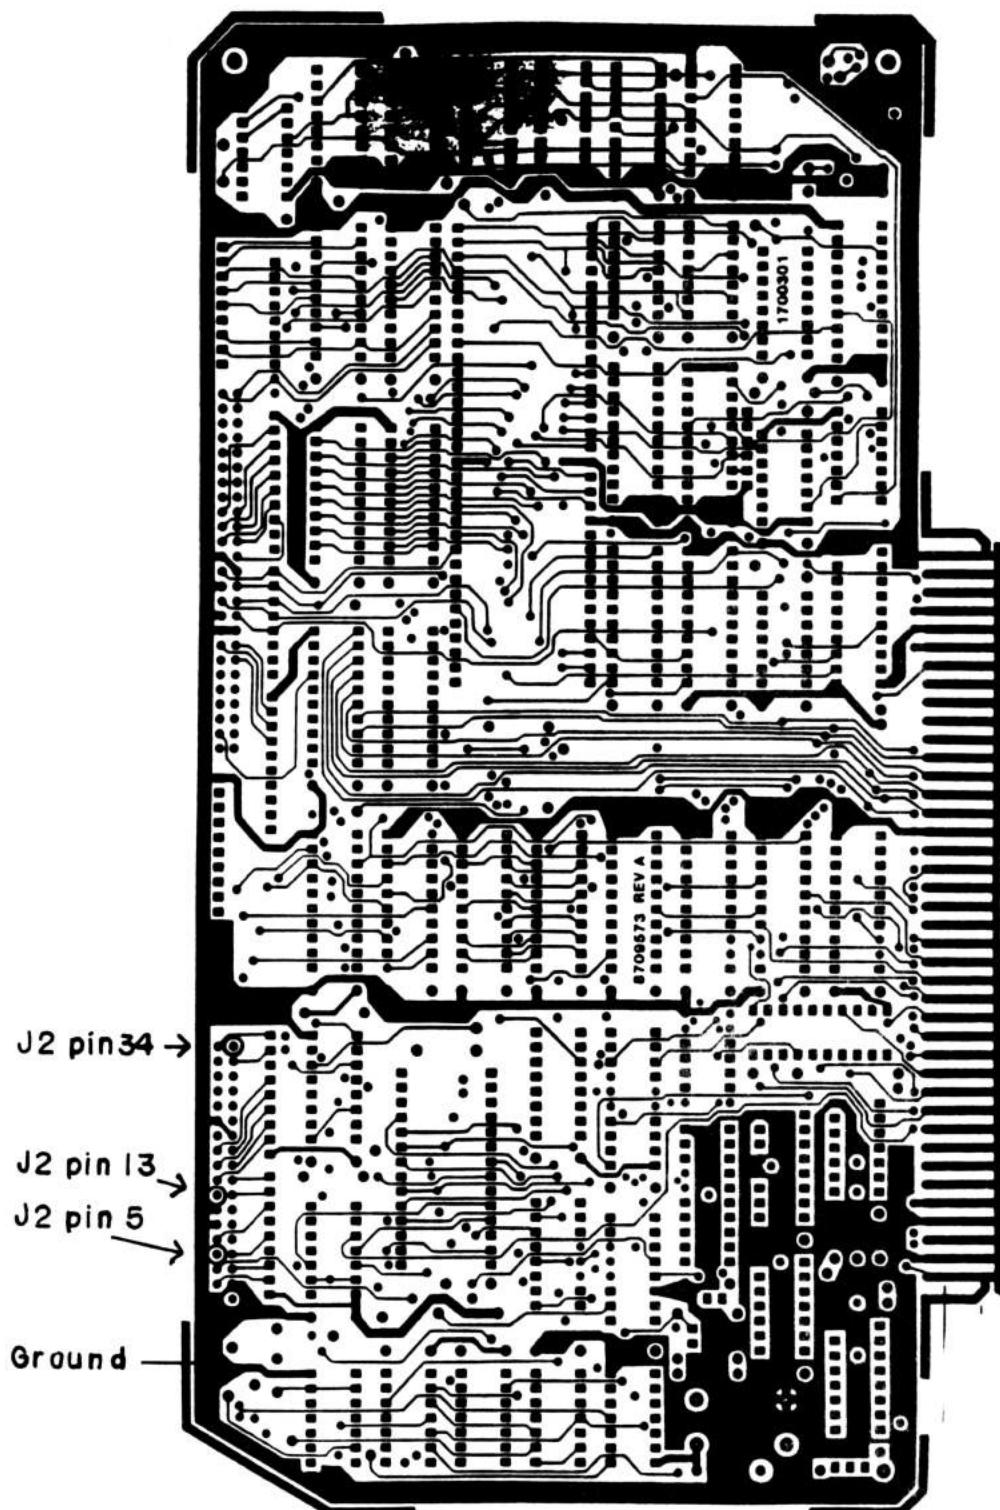
SOLDER SIDE (LAYER 4)

Due to an error in the artwork on early revision (Revision A) boards, a modification to insure good ground connections between the 68000 CPU board and associated memory boards is required.

Ground may be found at the feed-throughs on the ground plane near J2 on the solder side on the board.

Using wire wrap wire, install the following jumpers on the solder side of the 68000 CPU board:

- (1) Jumper J2, pin 5 to ground.
- (2) Jumper J2, pin 13 to ground.
- (3) Jumper J2, pin 34 to ground.

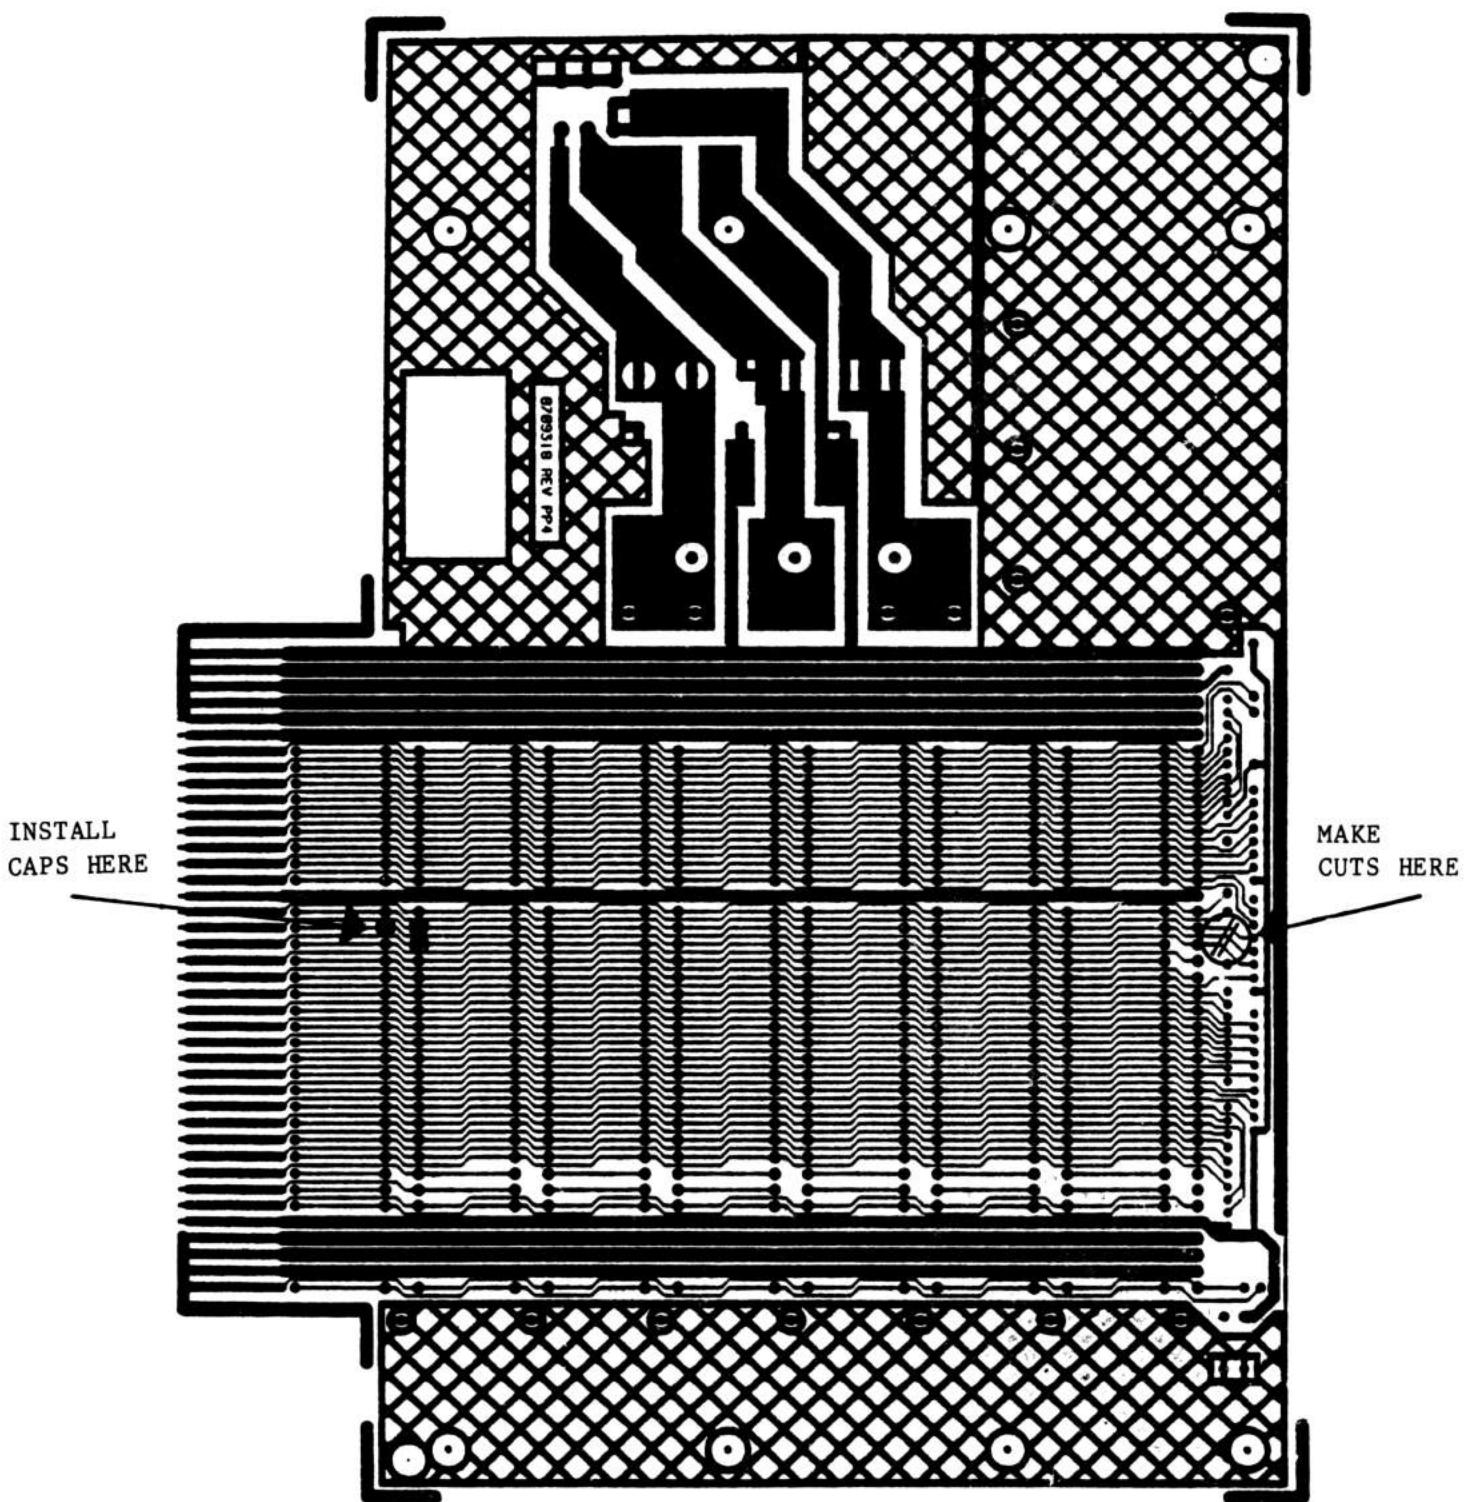
PURPOSE: To correct errors in artwork and prevent bus errors.

To prevent bus errors, three traces need to be cut away from a resistor pack and three capacitors need to be installed on the card cage mother board.

On mother boards of revision levels prior to Rev. B, pins 3, 4, and 5 on resistor pack R6 need to be cut.

On mother boards of revision level Rev. B or later, pins 4, 5, and 6 on resistor pack R6 need to be cut.

On boards of all revision levels, three (3) 220 pf caps should be jumpered from pins 44, 45, and 46 to ground on the bottom-most connector. These pins correspond to the traces cut on the resistor pack R6. See Figure 1 for clarification. The capacitors needed for this modification may be ordered as:

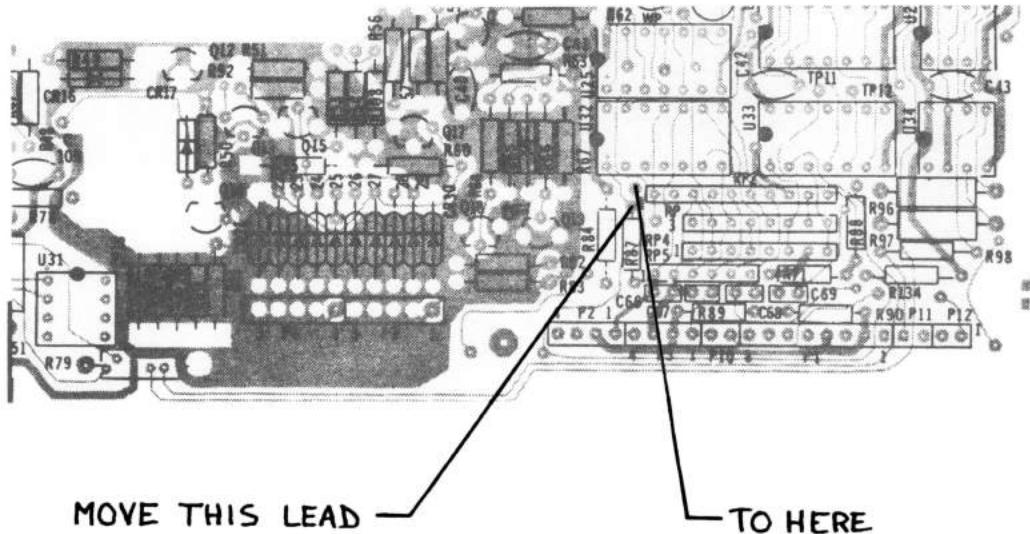
PURPOSE: To correct an error in installation of R87

DISCUSSION: Some Tandon Belt Drive Logic Boards (Rev. Y) have come from the vendor with R87, a 150 ohm pullup resistor, installed incorrectly. These boards may be identified by the existence of a small white sticker (bearing a bar code, three numbers, and the letter "Y") attached to the board right next to the "REV" marking. The defective boards will not see the index pulses at all and will not recognize an inserted diskette, i.e. will remain at the "Insert Diskette" prompt even after a diskette is inserted and the drive door is closed.

PROCEDURE: Locate R87 on the Drive Logic Board. Note that one lead is connected to a feedthrough which has a trace running to U32, pin 1. Unsolder this lead of R87 and resolder it to the feedthrough right above it. The correct feedthrough is a +5V trace.

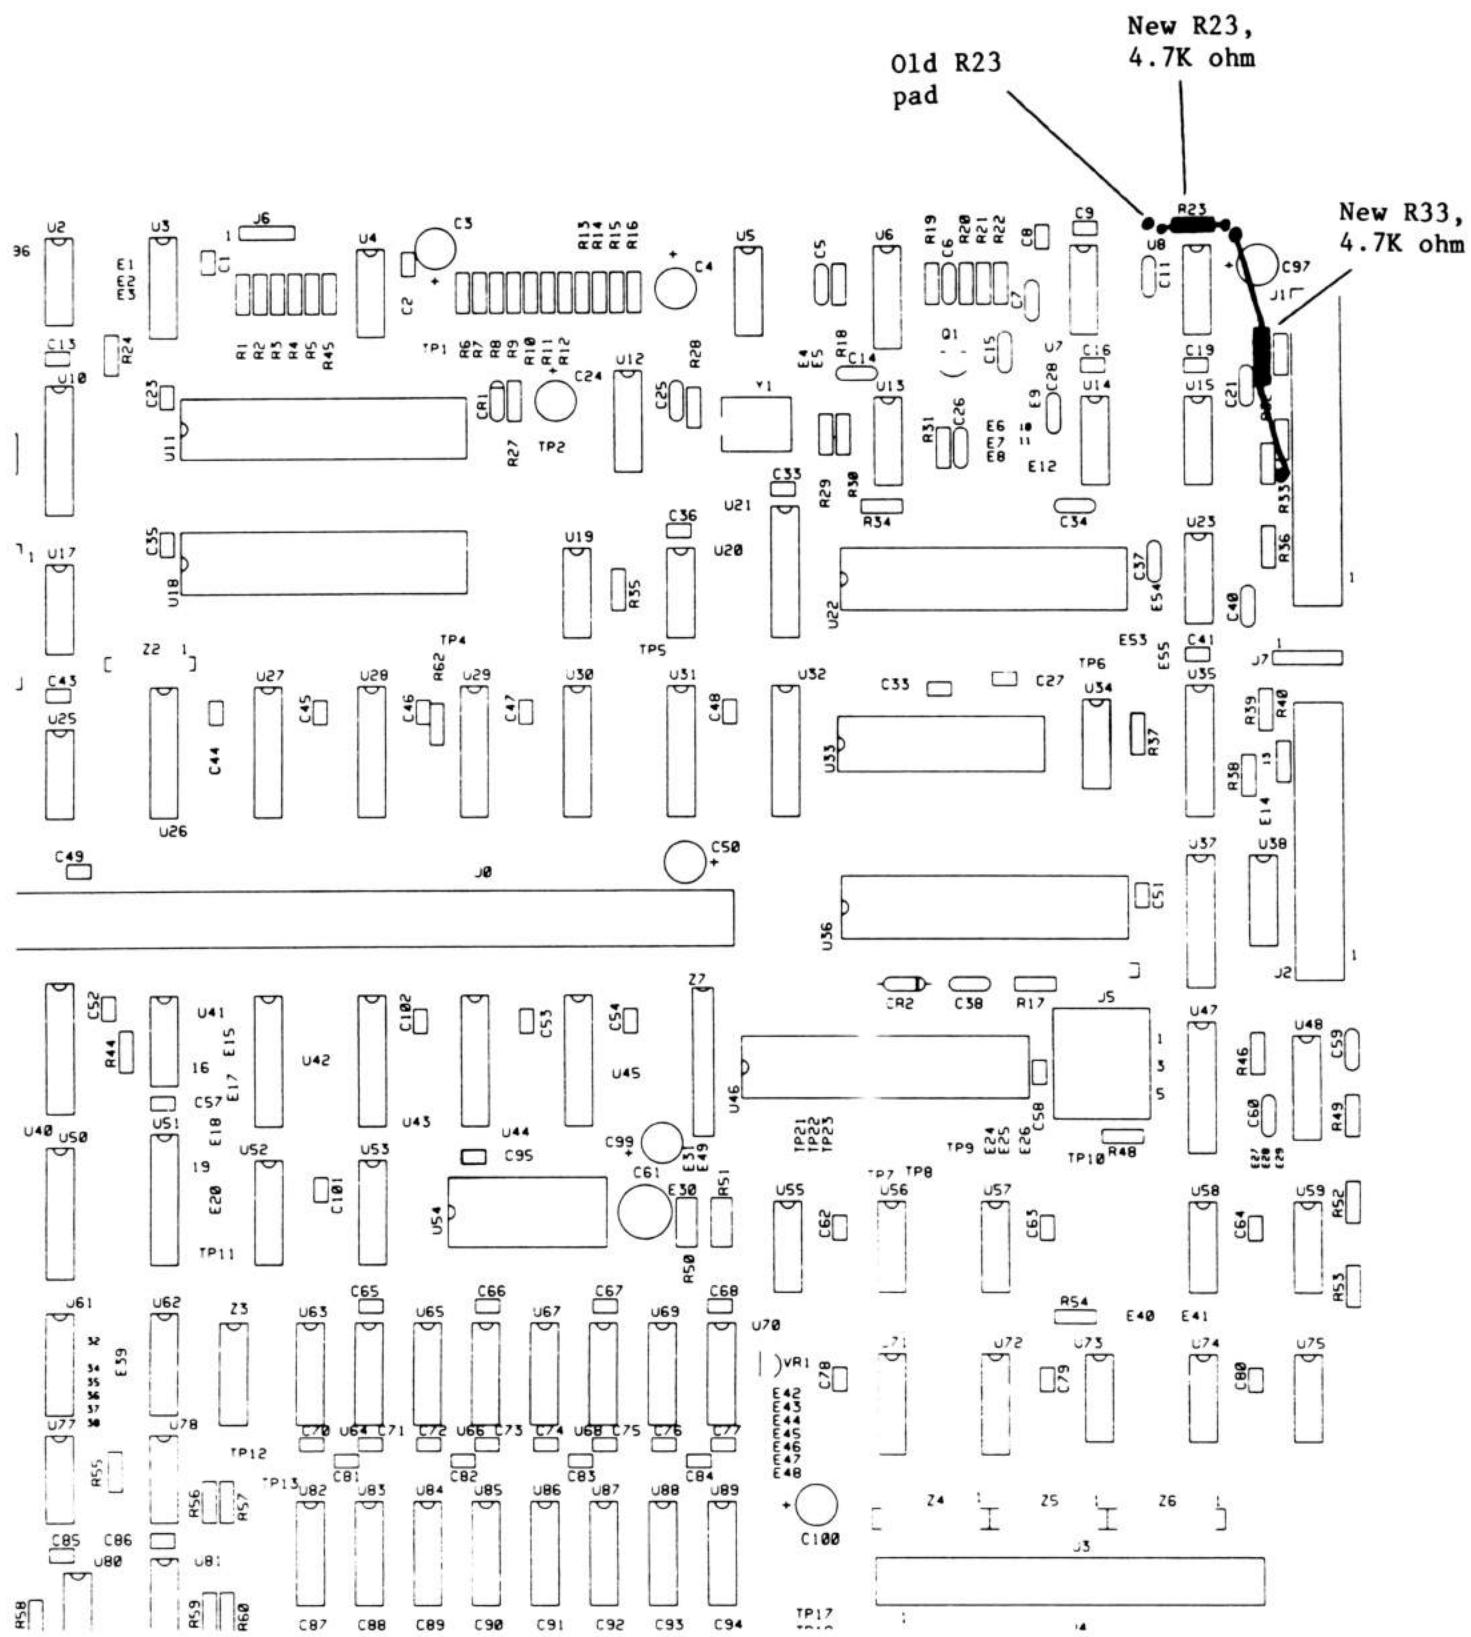
To make the serial ports more reliable the pullups for SIO control signals need to be changed. The pullup for carrier detect needs to be changed not only in value, but from -12V to +12V so that it is normally true. This modification is required on all Rev. Blank boards.

On some boards which display problems initializing port B in Xenix operation (i.e. boards which refuse to communicate with terminals on port B), an additional modification may be necessary, which pulls carrier detect normally true on port B as well as on port A. This modification may be necessary on both Rev. Blank and Rev. A main logic boards.

Change R21, R23, R25, R32, R36 from 10K ohm to 4.7K ohm resistors. Remove resistor R33. On the component side of the board, install a 4.7K ohm resistor with one lead attached to the old R33 solder connection closest to R36 and the other lead attached to the +12V line at the feedthrough adjacent to R23 between U8 and C97 (refer to figure 1). The leads should be insulated to prevent them from shorting.

Remove resistor R23. On the component side of the board, install a 4.7K ohm resistor with one lead attached to the old R23 solder connection closest to C97, and the other lead attached to the +12V line at the feedthrough adjacent to the remaining R23 solder connection. The +12V line in question also connects directly to U7, pin 14 (refer to figure 1).
