**REPORT OF OUT OF WATER SURVEY**

**VESSEL** R/V CORAL SEA

**SURVEYED OUT OF WATER AT** TOLEDO SHIPYARD, TOLEDO, OR.

**DATE** 6/15/2022

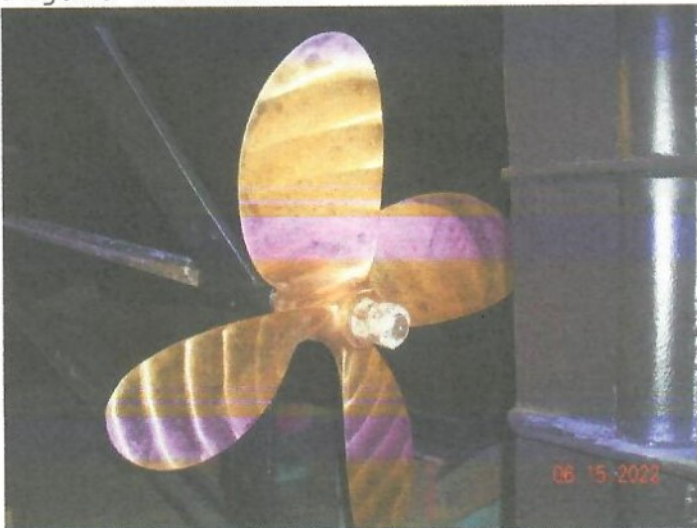
Figure 5 PROPELLER

PROPELLERS 1 EA 48"D X 32"P LH & RH 3-BLADE BRONZE (NEWLY RECONDITIONED)
