MISSION REPORT / RAPPORT DE MISSION

Humberstone and Santa Laura Saltpeter Works (Chile) (1178bis)
Usines de salpêtre de Humberstone et de Santa Laura (Chili) (1178bis)

4-10 November 2018

Report of the ICOMOS Advisory mission to Humberstone and Santa Laura Saltpeter Works (Chile) (1178bis)

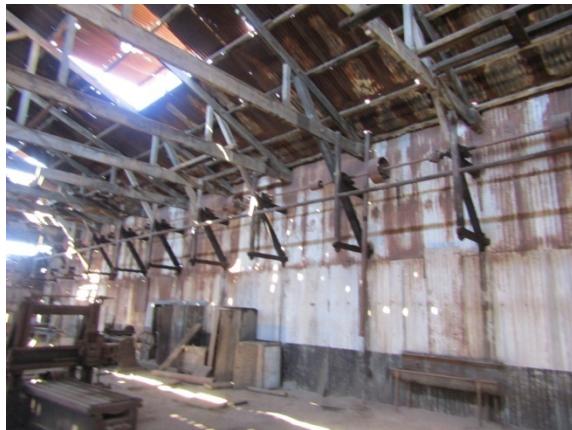
Industrial buildings are mainly built with wooden frame and covered in sheet metal known as *calamina*.

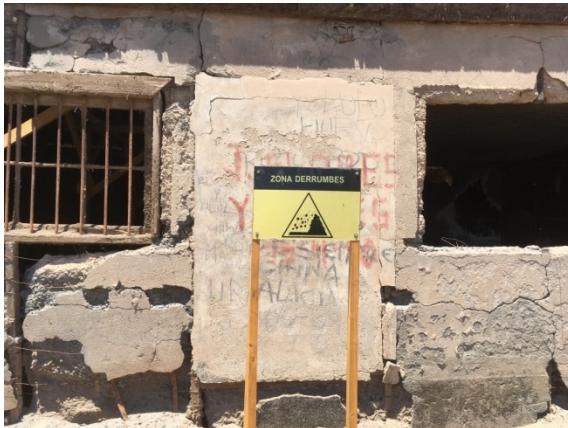
Safety signs for visitors in areas with a possibility of collapse caused by recent earthquakes.

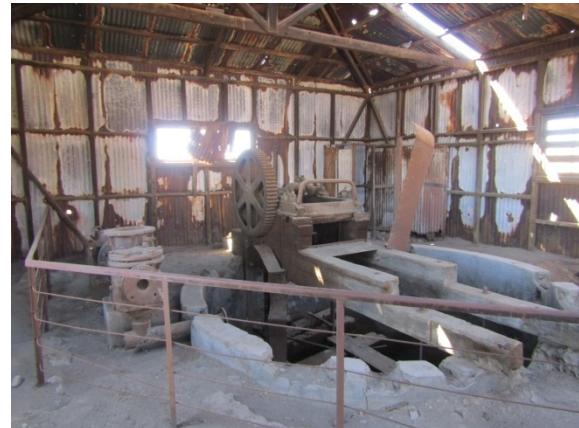
Security barrier for the protection of visitors.

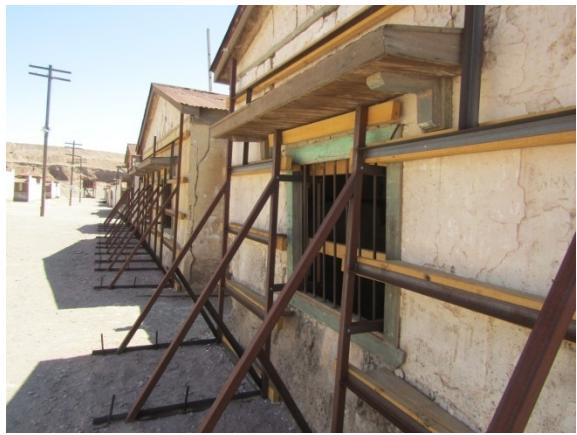
Bracing of buildings damaged by the earthquake of 2014.

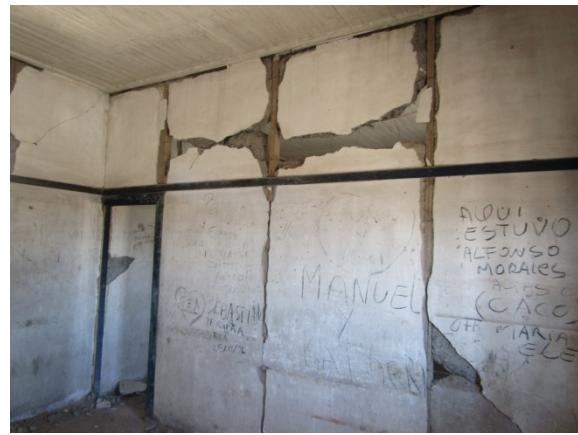
Some of the damage caused by the 2014 earthquake in the housing area.

Continue the works of structural reinforcement, preventive conservation, change of deteriorated material, and restoration of the buildings located in Humberstone and Santa Laura that were affected by the 2014 earthquake, particularly in the residential area of unmarried workers. The State Party should assess the appropriateness of reconstructing buildings that collapsed as a result of the 2014 earthquake using the same materials and construction systems.

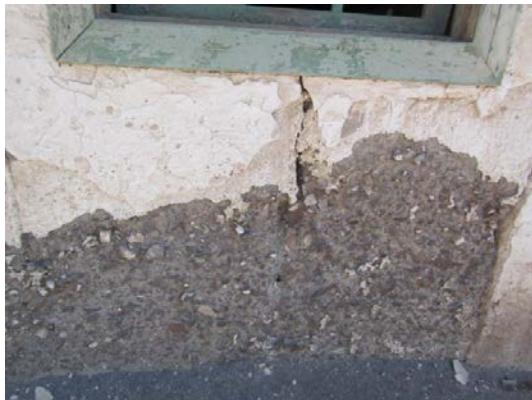
Deterioration in walls caused by the high salinity of the ground.

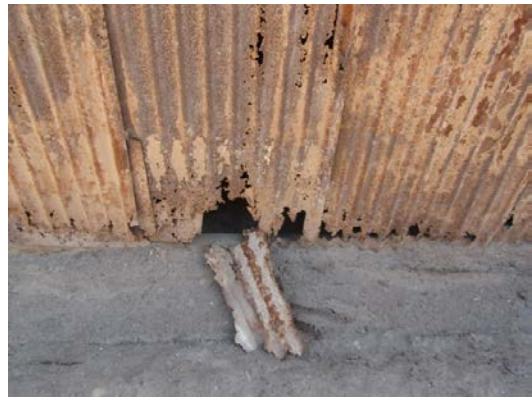
Degradation of the *calamina* by the action of saltpeter.

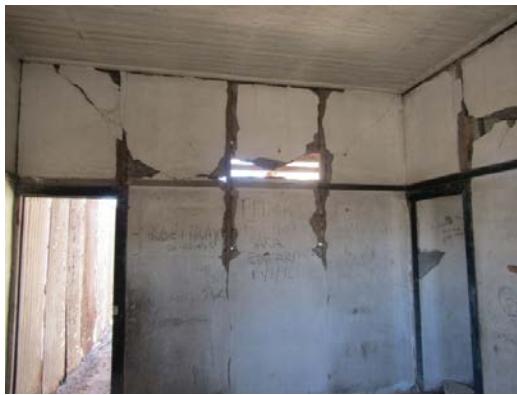
Restoration works of buildings in the residential area of Humberstone.

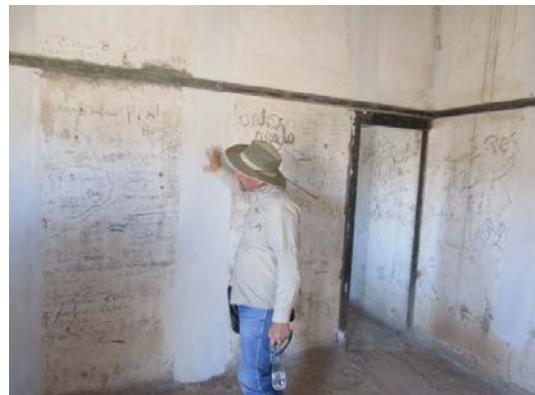
Restoration of walls in some damaged buildings.

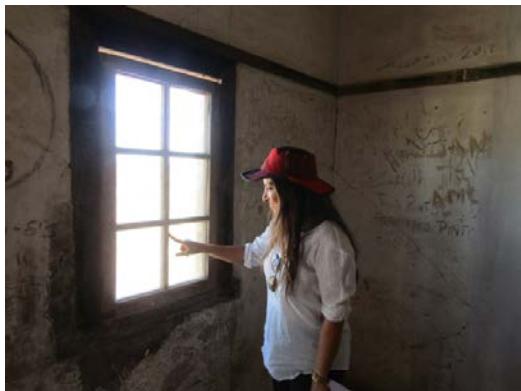
Replacement of windows and glass to protect homes.

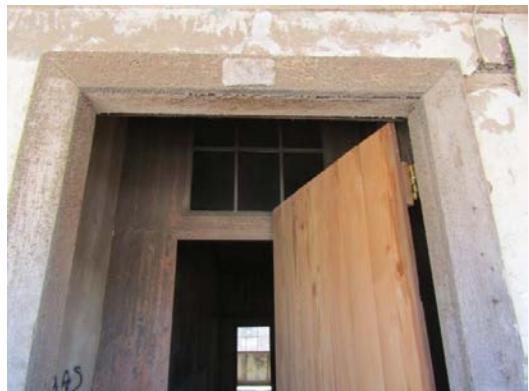
Placement of doors for safety and the protection of buildings.

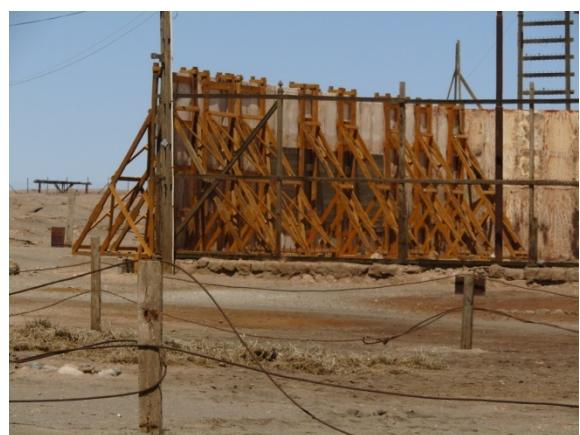
Shoring to prevent collapses on walls affected by the 2014 earthquake.

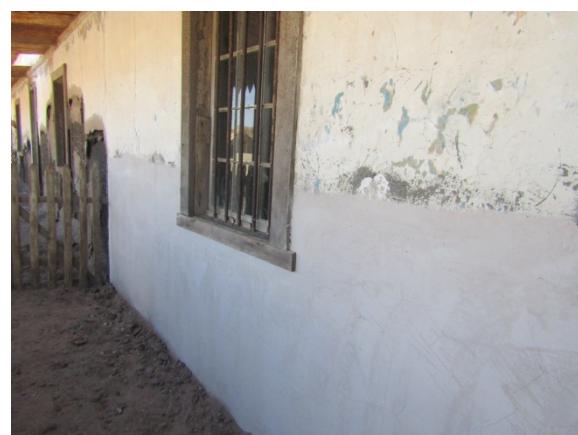
Restoration work in buildings.

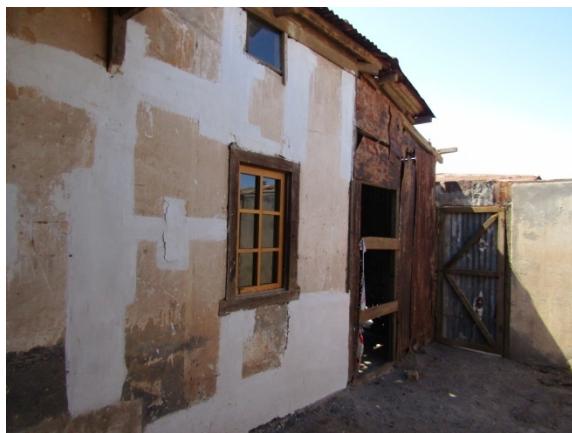
Restoration of walls in homes.

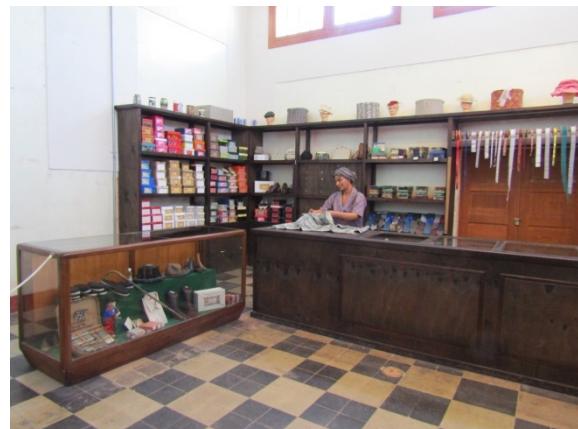
Restoration of the general store of Humberstone, part of implementation of the Management Plan.

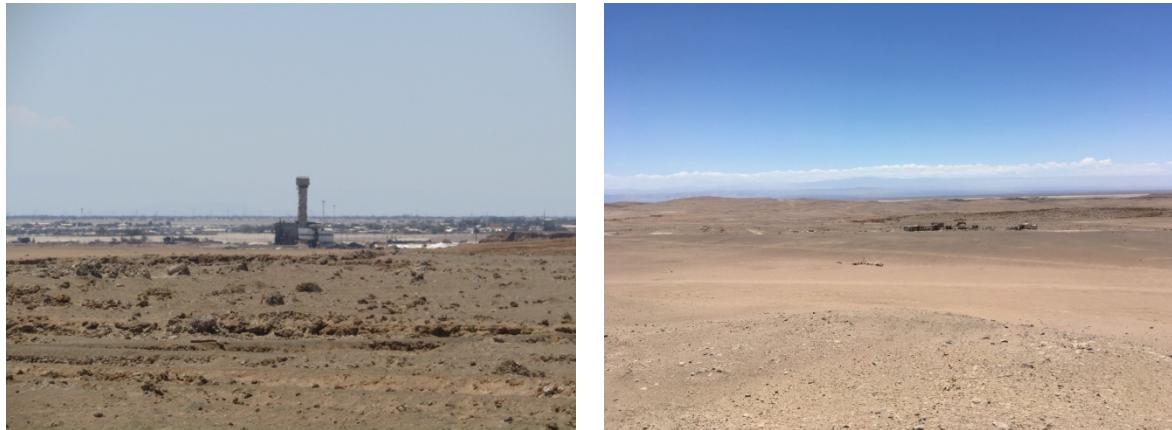
The proposed buffer zone includes all the elements of mining for the better understanding of the cultural values of the property.

The buffer zone includes a part of the Atacama desert landscape.

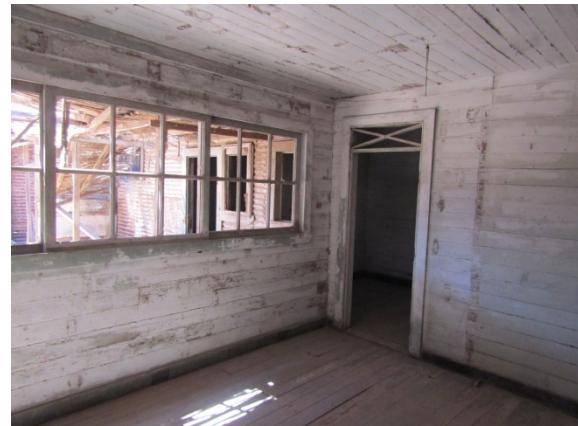
The recovery of buildings in Humberstone is part of the effective implementation of the Management Plan.

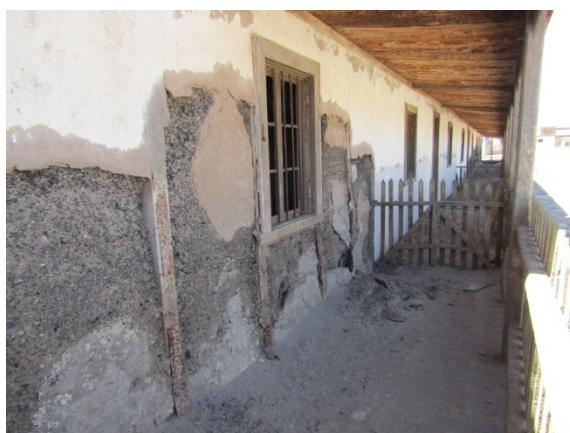
Work for the scientific assessment of the state of conservation of the materials of the historical buildings.

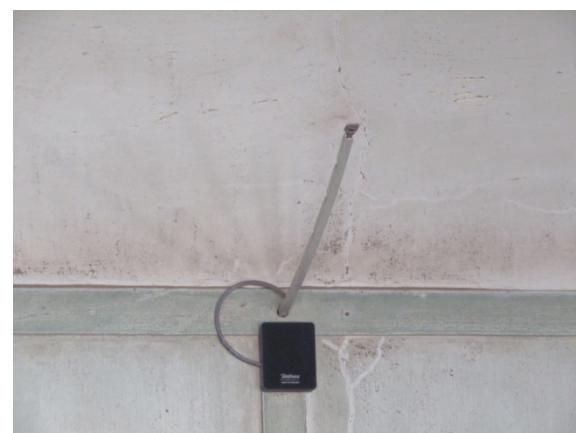
Sensors for monitoring weather conditions have been installed for the evaluation of the effectiveness of interventions.
