## Alonzo Inspections

| <b>Client:</b> | Realtor: S. Huang | <b>Report #:</b> | Huang4232026 |
| <b>City/State/Zip:</b> | | | 318 Avalon Ave<br>San Francisco, CA 94112 |

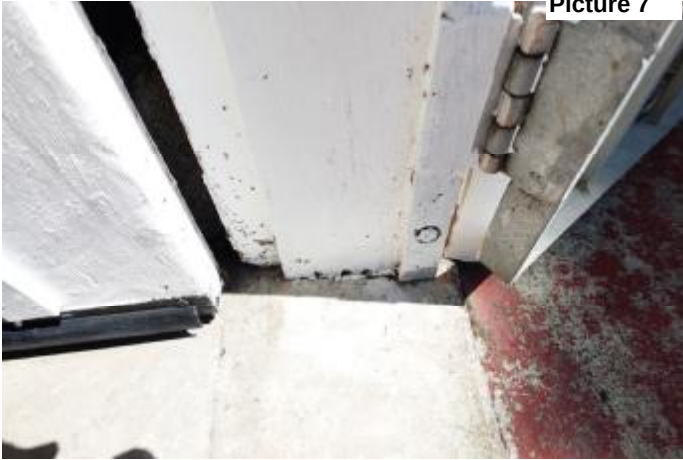
Picture 7

Refer to exterior #10 trim:  
Moisture damage were noted rear exit door at the at the  
time of the inspection. (2) (3)

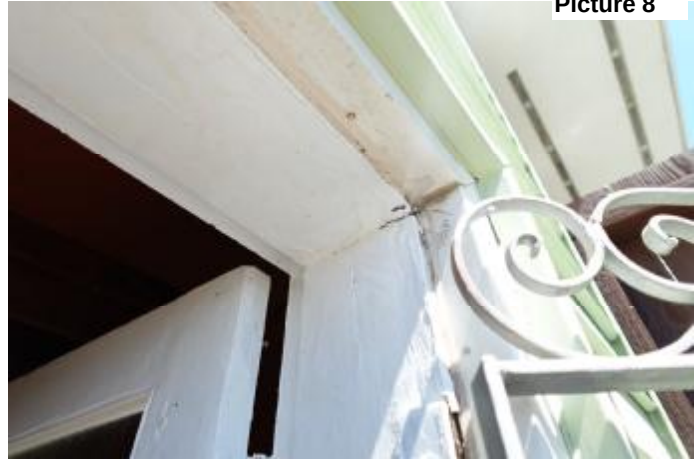
Picture 8

Refer to exterior #10 trim:  
Moisture damage were noted rear exit door at the at the  
time of the inspection. (2) (3)

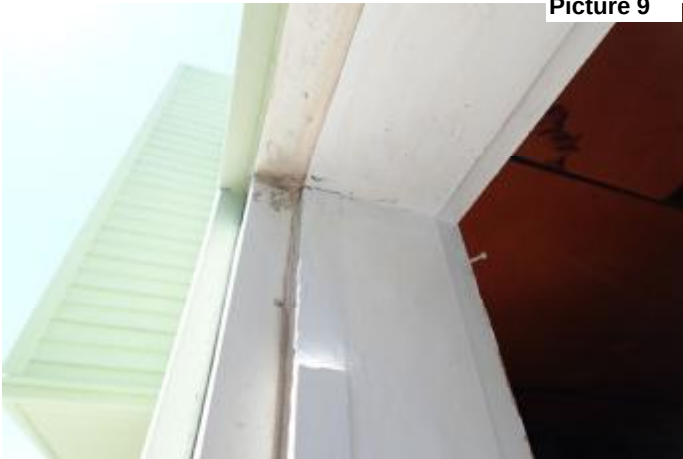
Picture 9

Refer to exterior #10 trim:  
Moisture damage were noted rear exit door at the at the  
time of the inspection. (2) (3)

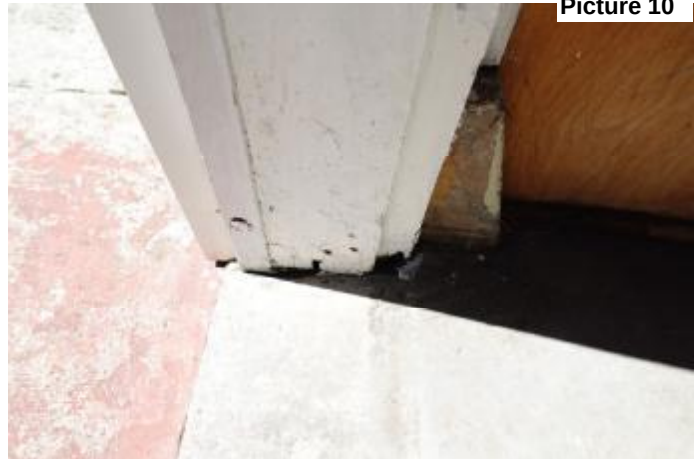
Picture 10

Refer to exterior #10 trim:  
Moisture damage were noted rear exit door at the at the  
time of the inspection. (2) (3)

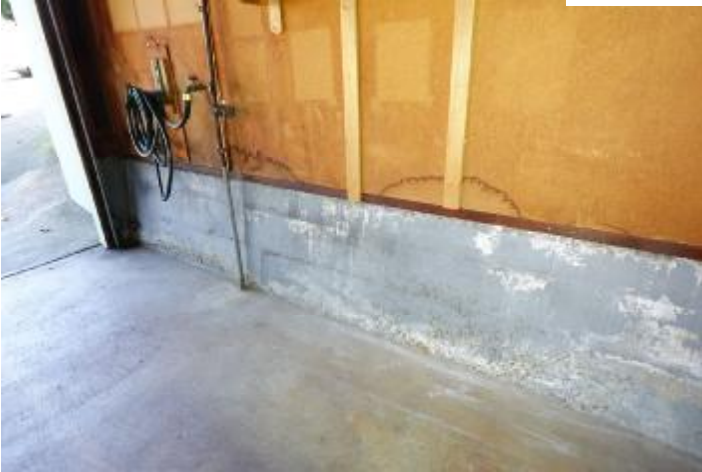
Picture 13

Refer to foundation #18 Basement:

The concrete perimeter and post framing was serviceable. Anchor bolts installed. No readily visible problems were found at the time of the inspection.

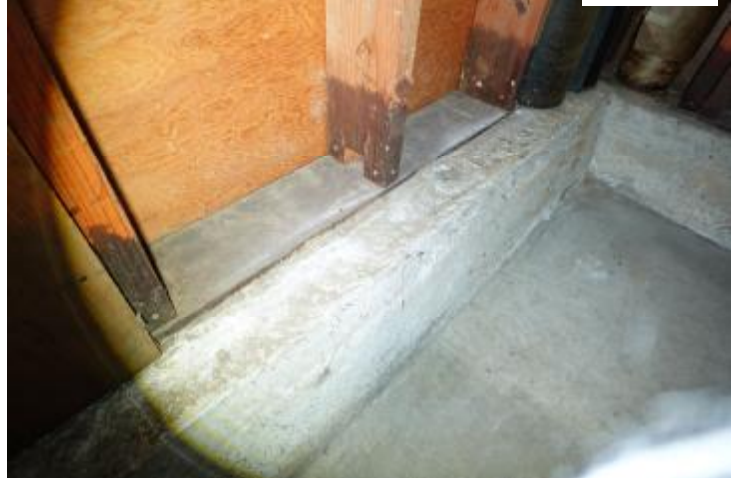
Picture 14

Refer to foundation #18 Basement:

The concrete perimeter and post framing was serviceable. Anchor bolts installed. No readily visible problems were found at the time of the inspection.

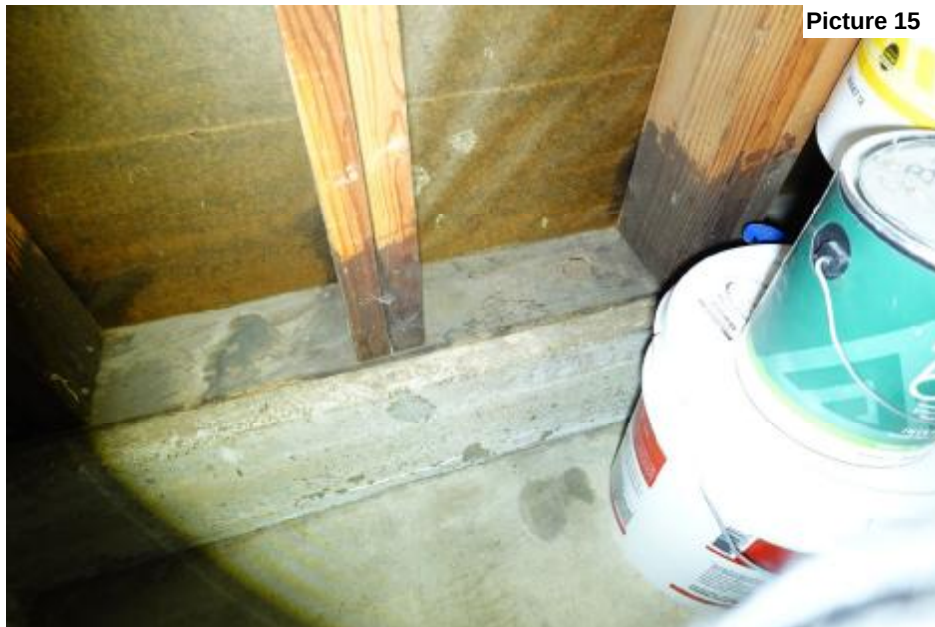
Picture 15

Refer to foundation #18 Basement:

The concrete perimeter and post framing was serviceable. Anchor bolts installed. No readily visible problems were found at the time of the inspection.

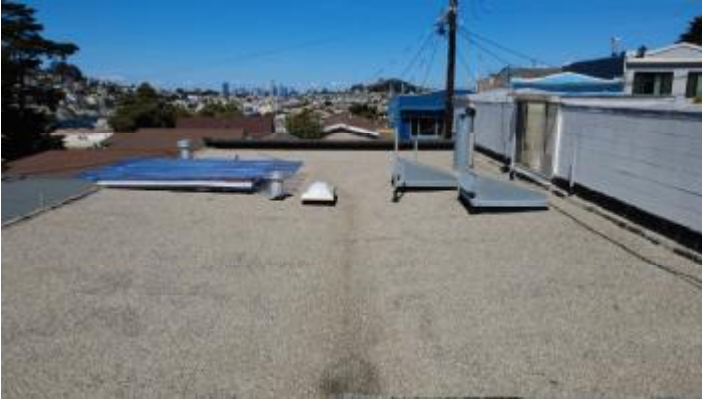
Picture 19

Refer to roof #19 main roof:

The general condition of the Tar and Gravel roof appears to be in serviceable condition with signs of weathering and aging. We recommend regular maintenance and inspection.

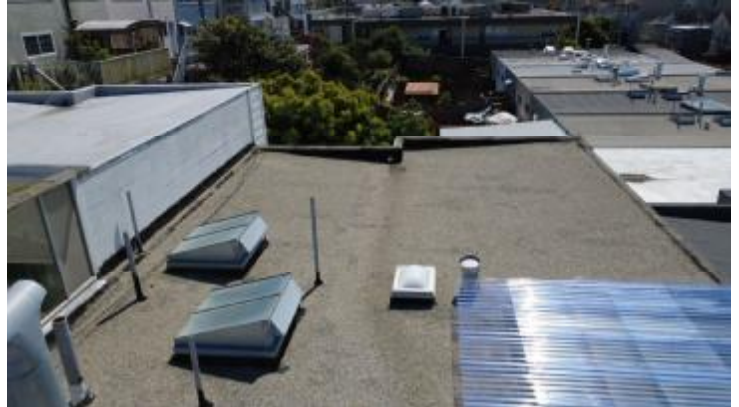
Picture 20

The general condition of the Tar and Gravel roof appears to be in serviceable condition with signs of weathering and aging. We recommend regular maintenance and inspection.

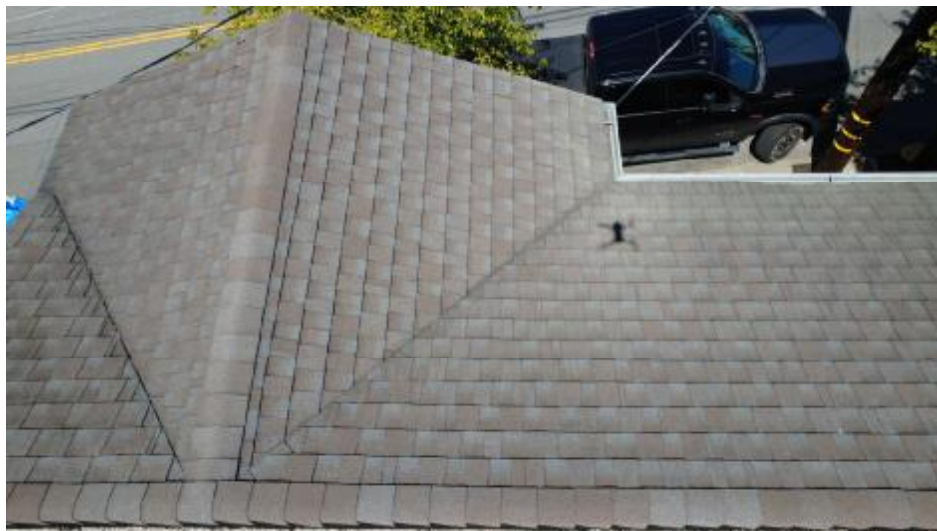
Picture 21

Refer to roof #20 Facade roof:

The secondary Asphalt Composition Shingle facade roof covering appears to be in serviceable condition.

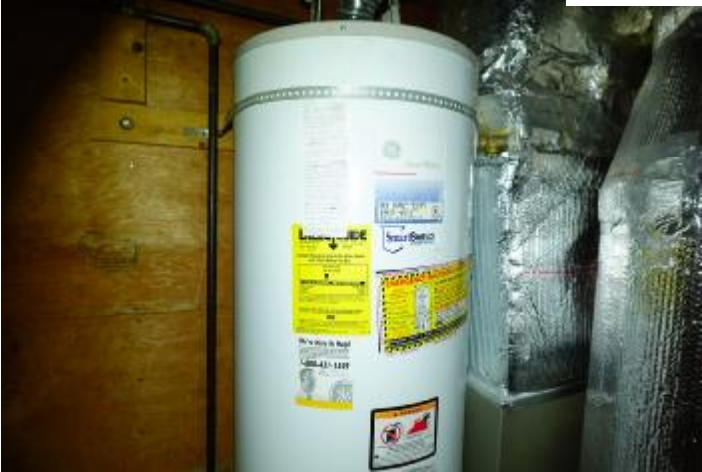
Picture 25

Refer to plumbing #27 water heater:  
Water heater appeared to be serviceable condition at the time of inspection. The water heater had improper seismic straps at the time of the inspection. T P R valve overflow pipe was missing at the time of the inspection.  
(2)

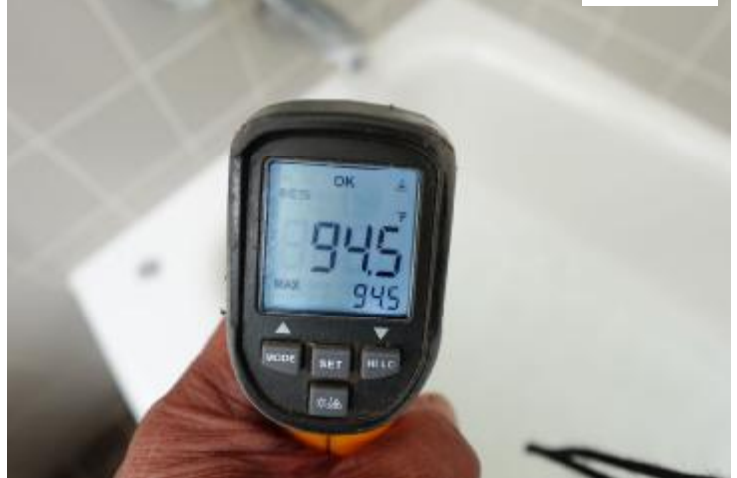
Picture 26

Picture of heated water @ 94 degree's

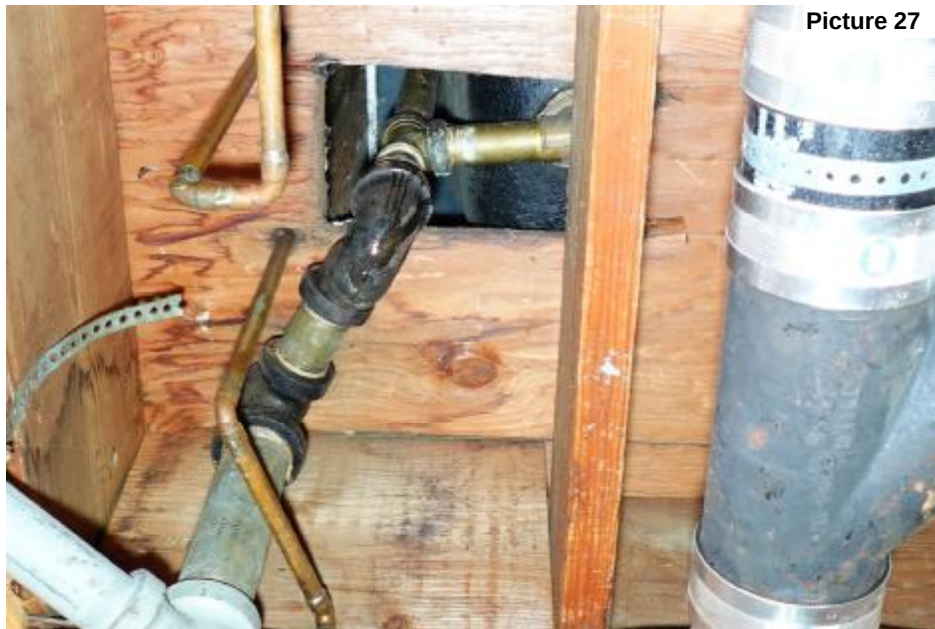
Picture 27

Comments: The bathtub waste lines were actively leaking at the time of inspection. (2)

Refer to plumbing #25 wasteline:  
The bathtub waste lines were actively leaking at the time of inspection. (2)

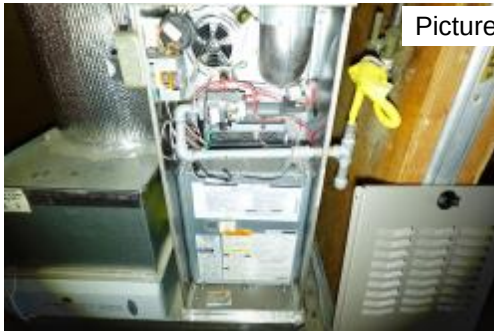
Picture 31

Refer to heating #29 condition:  
The heating system appeared to be operational at time of inspection.

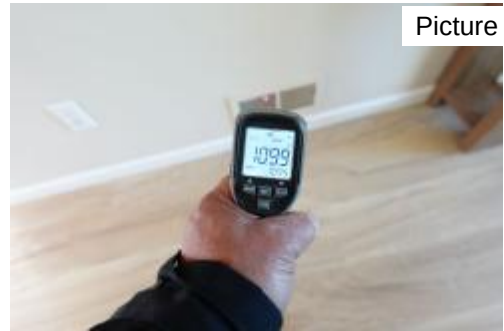
Picture 32

Picture of heated air @ 109 degree's  
Livingroom

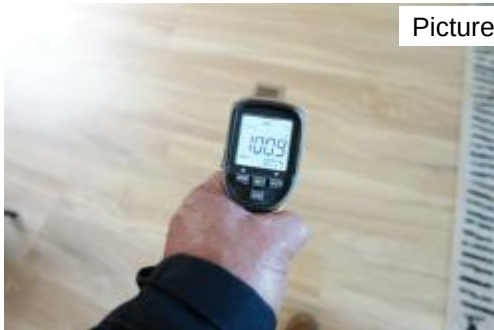
Picture 33

Picture of heated air @ 100 degree's  
Diningroom /Kitchen

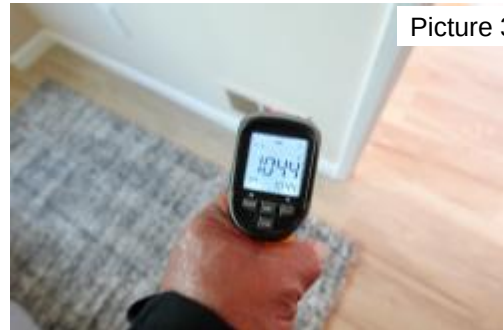
Picture 34

Picture of heated air @ 104 degree's  
Bedroom

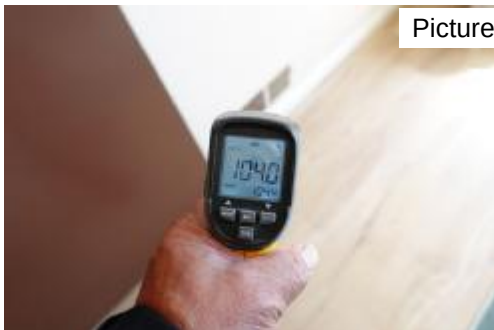
Picture 35

Picture of heated air @ 104 degree's  
Bedroom

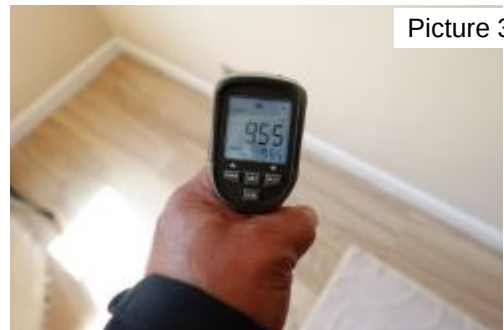
Picture 36

Picture of heated air @ 95 degree's  
bedroom

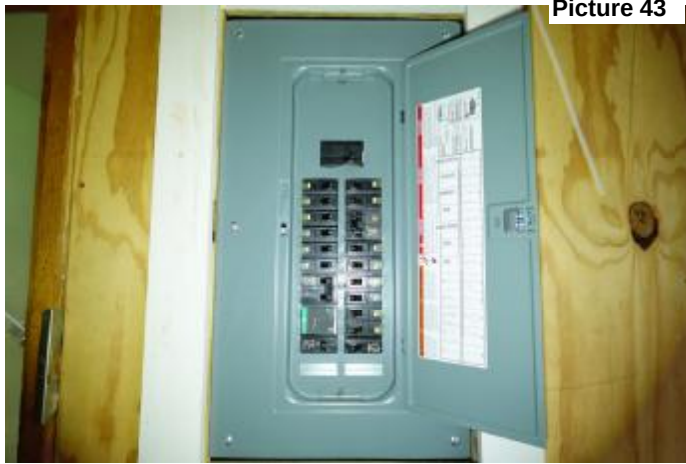
Picture 43

Refer to electrical #40 main panel:  
The main panel appeared to be in serviceable condition at the time of the inspection.

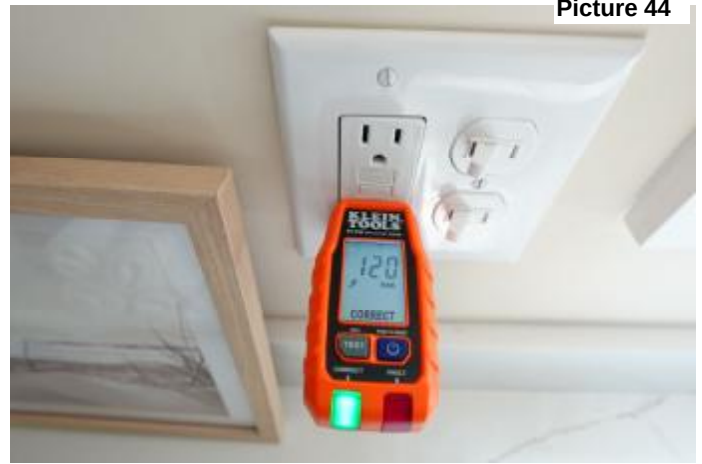
Picture 44

Refer to electrical #44 wiring notes:  
GFCI's responded adequately to test.  
Kitchen

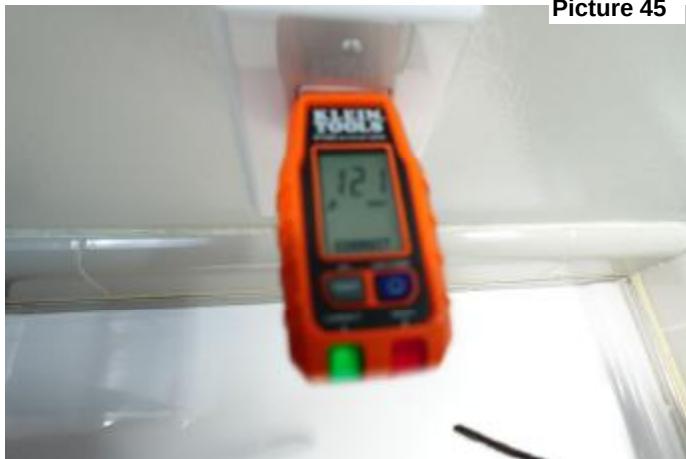
Picture 45

Refer to electrical #44 wiring notes:  
GFCI's responded adequately to test.  
Bathrooms

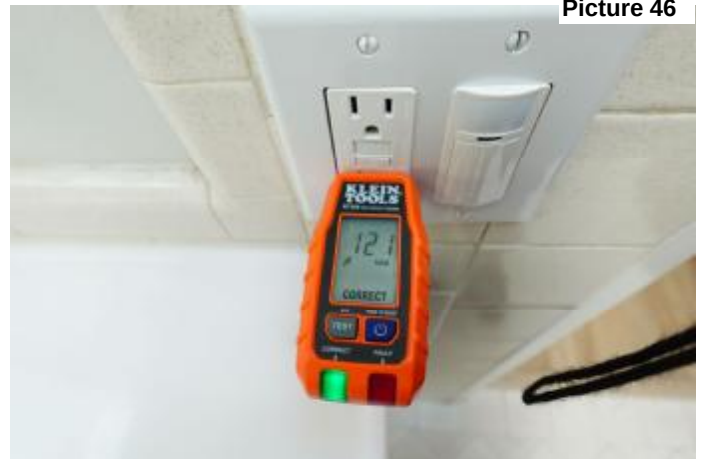
Picture 46

Refer to electrical #44 wiring notes:  
GFCI's responded adequately to test.  
Bathrooms

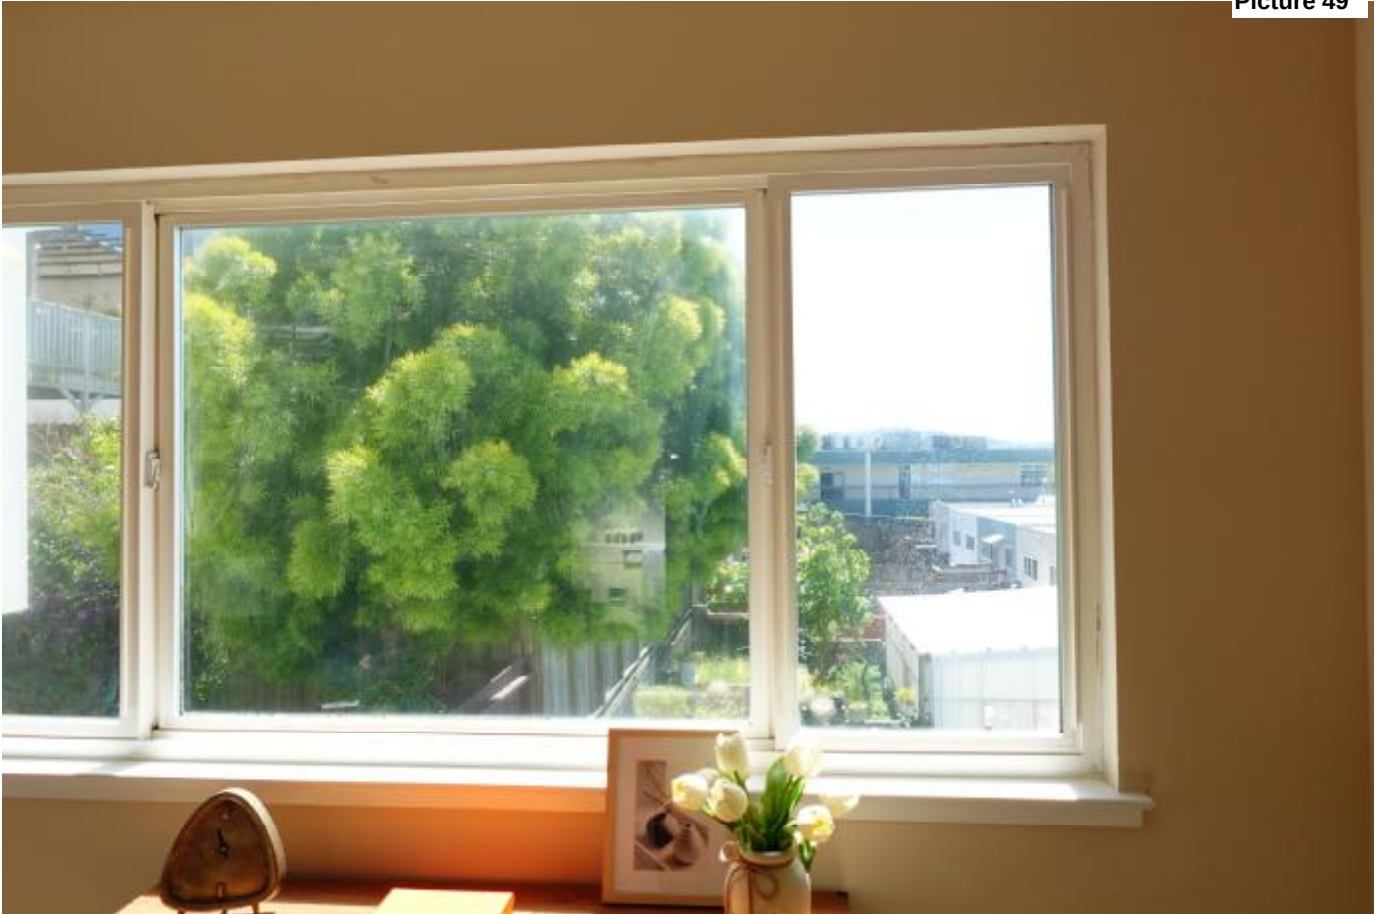
Picture 49

Refer to interior #48 windows:  
Dual-glaze windows were fogged at: primary bedroom (2)

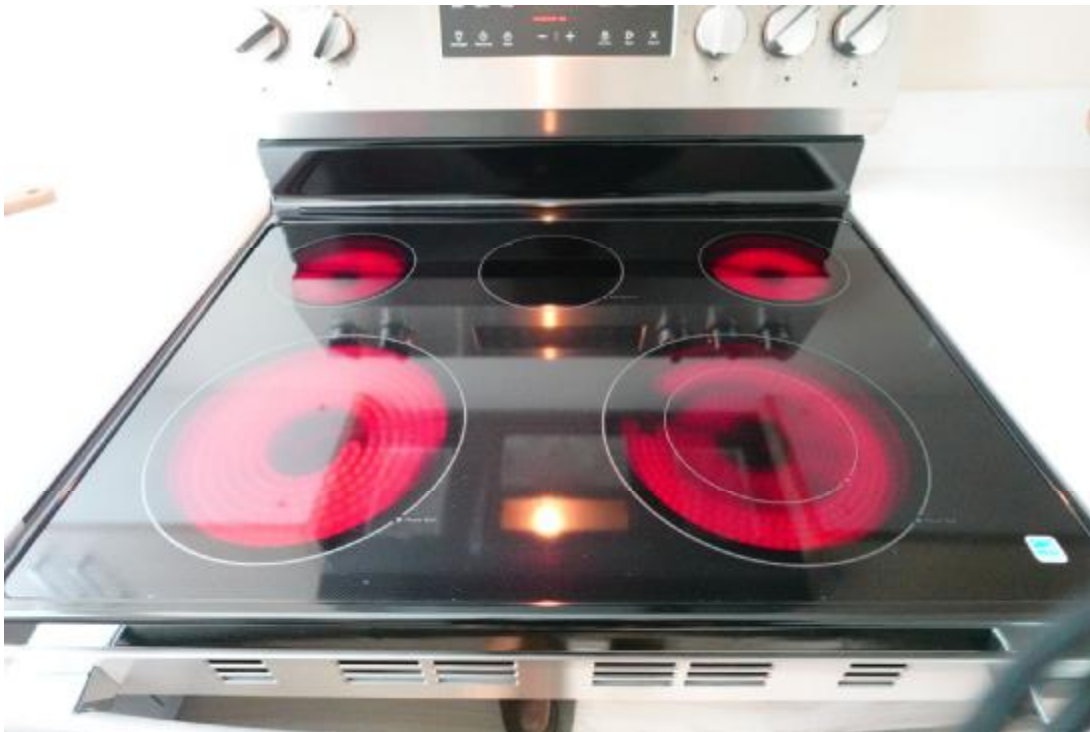
Picture 67

Refer to kitchen #69 Range:  
The range/oven appeared to be in serviceable condition at the time of the inspection.

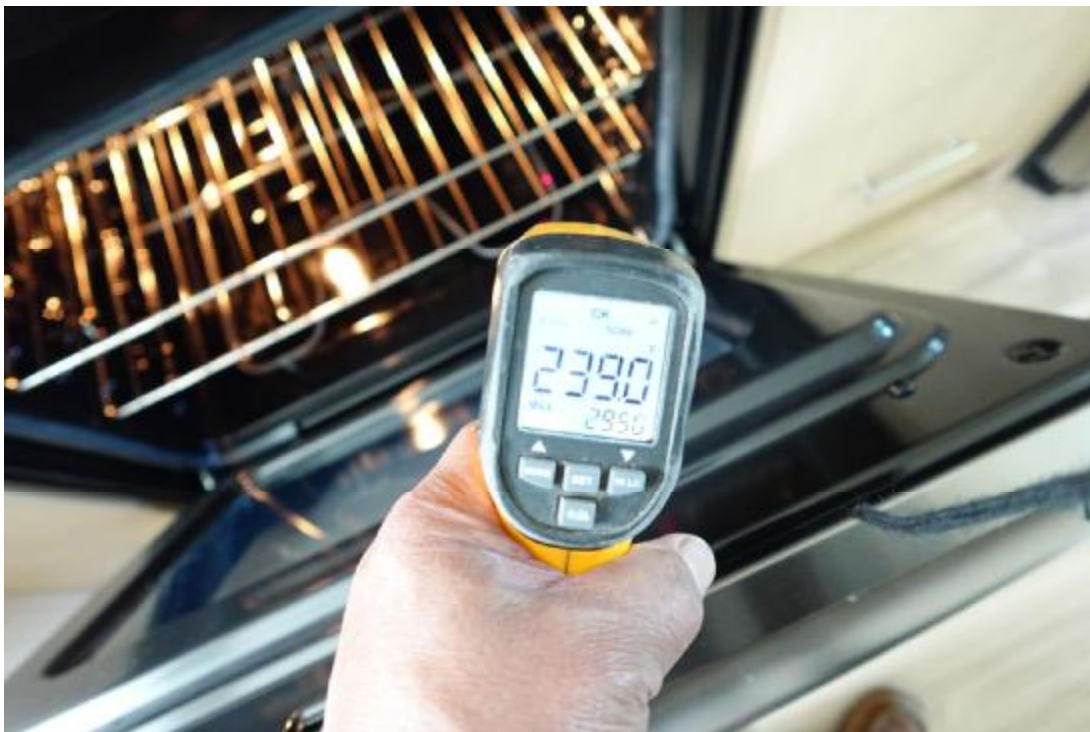
Picture 68

Refer to kitchen #69 Range:  
The range/oven appeared to be in serviceable condition at the time of the inspection.
