Inspection Report

This inspection report  
prepared specifically for:

Disen Cai  
45 Forest Grove Dr  
Daly City, CA 94015

Subject is a split level single family home built in 1951, consisting of 2 bedrooms and 1 bath on the top level and .5 bath at the ground level. Its gross living area is 1,250 square feet per public record.

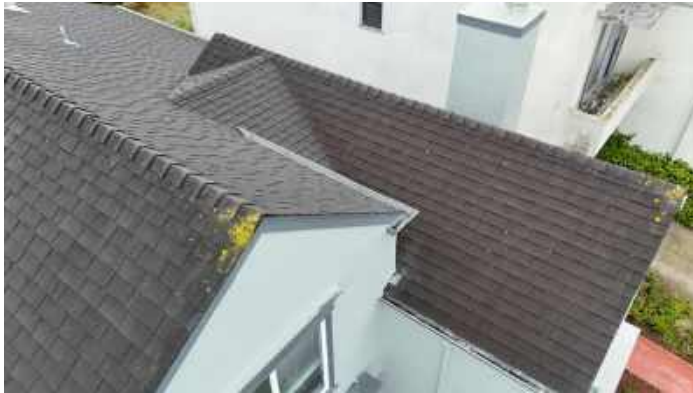
#R3

Cellular growth and moss noted at roof ridges at front and rear of property. Owner recommended to clear and clean all cellular growth and moss in order to prolong the life expectancy of roof. (See Picture #3)

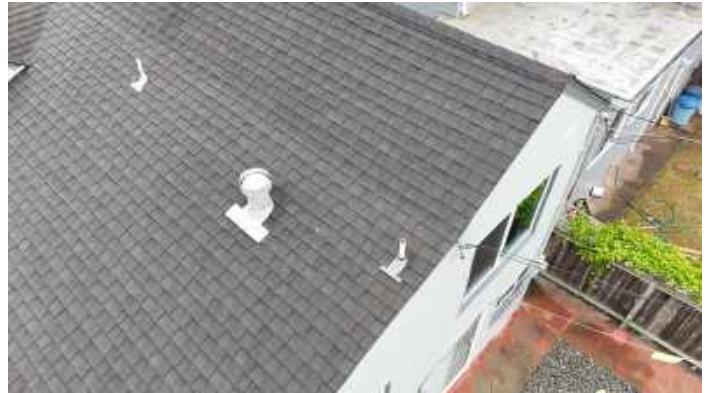
#R4

Exposed nails/screws noted at roof jacks/chimneys and vent pipes. Owner recommended to caulk all exposed nails/screws in order to prevent water intrusion and future damages. (See Picture #4)

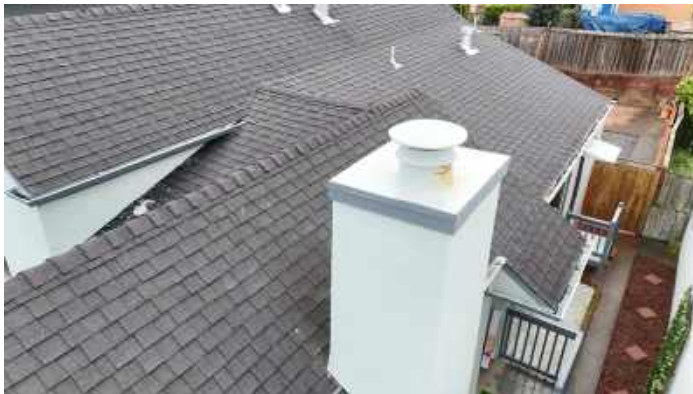
#R5

Rust and damage noted to fireplace chimney. Owner recommended to contact related trade for correction. (See Picture #5)

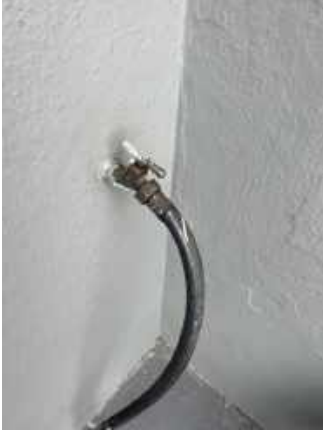
**#EX1**

No vacuum breakers noted at exterior hose bibs. A hose connection vacuum breaker should be installed on each faucet or hose bib that is connected to the potable water supply to prevent back-flow into the water supply. (See Picture #1)

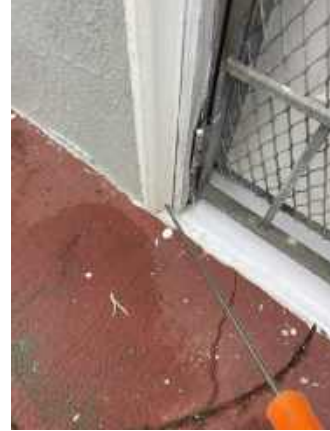
**#EX2**

Fungus infestation and wood rot noted at rear entry door jamb. See structural pest control report for details. (See Picture #2)

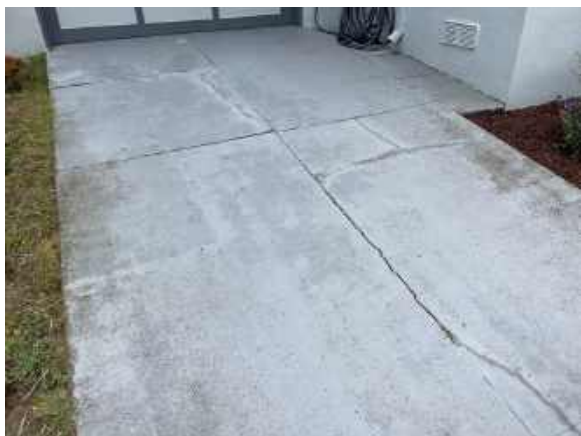
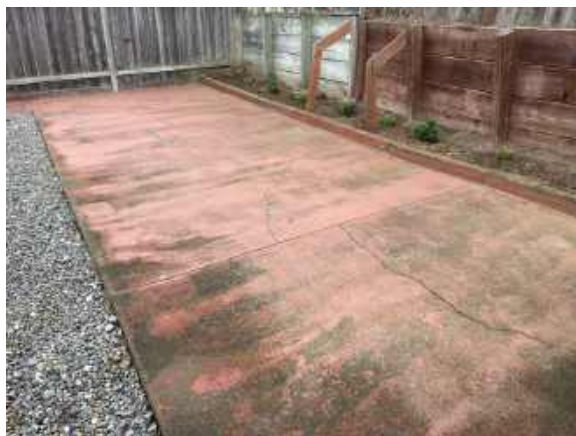
| 17 | <p>Settlement cracks noted at driveway and patio. Little negative effects noted. This is for information only. (See Picture #1 &amp; #2)</p> <p>Improper handrails noted for both side entry staircases at right side of property. Owner recommended to install appropriate handrails. (See Picture #3 &amp; #4)</p> <p><i>Current versions of these codes and standards now agree that handrail is defined as either a circular cross section with an outside diameter of 1¼" (32 mm) minimum and 2" (51 mm) maximum or a noncircular cross section with a perimeter dimension of 4" (100 mm) minimum and 6¼" (160 mm) maximum.</i></p> <p>Guardrails for rear side entry staircase at right side of property opposite kitchen are less than 42" in height which does not comply with latest building code. Missing guardrail also noted at said staircase landing. (See Picture #4)</p> <p>Evidence of fungus infestation and wood rot noted at decking boards for rear side entry staircase landing at right side of property opposite kitchen. See structural pest control report for details. (See Picture #5)</p> <p>Leaning noted at wood retaining wall and fence at rear of property. Owner recommended to contact related trade for necessary correction. (See Picture #6)</p> |

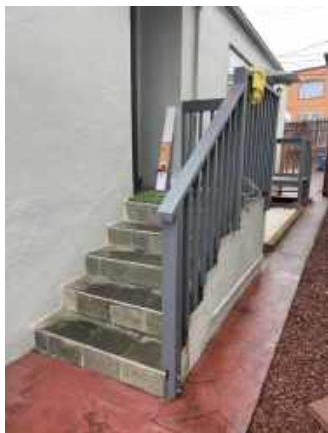
#GD3

Improper handrails noted for both side entry staircases at right side of property. Owner recommended to install appropriate handrails. (See Picture #3 & #4)

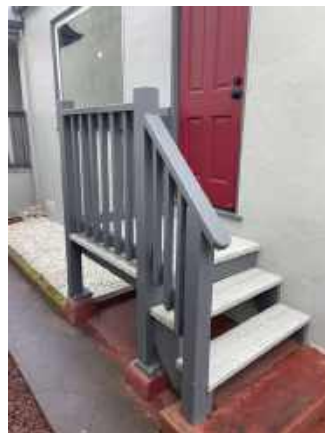
#GD4

Guardrails for rear side entry staircase at right side of property opposite kitchen are less than 42" in height which does not comply with latest building code. Missing guardrail also noted at said staircase landing. (See Picture #4)

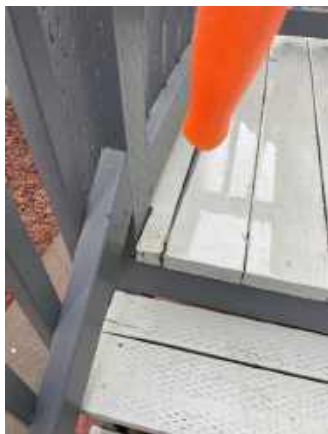
#GD5

Evidence of fungus infestation and wood rot noted at decking boards for rear side entry staircase landing at right side of property opposite kitchen. See structural pest control report for details. (See Picture #5)

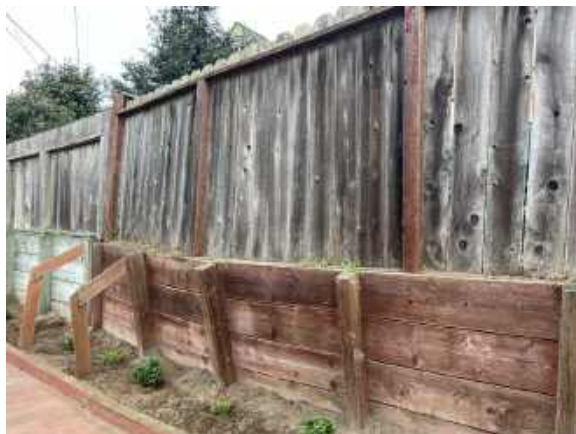
#GD6

Leaning noted at wood retaining wall and fence at rear of property. Owner recommended to contact related trade for necessary correction. (See Picture #6)

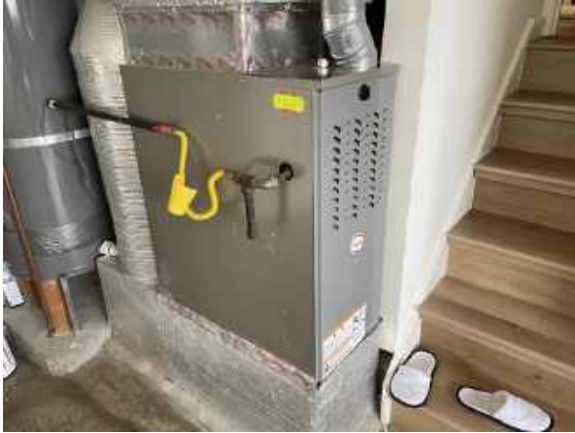
#HC1

- 24
- Subject has forced air heat from Payne, Mfg. Date: 10/2017. It was in working order at time of inspection. The life span for such furnace is estimated between 20-30 years with proper care and maintenance. Subject furnace is in serviceable condition. (See Picture #1)

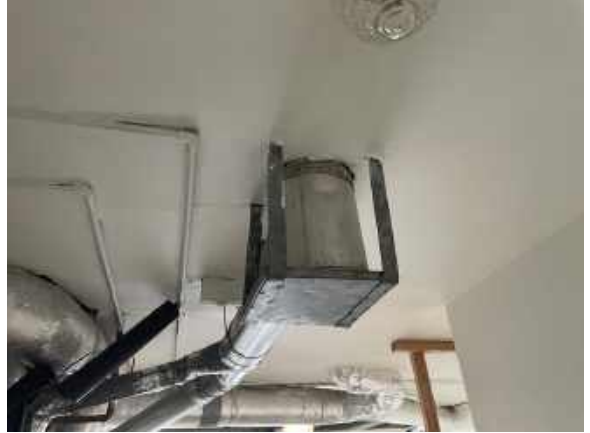
#HC2

Exhaust pipes for furnace is too close to combustible material, there should be minimum 1" clearance for double pipe and 6" clearance for single pipe. Owner is recommended to contact qualified tradesman for necessary correction. (See Picture #2)

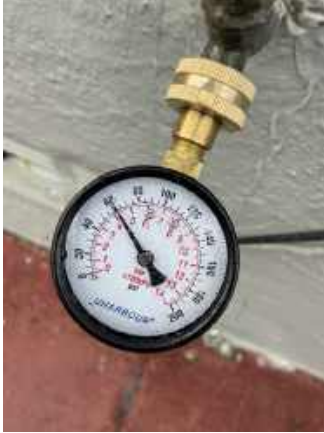
#P1

20 Water pressure is measured at 60 PSI +/- which is considered the norm. This is for information only. (See Picture #1)

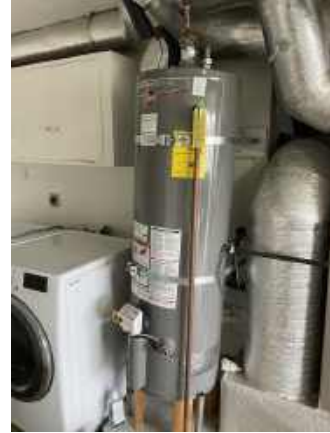
#P2

Subject has a 40 gallon hot water heater from Rheem, Mfg. Date: 4/2023. It was in operating condition at time of inspection. The life span for such water heater is estimate between 8-12 years with proper care and maintenance. Subject hot water heater is in serviceable condition. (See Picture #2)

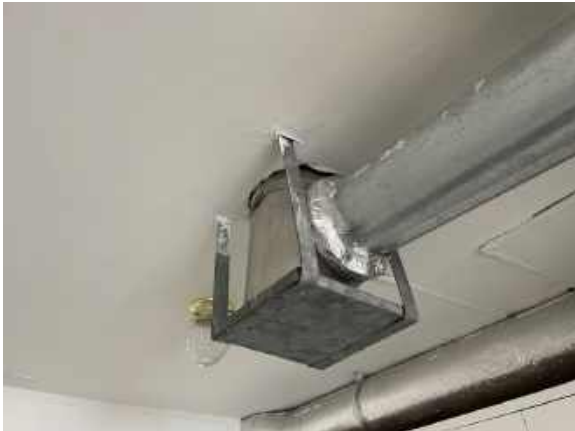
#P3

Exhaust pipe for hot water heater is too close to combustibile materials, minimum 1" separation for double pipe and 6" for single pipe. Correction is needed. (See Picture #3)

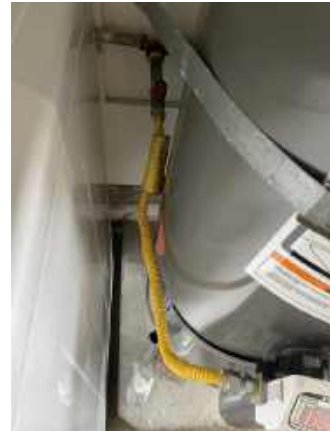
#P4

No sediment trap noted at the gas gate valve for water heater which does not comply with the latest plumbing code. (See Picture #4)

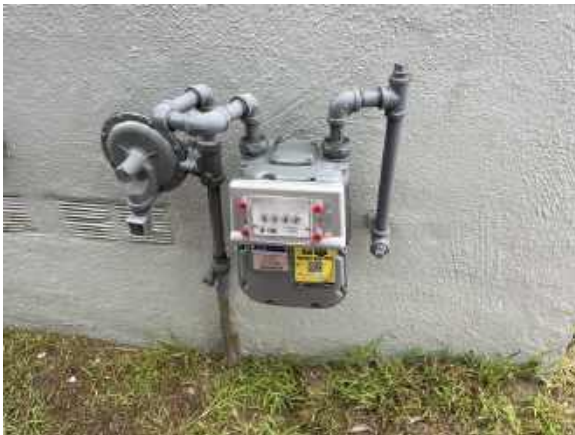
#P5

No seismic gas shut-off valve noted for subject property. (See Picture #5)  
Since 2000, all newly constructed, renovated, or reconstructed residential buildings in California are required to install earthquake gas shut-off valves however such requirements vary across the Bay Area and mostly depending on local ordinances. Owner advised to consult qualified professionals and local authorities to ensure compliance with the latest regulations. This is for information only.

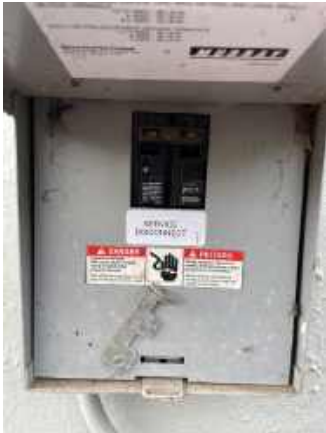
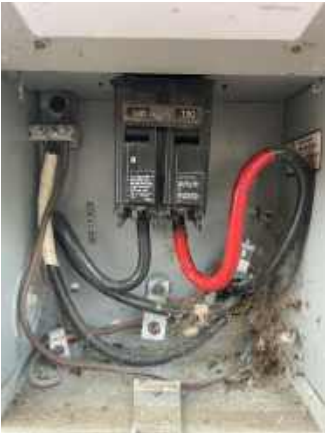
**19 Subject has 100 Amp service with Murray main panel. (See Picture #1 & #2)**

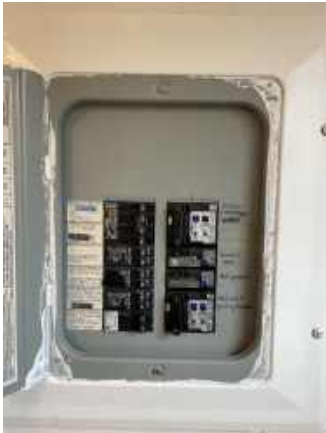
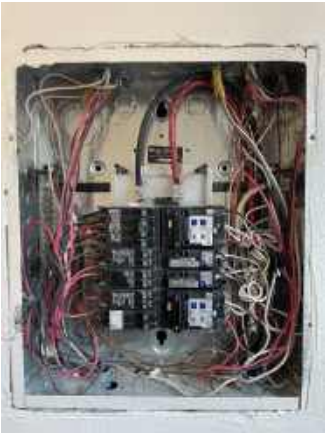
There is also Cutler-Hammer sub-panel located in the ground level bonus room and it was appropriately wired at time of inspection. This is for information only. (See Picture #3 & #4)

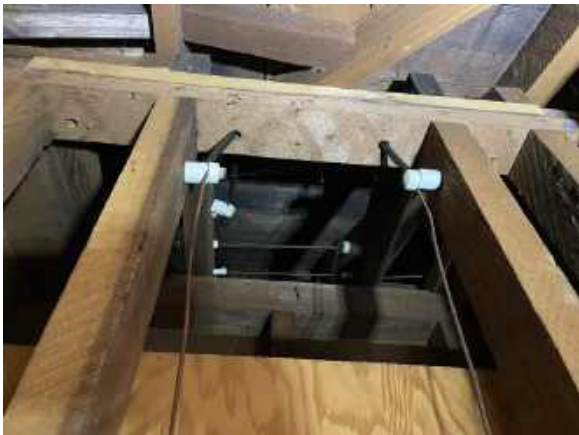
#EL5

Knob & Tube wiring noted at attic and they are part of the original wiring and removal/upgrade is recommended. (See Picture #5)

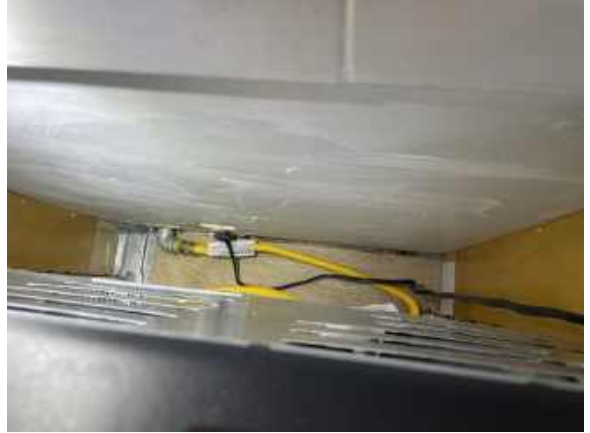
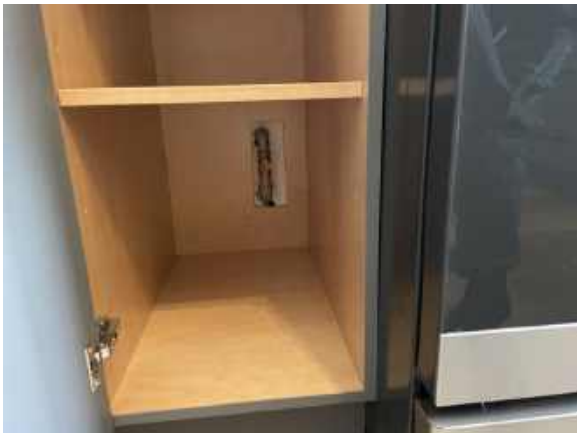
26 Anti-tipping device noted for stove which complies with current safety code and gas gate valve is located inside lower left cabinet beside stove which complies with latest plumbing code. This is for information only. (See Picture #2 & #3)

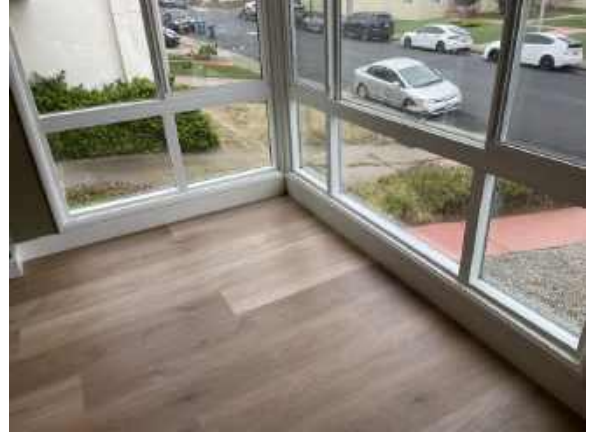
#IR2

3 out of 5 lower fixed windows in living room are less than 18" from the floor and they are not tempered which do not comply with the current building code. (See Picture #2)

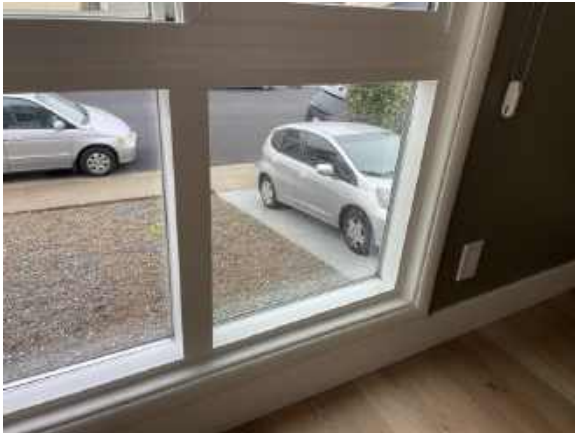
#IR3

Low-E reaction noted at 1 lower fixed window for living room. Owner recommended to contact related trade for repair or replacement. (See Picture #3)

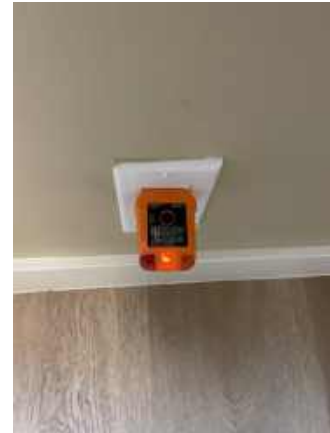
#IR4

Non-grounded outlets noted throughout subject interior. Owner recommended to contact licensed electrician for correction. (See Picture #4)

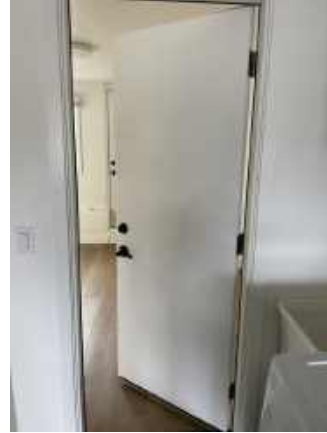
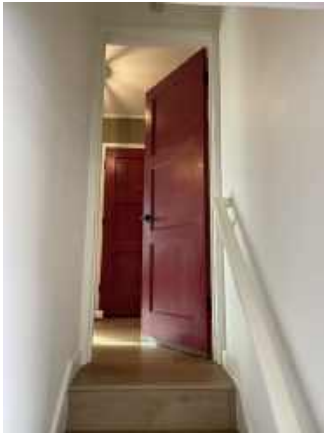
No self closing devices noted for doors between garage and living area and door between garage and main level is not fire rated which does not comply with the latest safety code. (See Picture #2 & #3)

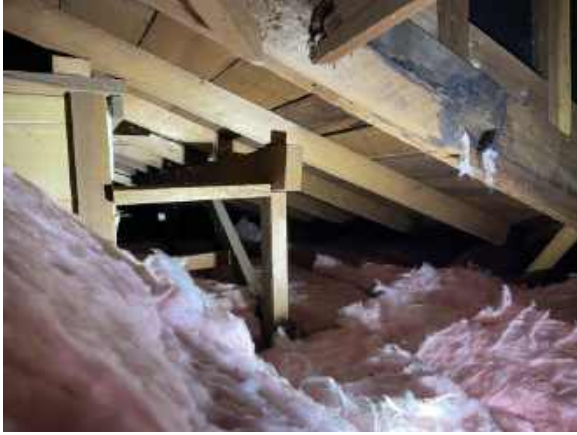
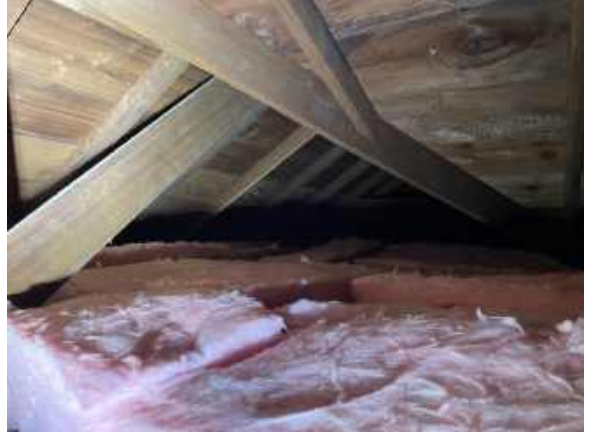
17 The tops of ceiling joists at attic over living area are covered by fiberglass insulation. This renders the attic area inaccessible for inspection due to safety hazard (it is unsafe to walk on ceiling joists which are covered by insulation). A “visual” inspection from opening was made. (See Picture #1 & #2)

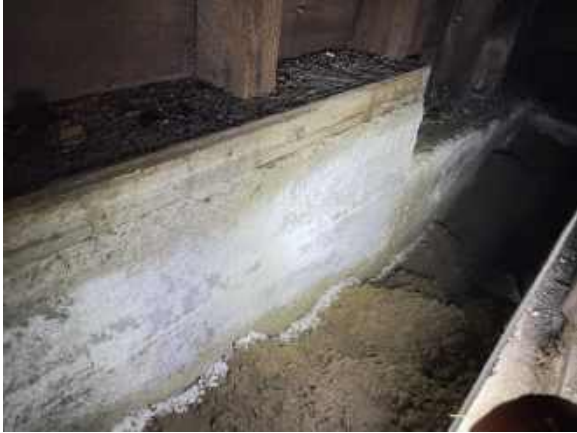
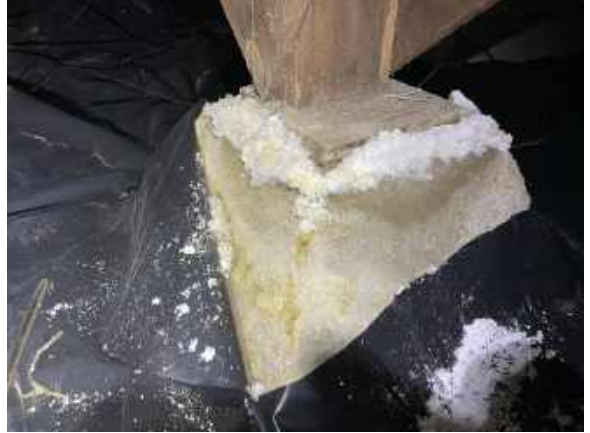
Efflorescence noted at foundation wall at front right corner of property and throughout block piers in crawl area. These areas have excessive moisture and/or water, and left behind salt deposit. (See Picture #7 & #8)
