SAMPLE SUMMARY REPORT
(START AND END POINT DETAILS)

ROUTE: STUDIED BETWEEN ----- TO ----- FOR A STRETCH OF AROUND 854 KMS.

GIVEN DIMENSION: (L) 110m x (w) 8m x (H) 7 m, MT -160 ton approximate. When loaded on the vehicle total height from the ground is 7.3m (Hydraulic axle) – **Cargo movement can Possible.**

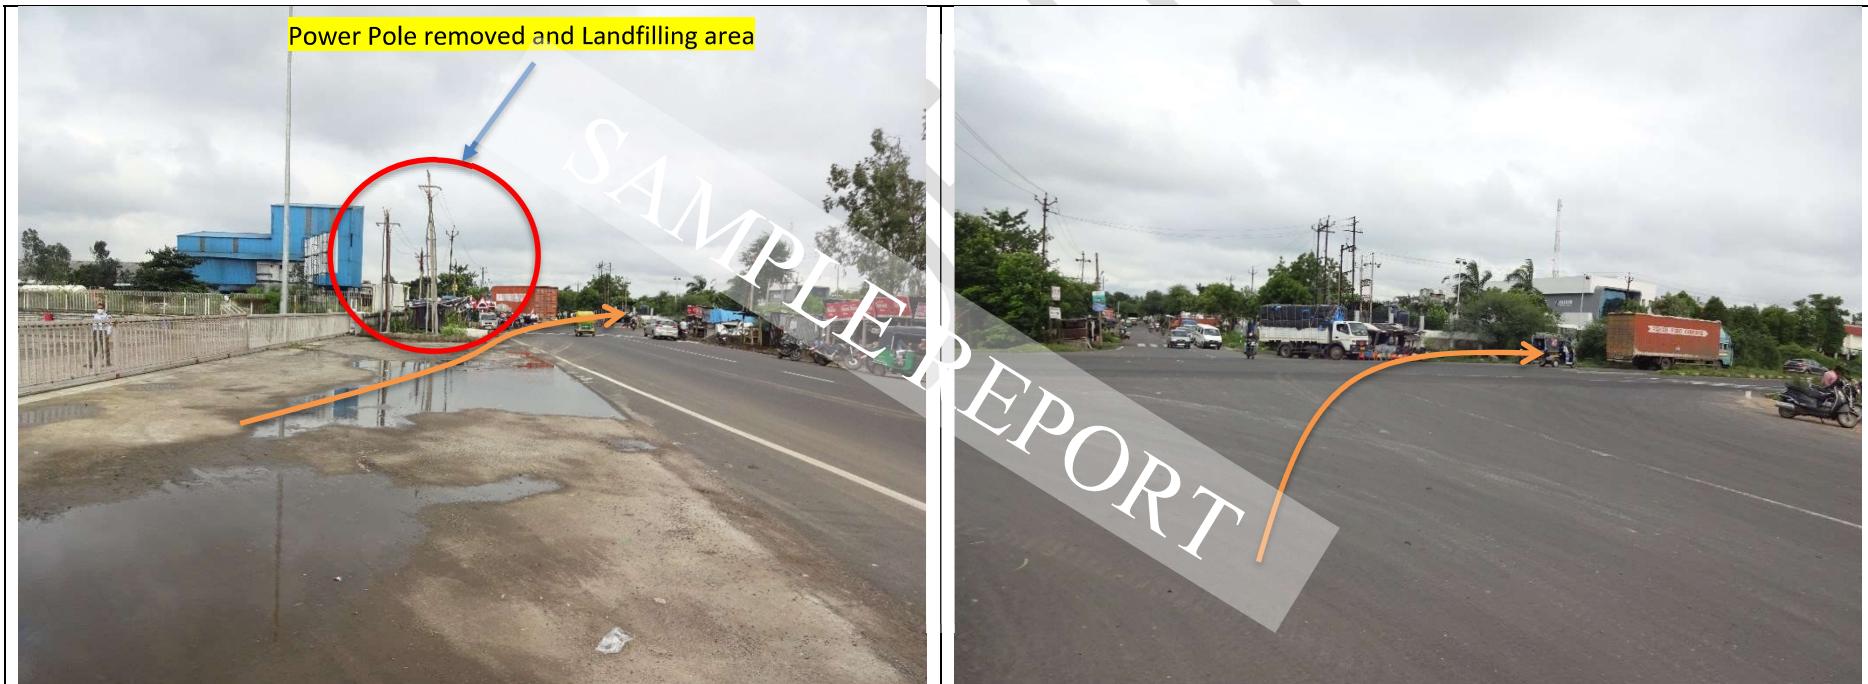
1. NE COORDINATES: ----- Factory, Gate No.8 width is 31m available, Vehicle should move left from gate and immediately have to take right turn to leads at ----- Due to length and width factor LHS power cable pole and landfilling with levelling should be done before transportation.

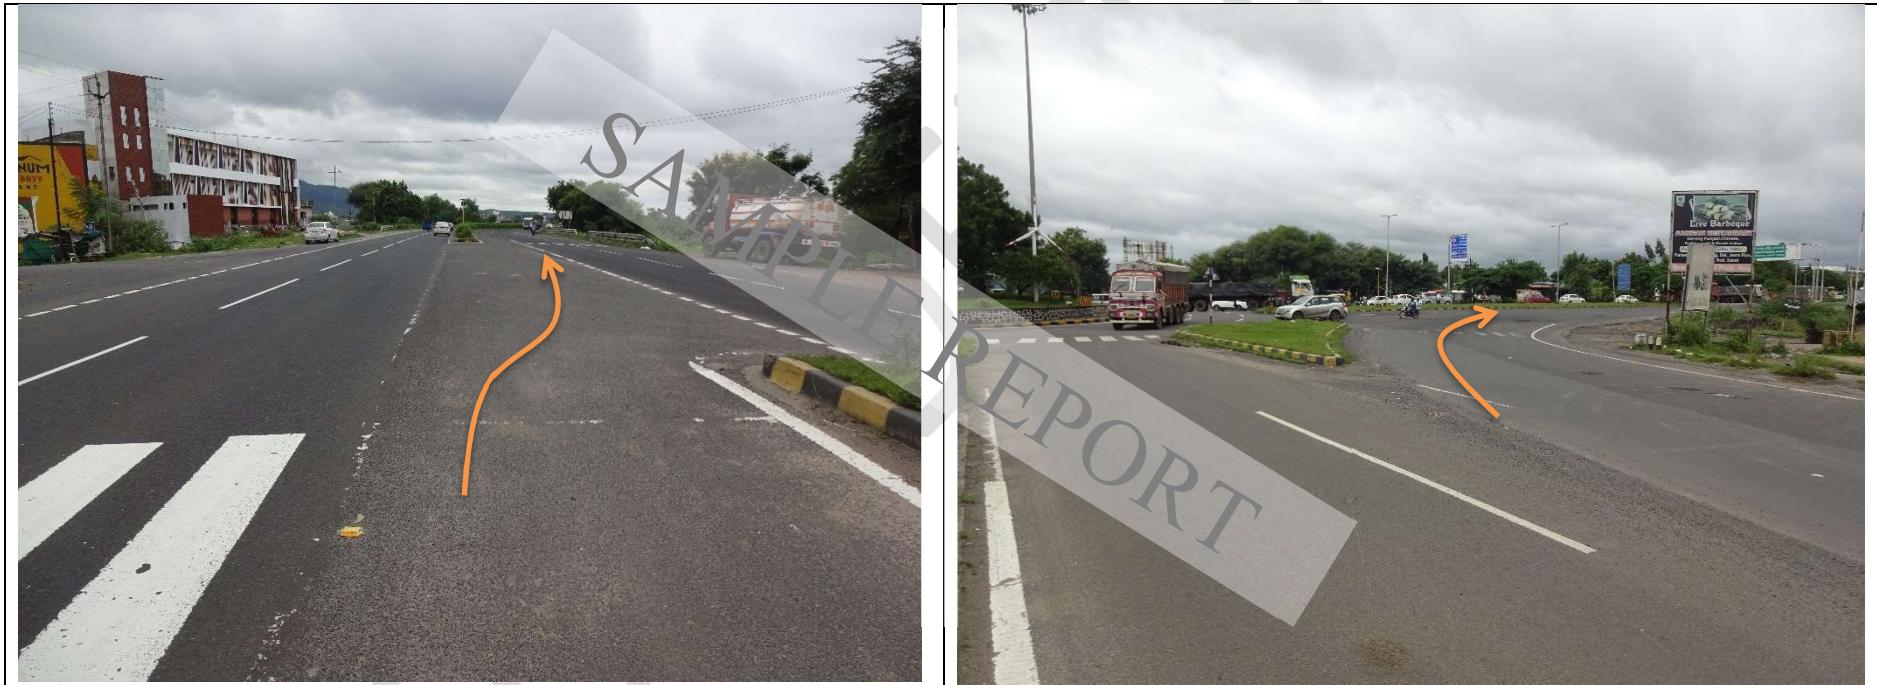
2. NE COORDINATES: At ----- which is 6.5m from -----factor vehicle should take a right turn at this location due to length factor vehicle should be moved from opposite road.

- To connect opposite road vehicle should to be take 2km before from normal to opposite road.
- Refer picture below.

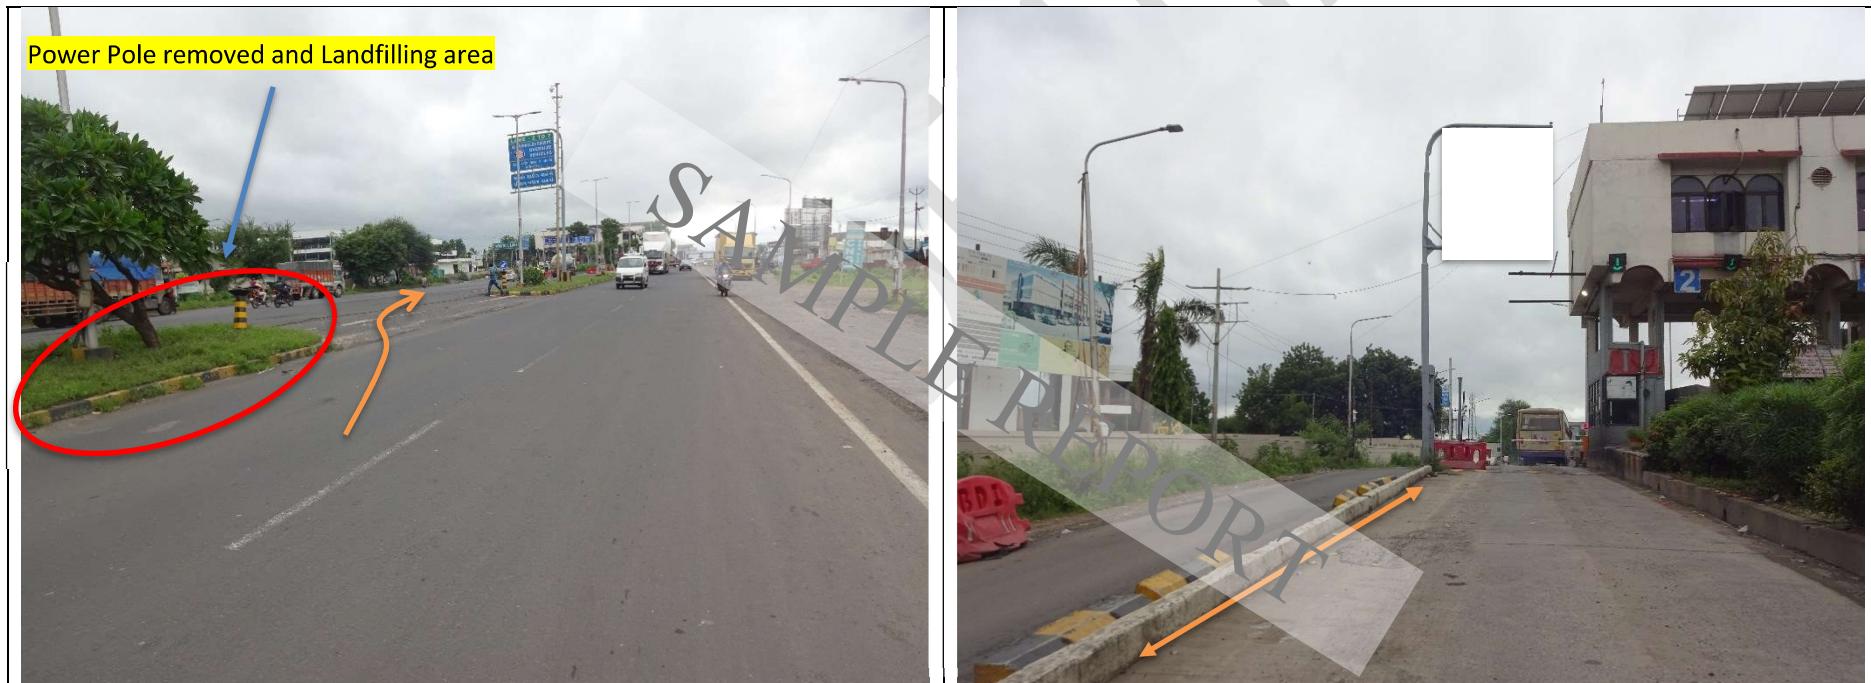
3. NE COORDINATES At -----Toll Booth which is 6.8km form -----factory, continue on above previous location point vehicle should be move opposite to normal road due to length factor landfilling should be done at this location before transportation Refer below on LHS picture.

- Also, due to width (width is 5.5m) factor camera pole, centre median and signboard should be removed with necessary permission from toll.

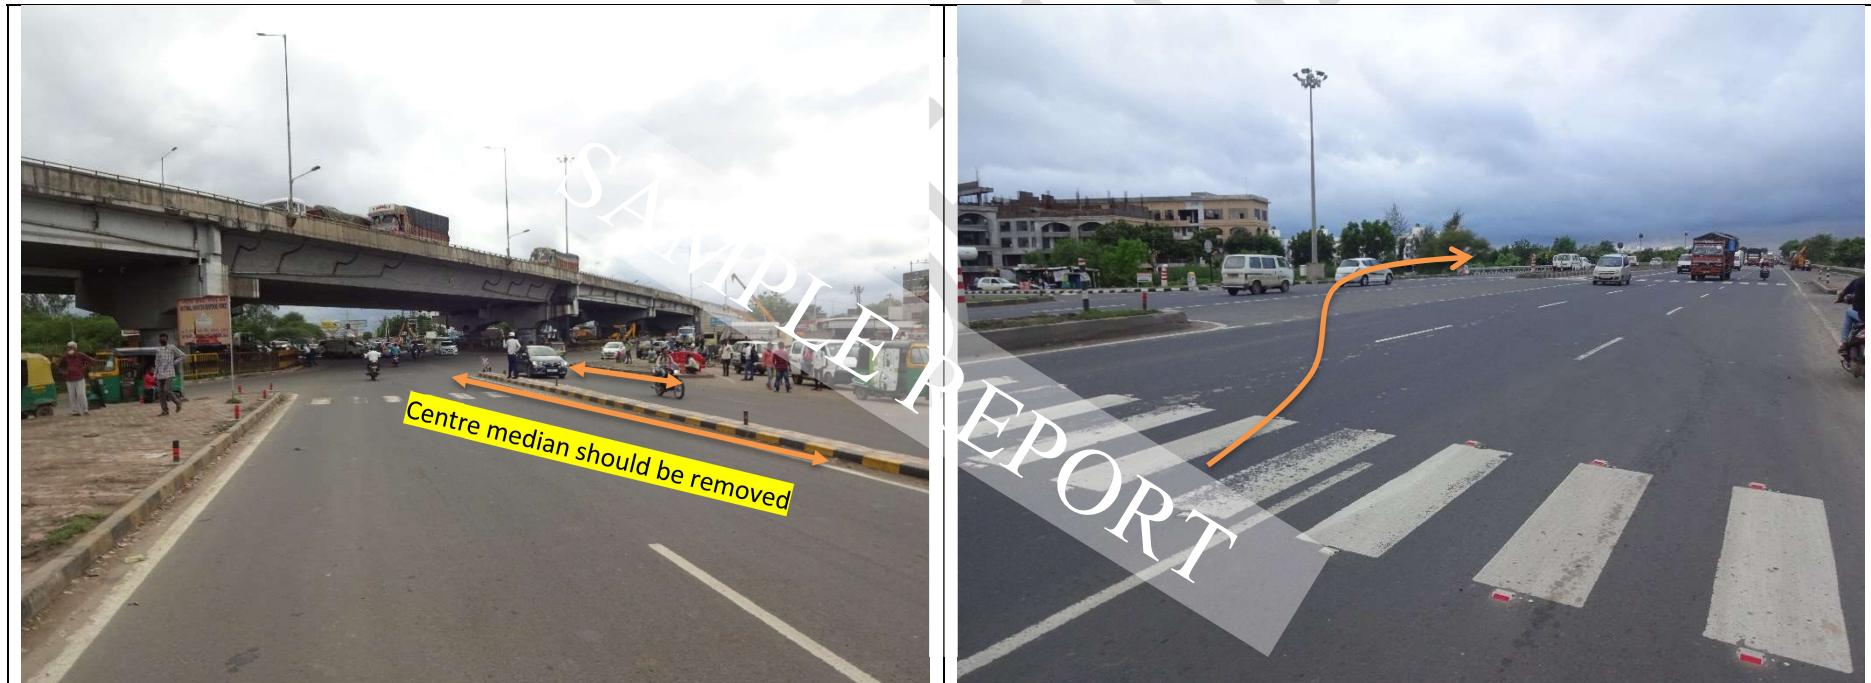
4. NE COORDINATES: At ----- junction which is 38 km from----- factory vehicle should be take right under the bridge height is 5.5 due to height factor, which is not possible to move under the bridge.

- So, we suggested vehicle should be take right on opposite service road before bridge, while taking right turn centre median should be removed.
- Continue on opposite service road up to 1.4km to connect normal road. Refer Picture below

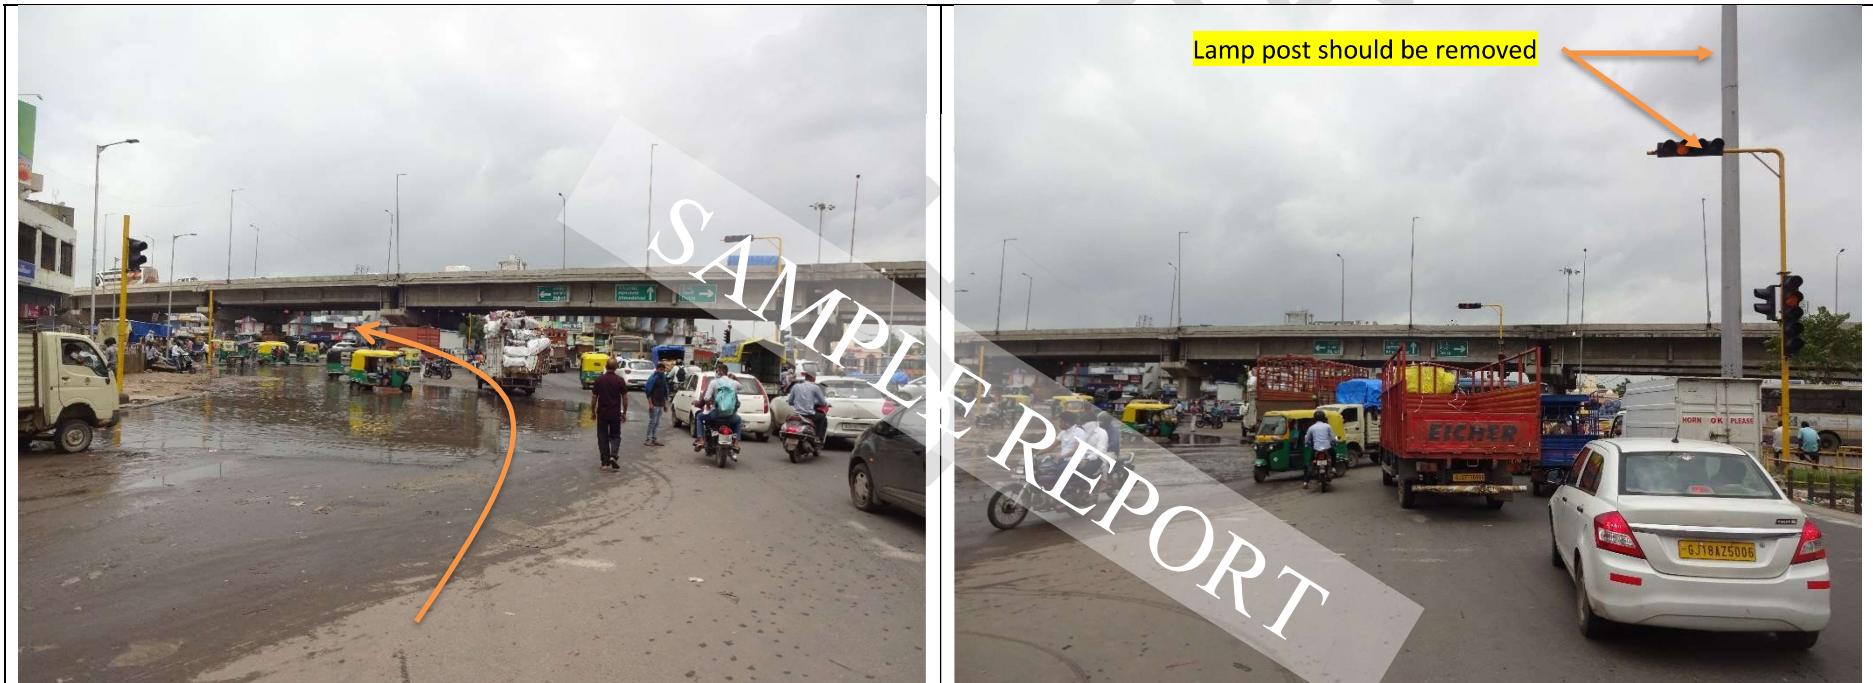
5. NE COORDINATES: At ----- junction which is 140 km from ----- factory vehicle should be take a left turn, due to length factor while taking left turn rear overhang blade should be hit on RHS lamp post, so we suggested lamp post must be removed before transportation. *Refer below picture: -*

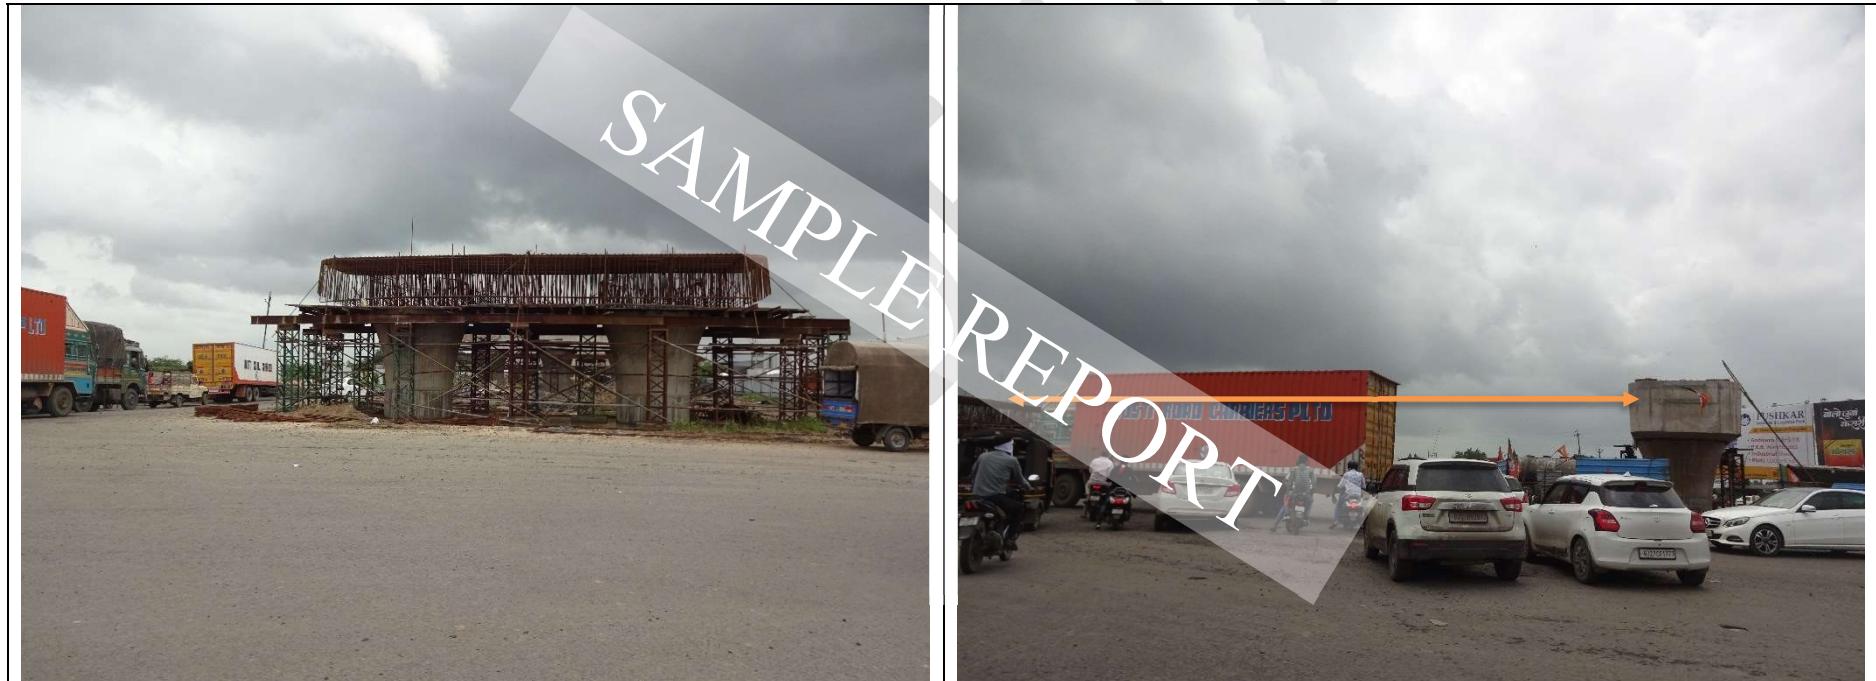
6. NE COORDINATES: At -----circle which is 19 km from -----junction move straight at this location, flyover under construction, height problem it may happened in future.

- We suggested 110m blade can be move current situation; In future please get the stay order from ----- government as well as NHAi if possible.

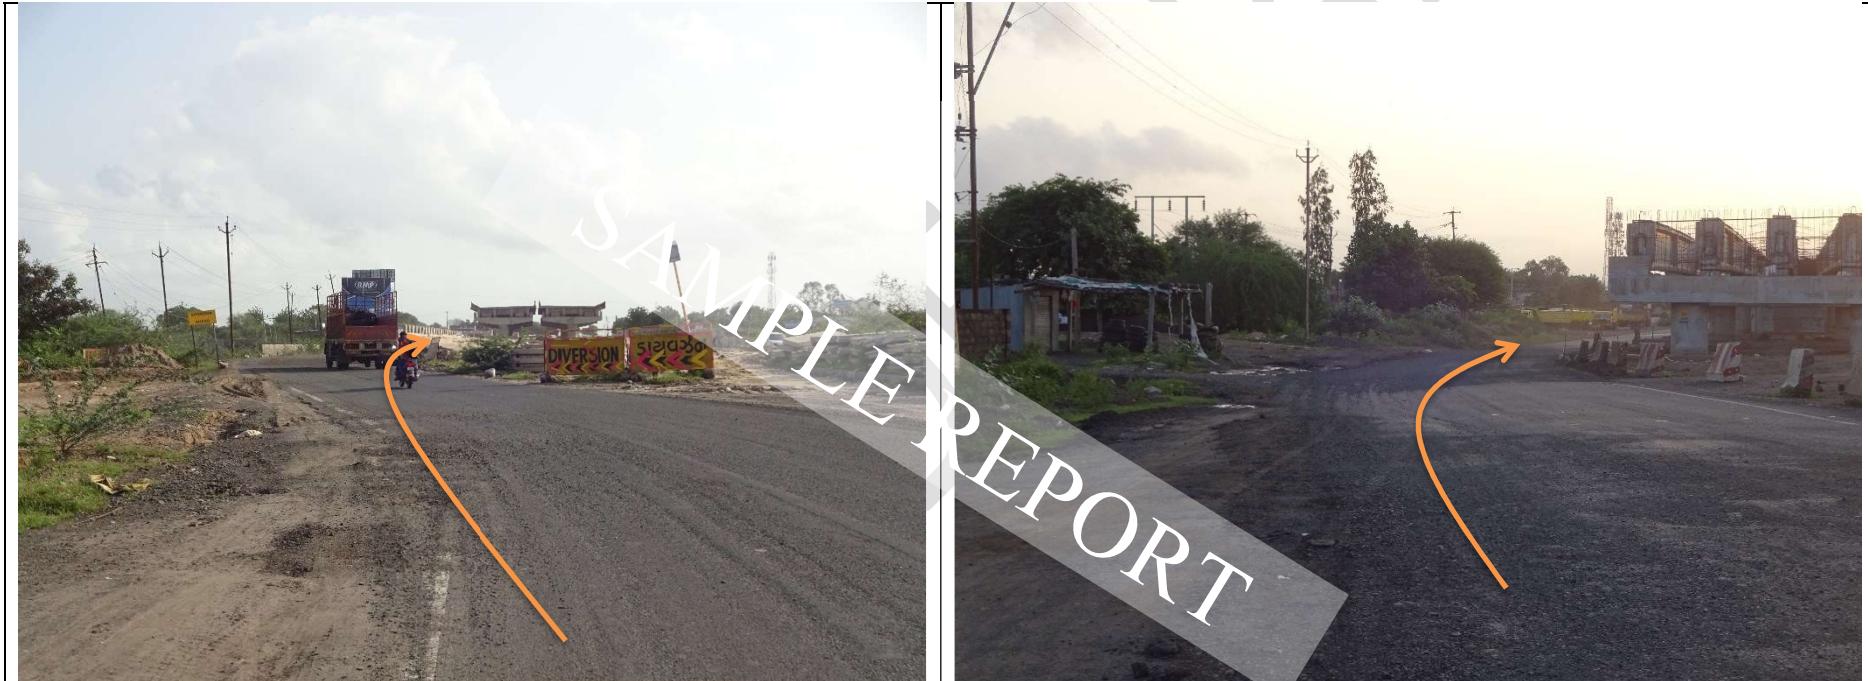
7. From ----- to----- NH 47 which is 200km road extension and flyovers under construction we found many **diversions** on in this stretch, vehicle should be move slowly and carefully. This stretch construction will complete in next 8 months. *Refer below picture:*

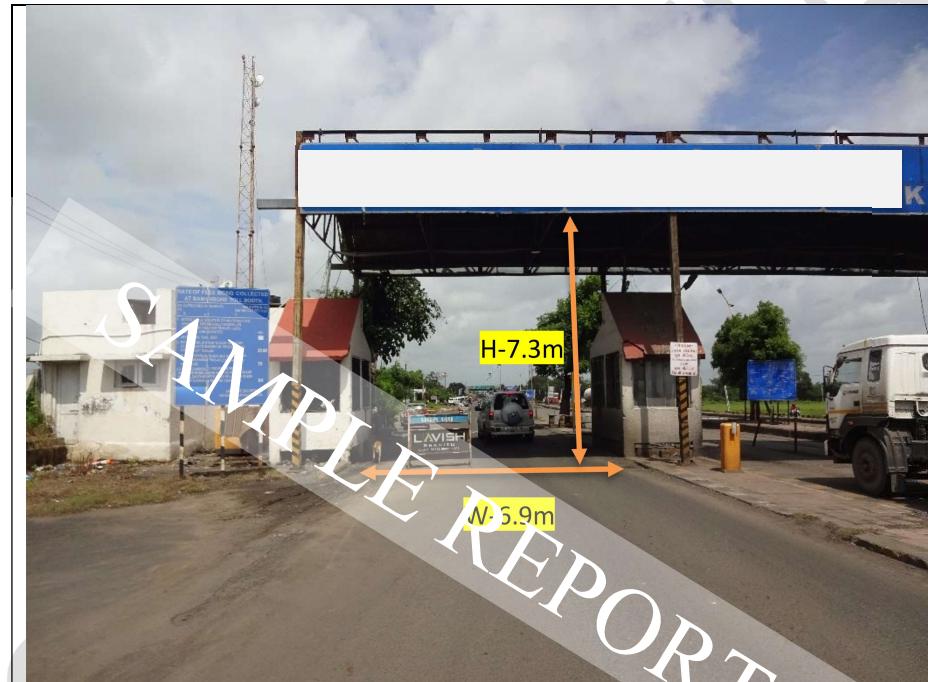
8. NE COORDINATES: At -----toll near ----- which is 350km from ----- factory we identified toll width is 6.9m, height is 7.3 due to width constrain entire ODC lane should be removed with necessary permission from same toll office. ***Refer below picture:***

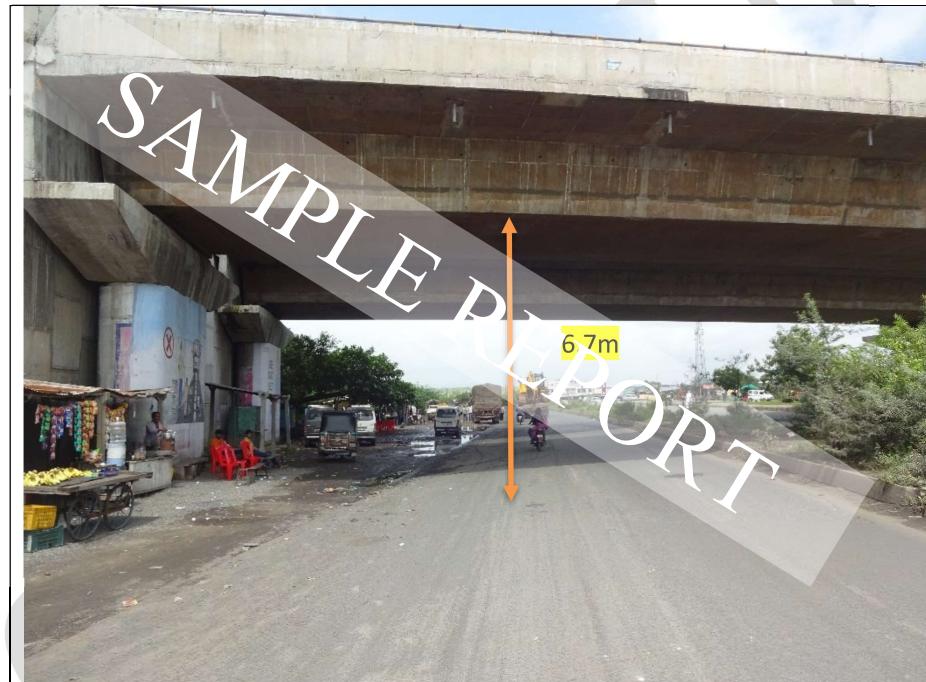
9. NE COORDINATES: At ---- boundary circle which is 350 km from----- Factory we identified the overhead bridge which **height is 6.7m** due to height factor only 6.5m hight cargo can pass this location. Our cargo is impossible to pass this location.

No Alternate route. *Refer below picture:*

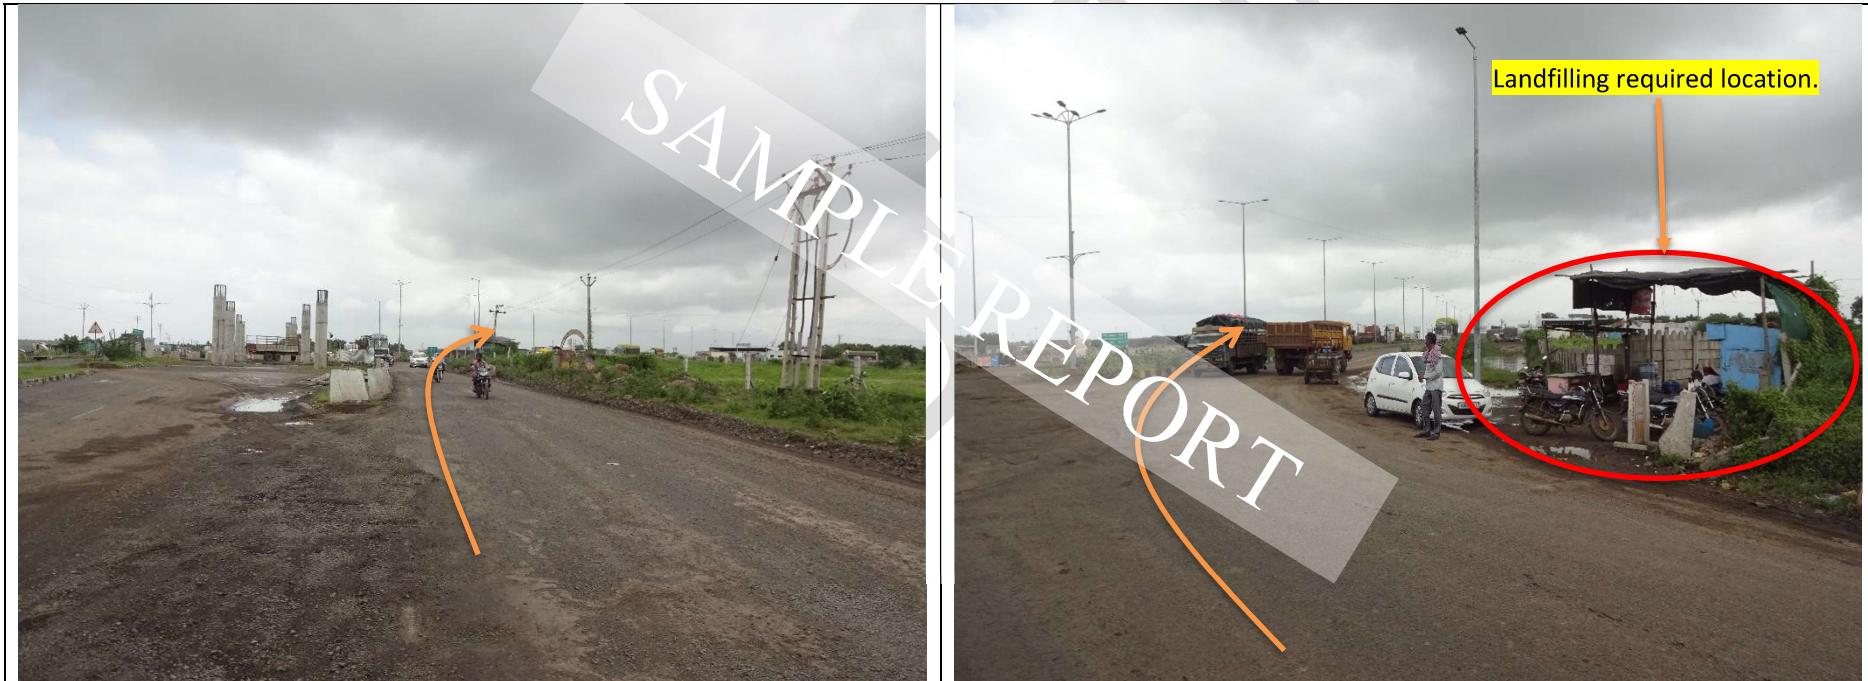
10. NE COORDINATES: -----At ----- Bypass road Junction which is 377 km from -----Factory vehicle should take right turn, while taking a right turn on opposite road due to length and height factor land occupied with filling required on RHS at this location with necessary permission form NHAI office at -----.

Kindly note: Flyover under construction at this location We suggested 110m blade can be move current situation, in future please get the stay order from ----- government as well as NHAI if possible. **No Alternate route. Refer below picture:**

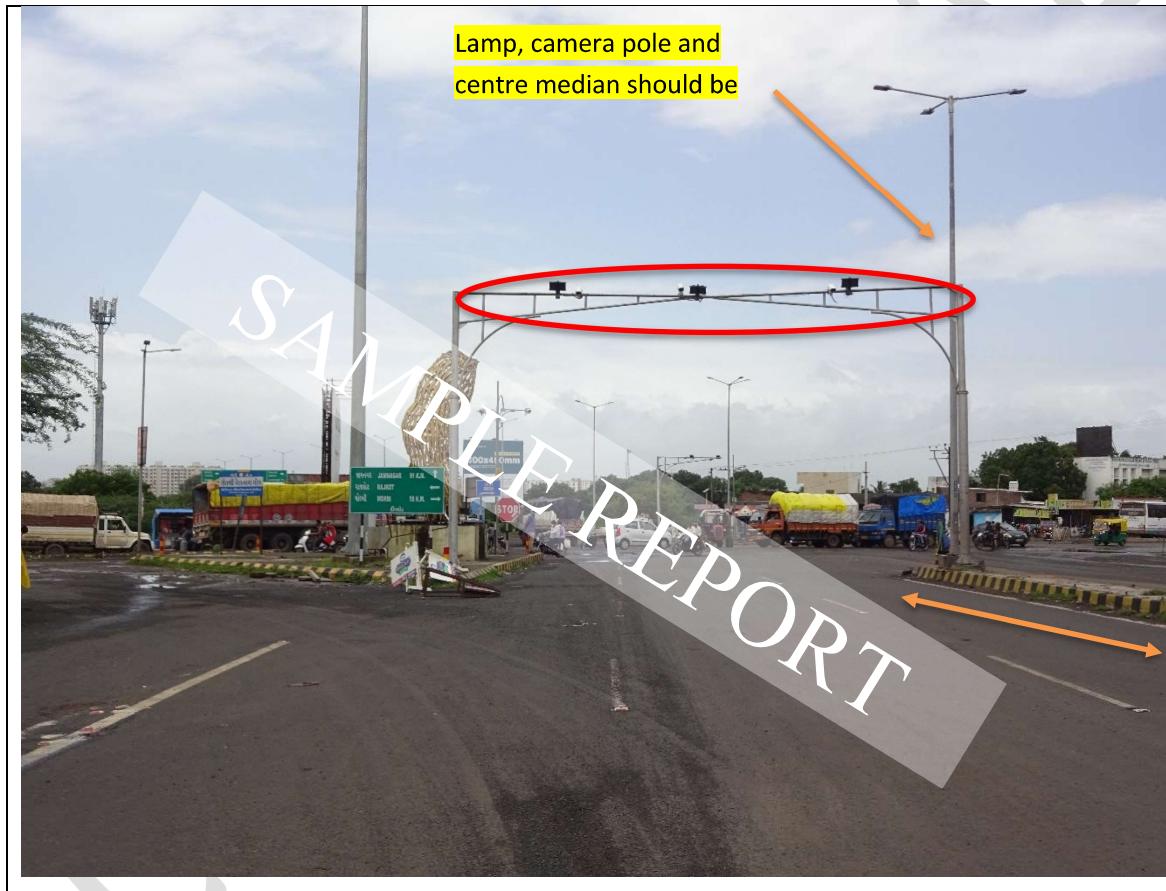
11. NE COORDINATES: ----- At-----150 feet ring road Junction which is 383 km from ----- Factory vehicle should take Right at this junction while taking right turn centre median camera pole and lamp post should be removed with necessary permission form NHAI office at -----.

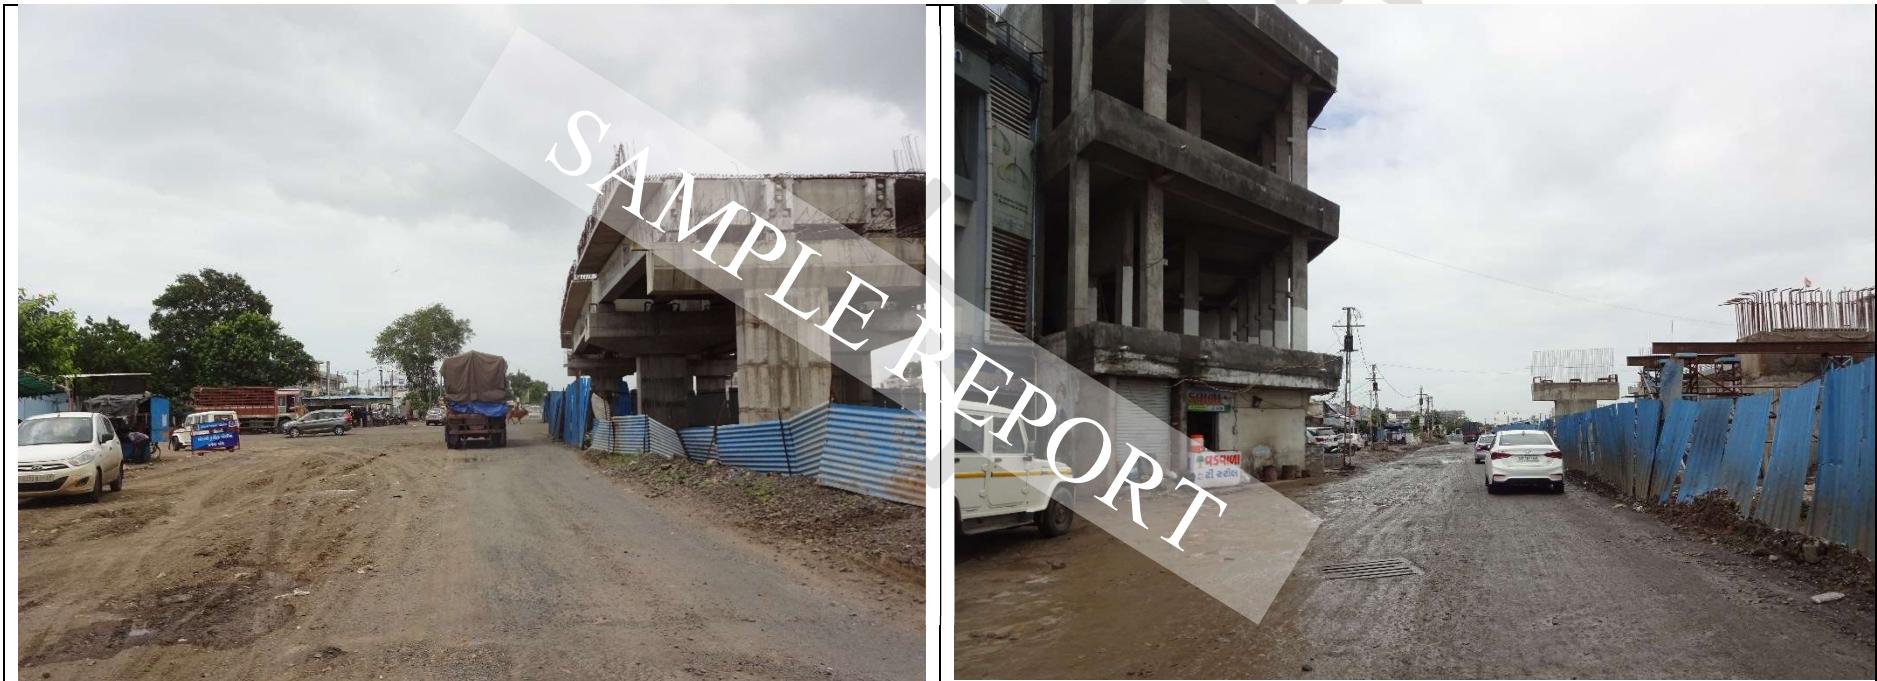
12. NE COORDINATES: ----- At ----- Bypass junction which is 437km from ----- Factory we identified the flyover under construction for bypass road width is very less 5.5m in current situation our cargo is impossible to pass this location. Construction work it may complete in next 6 months. **No Alternate route.** *Refer below picture:*

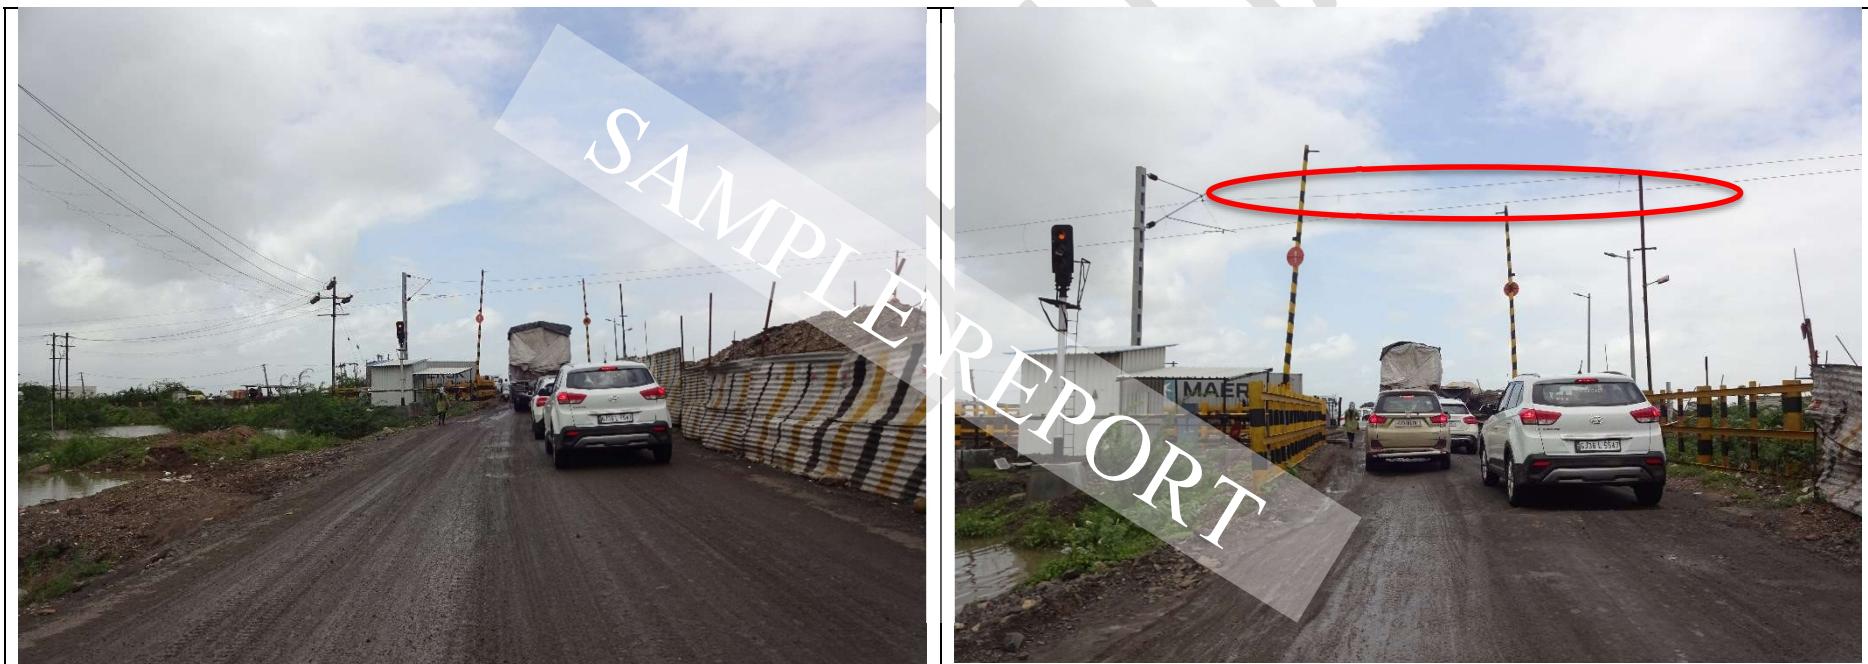
13. NE COORDINATES: -----At -----Bypass which is 442km from -----Factory we identified the flyover under construction for railway level cross road width is very less **6m** only in current situation our cargo is impossible to pass this location. Construction work under progress it may complete in next 6 months.

Power cable height is 6m and road width is 5m. currently power cable is not working, **No Alternate route.**

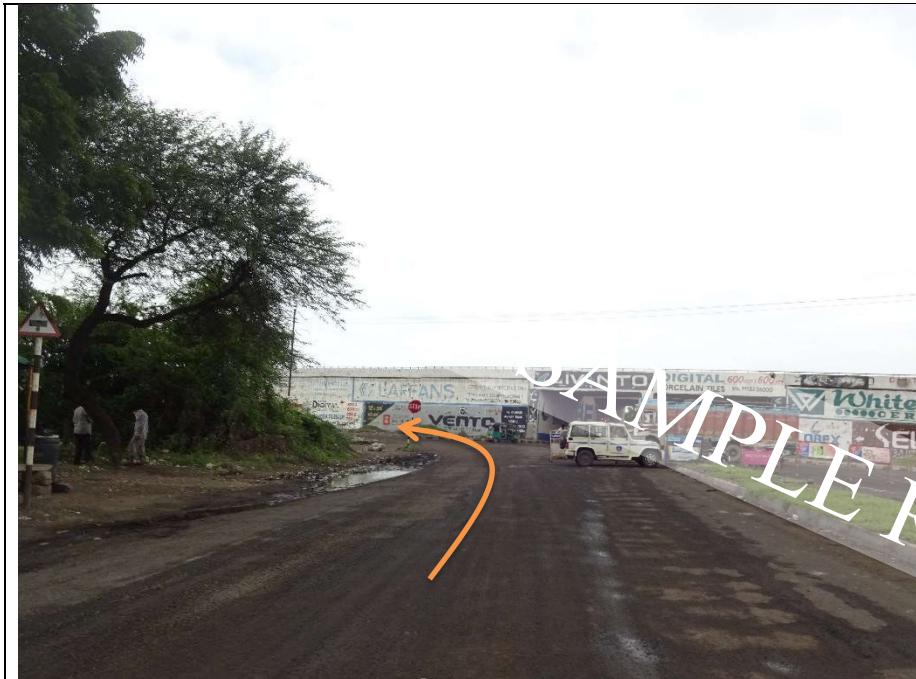
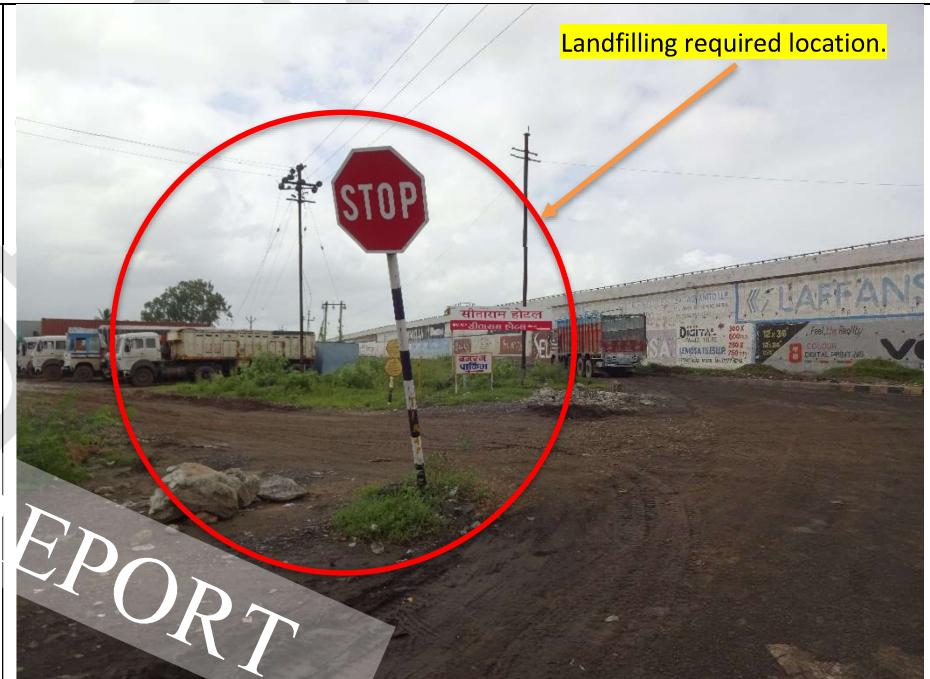
14. NE COORDINATES: -----At----- Bypass end road Junction which is 450 km from ----- Factory vehicle should take left turn, while taking a right turn due to length factor land occupied with filling required on LHS at this location with necessary permission form NHAI office at----- **No Alternate route. Refer below picture:**

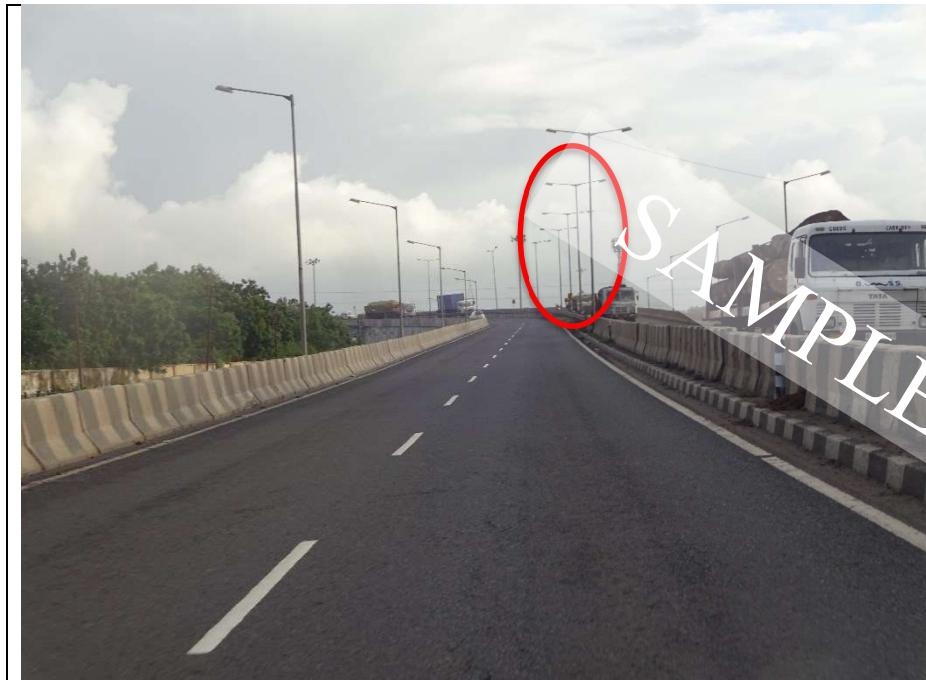
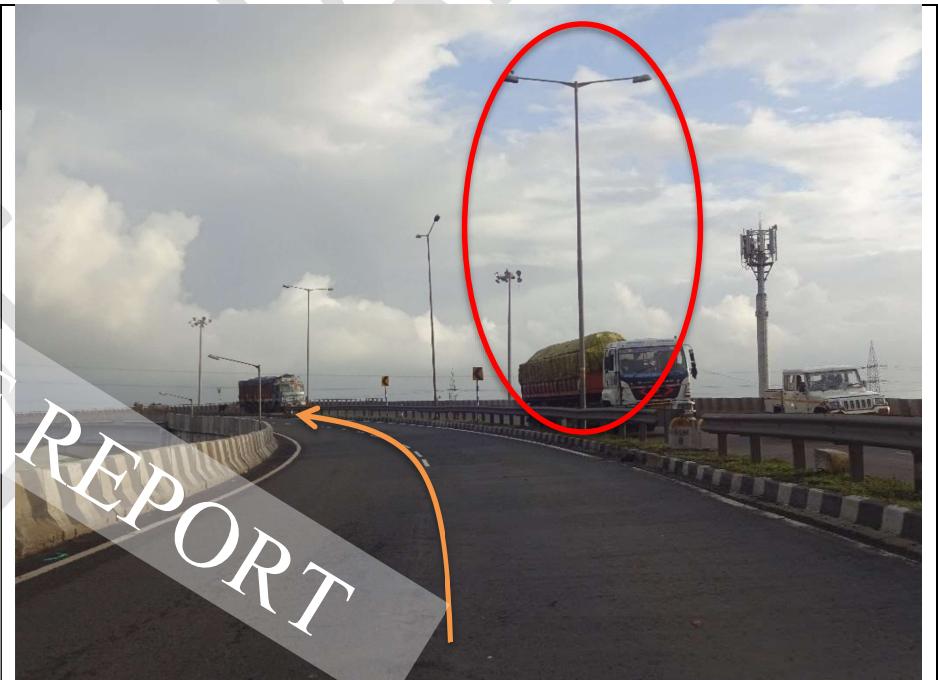
15. NE COORDINATES: ----- At ----- vehicle should be move on flyover to reach ----- due to length factor in centre lamp pole should be removed at this location with necessary permission form NHAI office at--- -----. No Alternate route. *Refer below picture:*

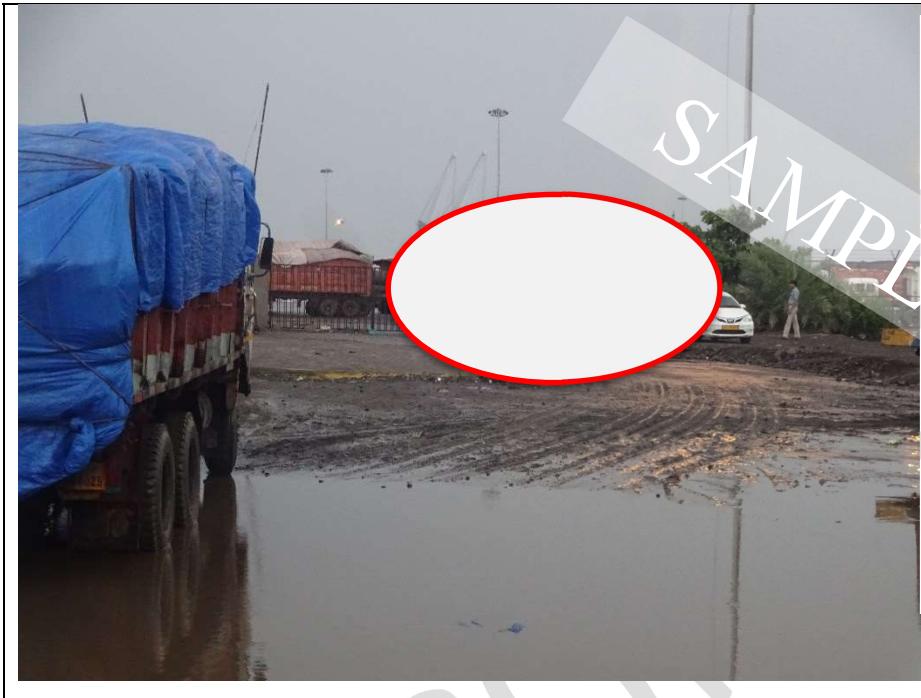
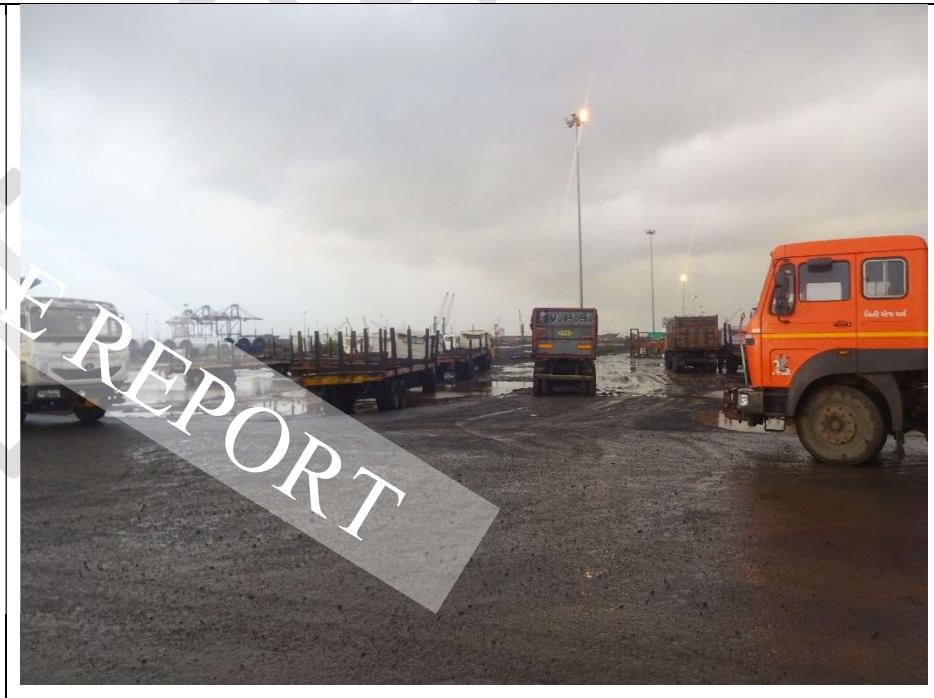
SURVEY END POINT ----- WALL SHOULD BE REMOVED DUE TO LENGTH AND WIDTH FACTOR.

Kindly note our cargo should be move Gate No.■.
