ISMP Medication Error Report Analysis

Pump Resumes PCA Dosing When Turned Off Then On Again

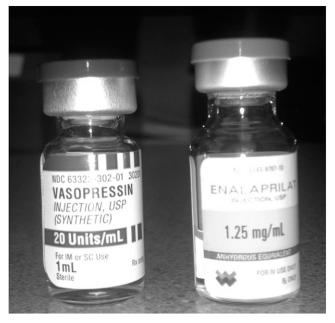
Figure 1.

A nurse who was trying to retrieve enalaprilat injection from an automated dispensing cabinet (ADC) in the intensive care unit (ICU) discovered a vial of vasopressin mixed in the same pocket with the enalaprilat vials. The vasopressin was removed and returned to the pharmacy. Pharmacy staff recognized that when they restock the ADC, they often package and transport multiple vials of a drug at the same time. Barcode scanning during restocking occurs, but only one of the vials is scanned. Other hospitals have reported similar errors when packaging numerous doses or vials in a plastic bag or container but scanning only the label that is affixed to the outer bag or container, either because the software will not allow all individual packages to be scanned or because it is considered impractical when counts are high. Therefore, there is an ever-present danger that the wrong medication may be transported and placed into the ADC, especially if medications have look-alike packaging, as was said to be the case with vasopressin and enalaprilat vials. Sometimes when selecting a product out of a pocket or matrix drawer, the vial's cap color can be misleading, especially when one cap color has been consistently associated with a particular drug and the product is stored with only the caps in view (see Figure 1).

Since the incident described above, the stock bins in the pharmacy at this facility have been separated and labeled with caution stickers. Incidentally, although the 2 vials involved in this event have the same color caps, the labels are dissimilar and can help to differentiate the products if practitioners read the label and do not rely on cap colors to identify drugs.

are scanned, it is just a sampling technique. Organizations need to make sure that other error prevention strategies are also in place. For example, whether or not barcode scanning is used, there is great value in having a pharmacist double-check all the items that are pulled from a carousel or general pharmacy stock prior to leaving the pharmacy. Even though it may seem efficient to transport and refill small vials and tablets in full containers or packs, dispensing or placing large quantities of medication in one pocket should be avoided to reduce the risk of errors. If the ADC has a scanner, the ADC can be set up with a remove function, thus requiring barcode scanning when a nurse retrieves a medication to ensure the medication selected matches the drug on the ADC screen or patient's drug profile.
