Issued: September, 2024

## SUBJECT: Non-Repairable Zones on Bumper Covers

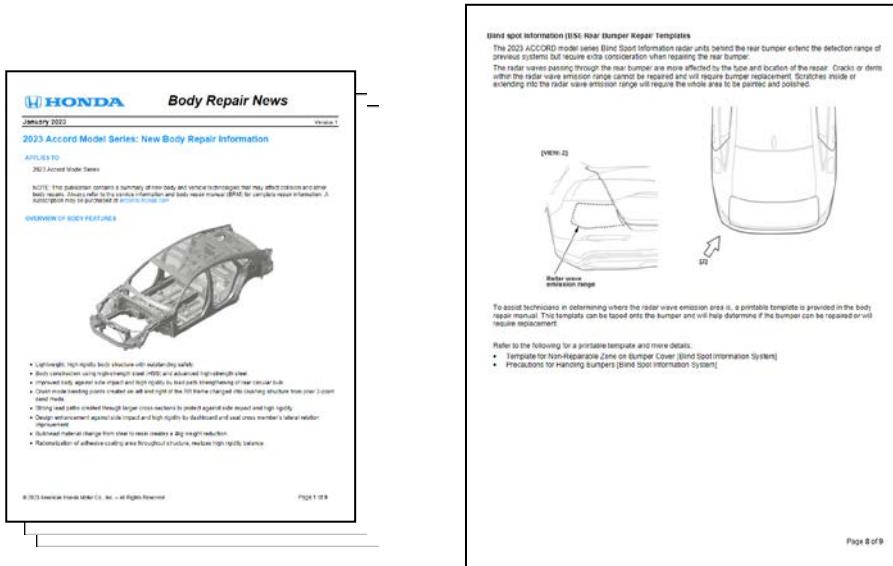
## Body Repair News (BRN)

The BRN can be used as a resource to determine whether a BSI equipped model requires special attention for the bumper covers.
