HOME INSPECTION

## 3BHK inspection

Skypark

**May 8, 2026**

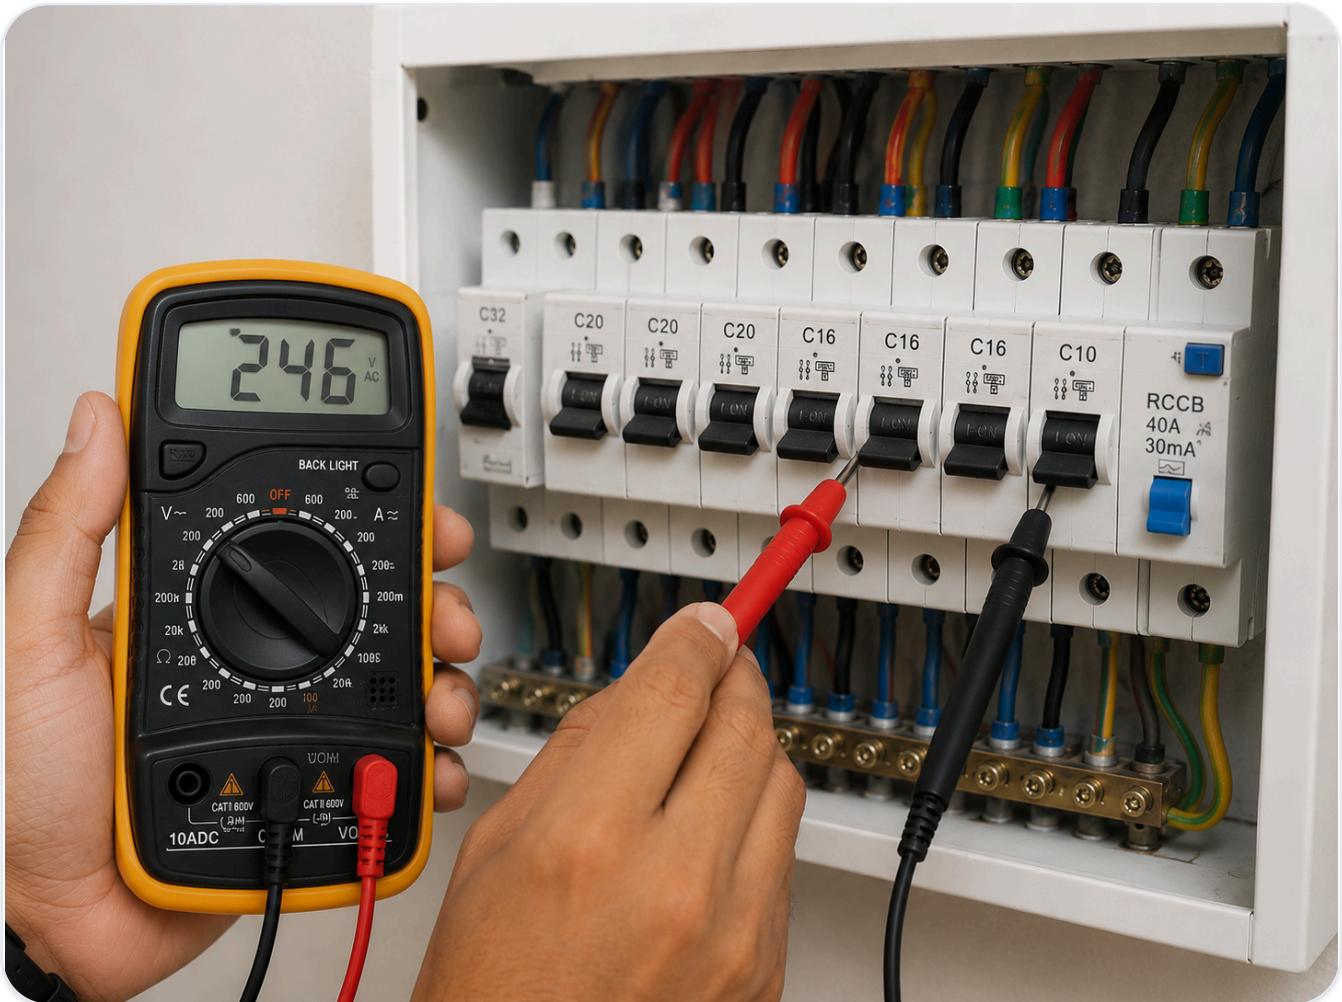
Observation 1

NO MINOR

Electrical D.B. Work: Is the Voltage between 220 - 240 V?

CATEGORY  
Living Room

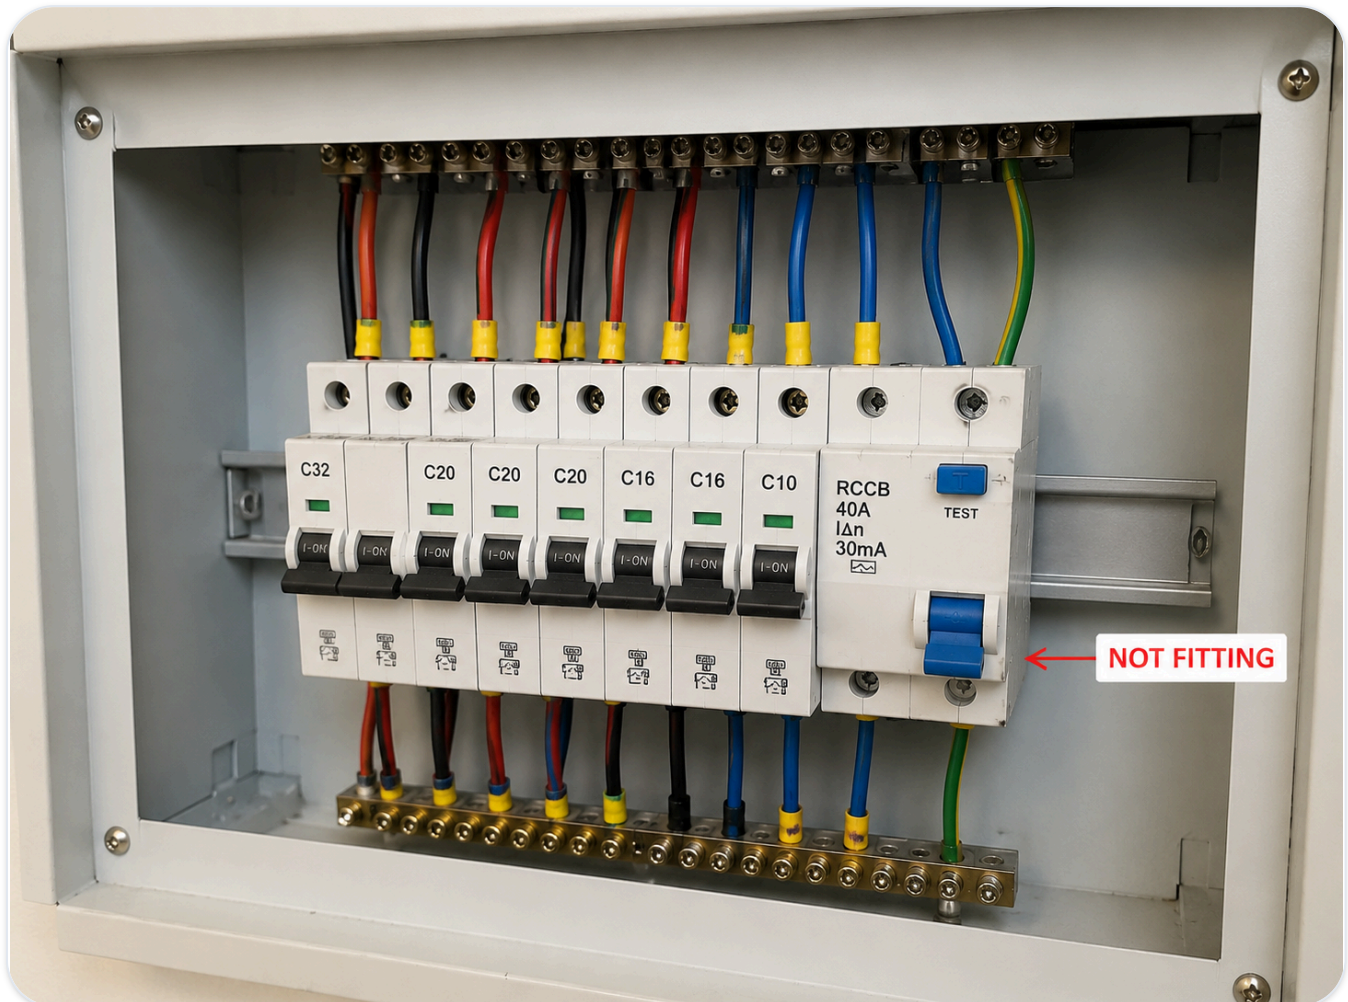
## Observation 2

NO

MAJOR

### Electrical D.B. Work: ELCB / RCCB MCB fitted & functioning

Living Room

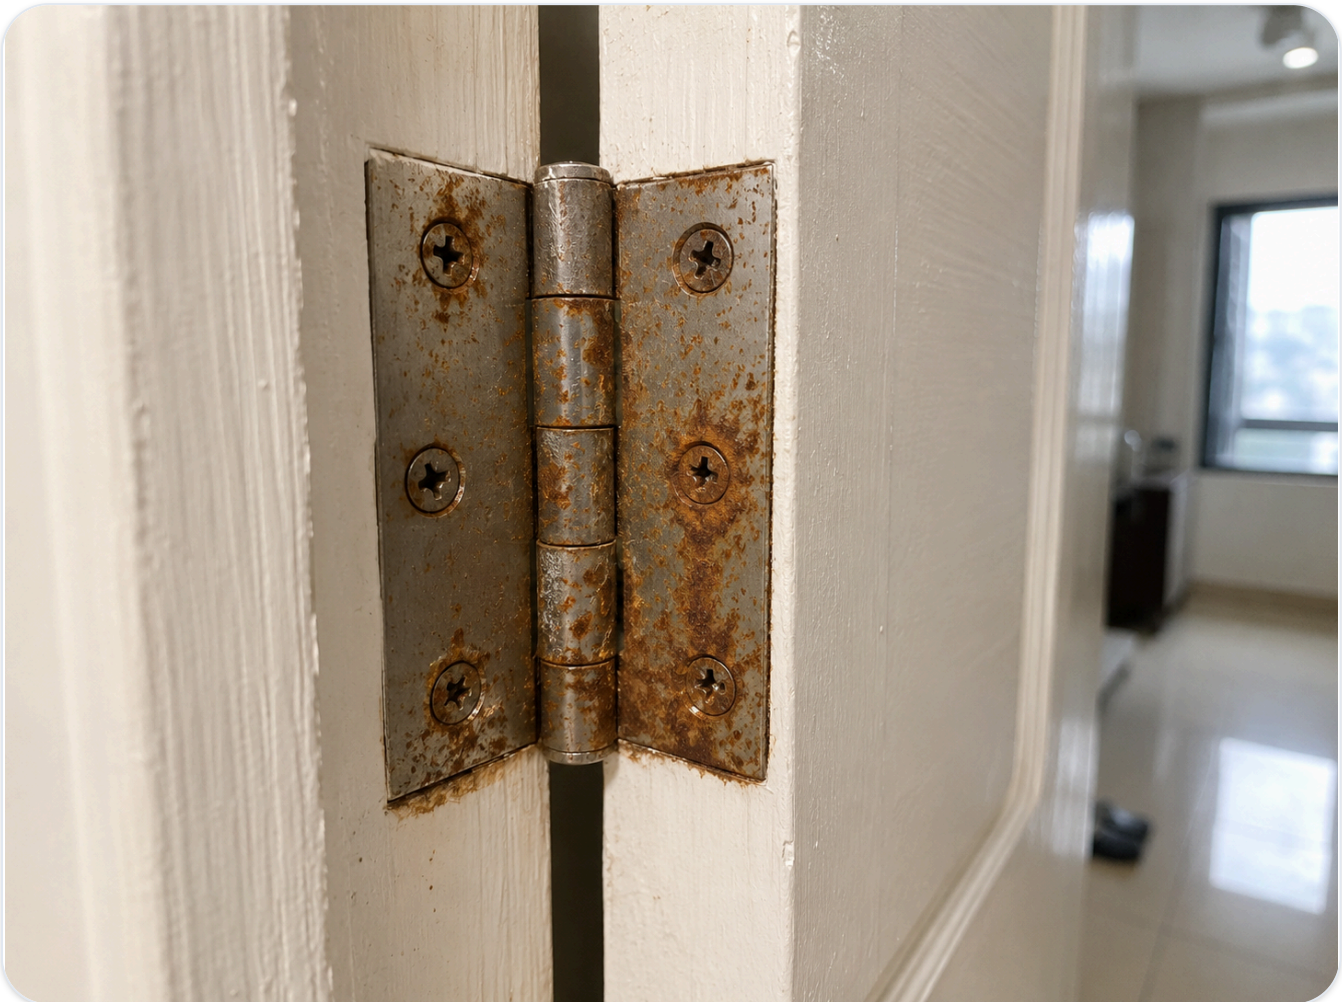
Observation 3

NO MINOR

Doors: Door fittings are free from paint, dust and rust

CATEGORY  
Master Bedroom

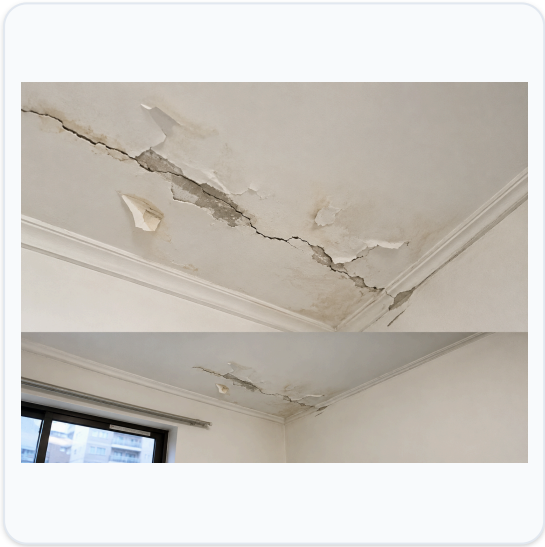
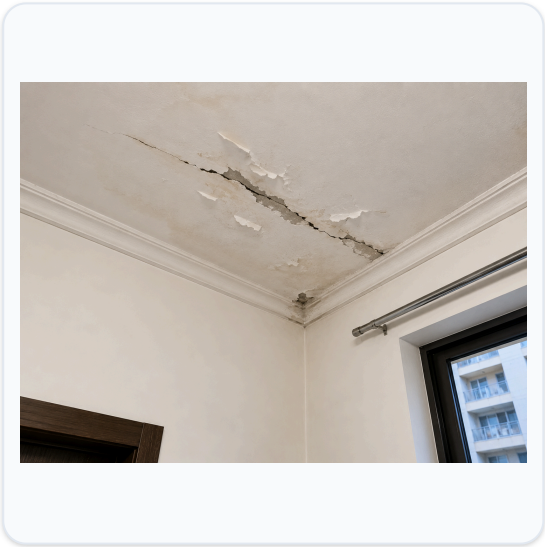
1 Ceiling Plaster Crack & Paint Peeling

MEDIUM

Visible plaster cracks and paint peeling observed on the living room ceiling near the corner joint. Minor dampness marks and surface deterioration indicate improper finishing or possible moisture seepage. Repair and repainting are recommended to prevent further damage.

Living Room Ceiling Corner
