GREENWORKS SERVICE COMPANY

GW STANDARD HOME INSPECTION

117 Red Leaf Cove
Georgetown, TX 78628

PROPERTY INSPECTION REPORT FORM

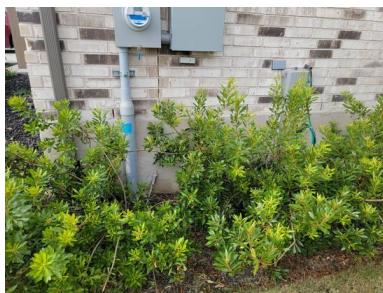
Heavy Foliage:

The heavy foliage around the structure should be trimmed and lowered to allow observation for insect activity. This condition is also conducive to moisture issues.

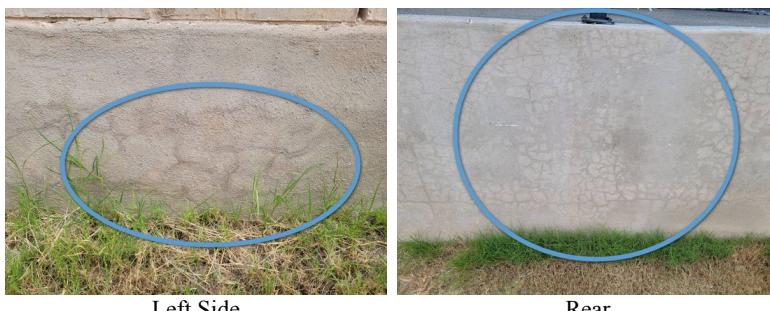
Honeycombing was present at the foundation wall. These areas should be monitored.

Recommendation: Recommend monitoring.

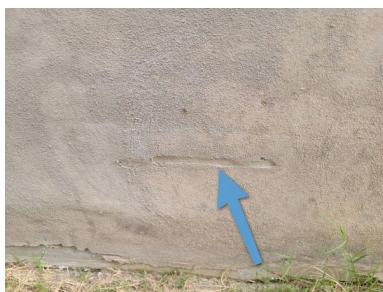
Left Side

**2: Damaged Skim Coating**

Damaged parge or skim coating was observed. Cracked parge coating can be repaired by resurfacing using a quick setting cement. For severe breaks, a completely new coat should be applied.

Recommendation: Contact a qualified professional.

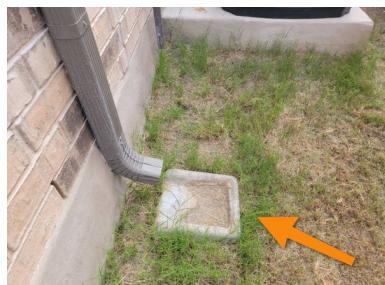
Left Side

2: Over-Exposure

There were areas of overexposure of the foundation wall. Preferably 6 to 8 inches of foundation exposure should be present around the perimeter of the home.

Recommendation: Contact a qualified landscaping contractor

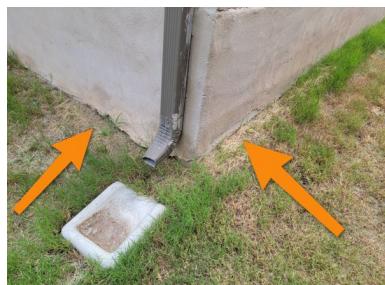
Back Left

3: Splash blocks not properly installed

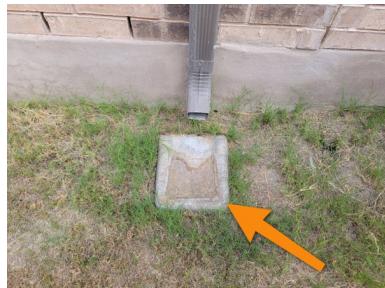
Left Side

Splash blocks have not been properly installed in areas.

Recommendation: Contact a handyman or DIY project

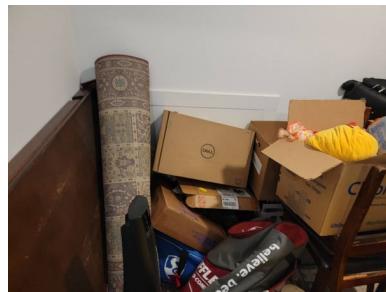
Access Blocked:

The attic access hatch/door was blocked by stored items, vehicles or shelving. Unable to comment on/ inspect this area.

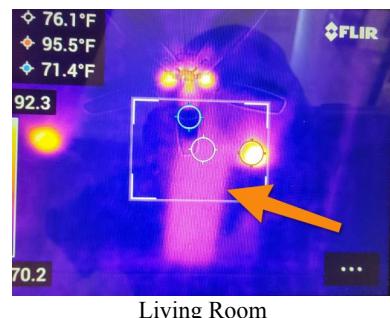
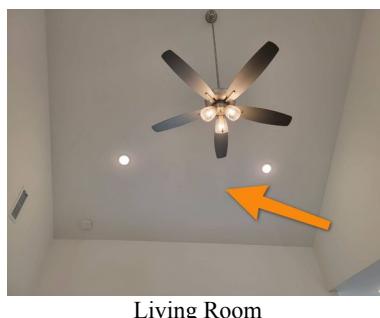
**1: Insulation Low - Infrared****► Recommendation**

There were areas of low/missing insulation observed with the infrared camera.

Recommendation: Contact a qualified insulation contractor.

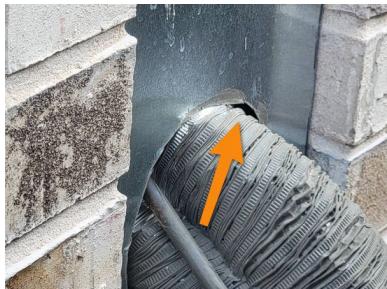
Left Side

It is recommended that all protrusions through the siding and fixtures mounted on the exterior be sealed in order to prevent moisture incursion. Using a quality exterior caulk type sealant around pipes, wires, light fixtures etc. can prevent moisture related failure of electrical components and siding materials.

Recommendation: Contact a qualified professional.

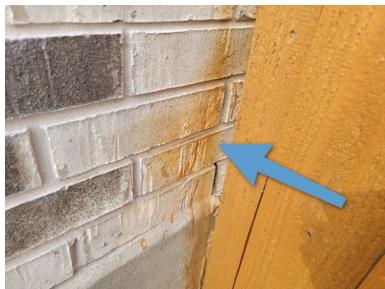
Right Side

2: Paint Splatter**● Handyman/Maintenance Item**

Paint splatter was noted on the walls.

Recommendation: Contact a qualified professional.

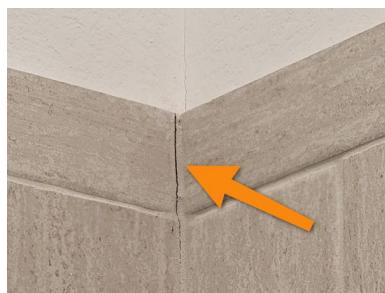
Downstairs Guest Bathroom

*Interior Wall Finishes: Sheet Rock***1: Caulking - Showers****● Recommendation**

There were various areas of missing and damaged caulking and grout at the shower walls. All enclosures should be completely water tight and sealed.

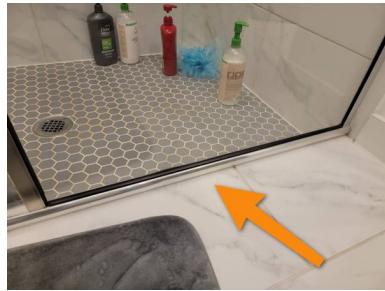
Master Bathroom

2: Shower Wall Leak**● Recommendation**

The bathroom shower enclosure leaks water when the shower is in use. Repair is recommended.

Recommendation: Contact a qualified professional.

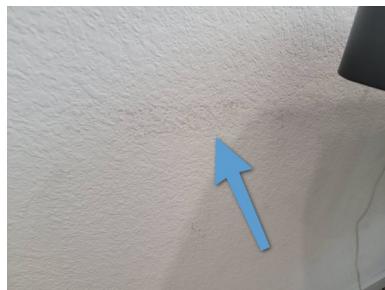
Upstairs Back Left Bedroom

4: Joint Separation

Recommendation: Contact a qualified drywall contractor.

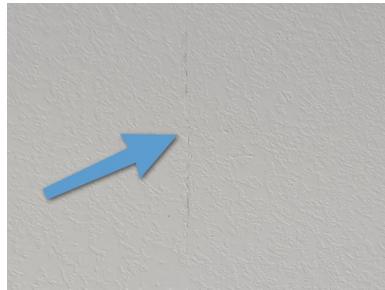
Garage

There are joint separations in various areas.

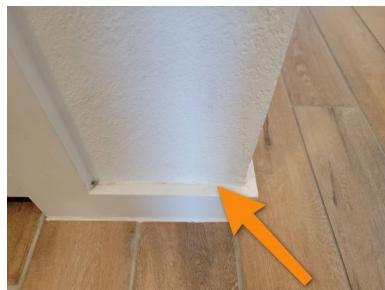
Garage Hallway

5: Walls Out Of Square

Recommendation: Contact a qualified professional.

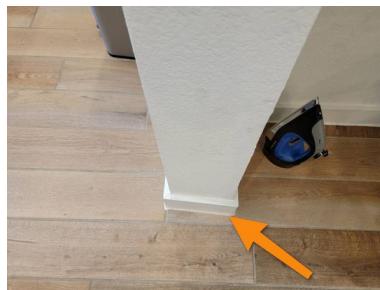
Kitchen

6: Trim Separation/Gapping**Handyman/Maintenance Item**

Trim separation was observed at areas of the interior trim materials.

Recommendation: Contact a qualified professional.

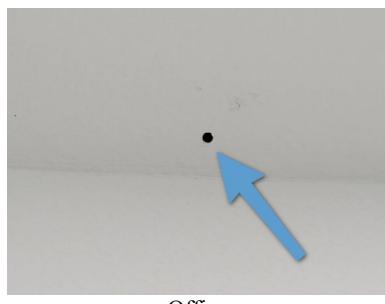
Office

2: Joint Separation

There is joint separation in various areas.

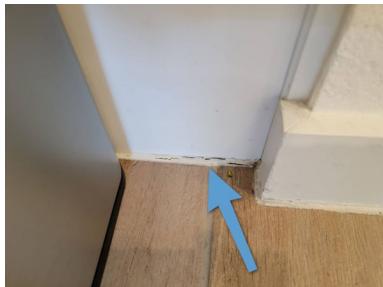
Kitchen

**1: Flooring Gap**

There were gaps at the flooring within the home.

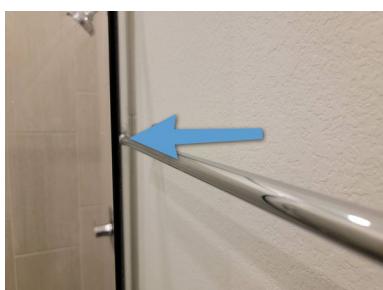
Downstairs Guest Bathroom

The shower door collides with another surface in the bathroom. Risk for damage is high and adjustment or stopper installation is recommended.

Recommendation: Contact a handyman or DIY project

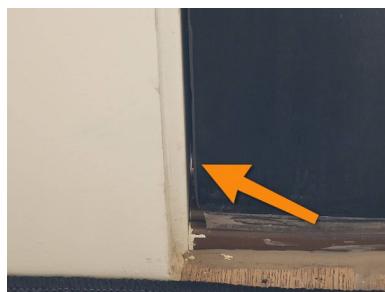
Entryway

Light and air gaps were present at the exterior doors. This can result in significant energy loss and moisture intrusion. Recommend installation of additional weatherstripping.

Recommendation: Contact a qualified door repair/installation contractor.

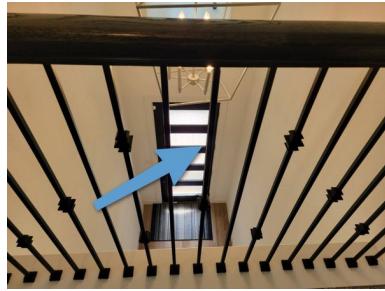
Upstairs Playroom

1: Loose Stairway Spindles**🔧 Handyman/Maintenance Item**

Stairway spindles are loose.

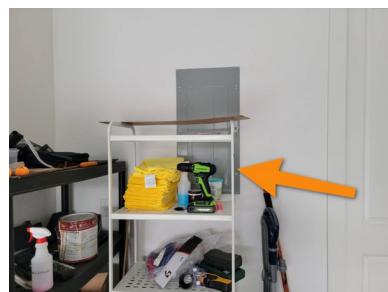
Garage

2: Partially Labeled**⊖ Recommendation**

The electrical panel was not completely labeled. It is recommended that a licensed electrician label the breakers and confirm proper amperage.

Recommendation: Contact a qualified electrical contractor.

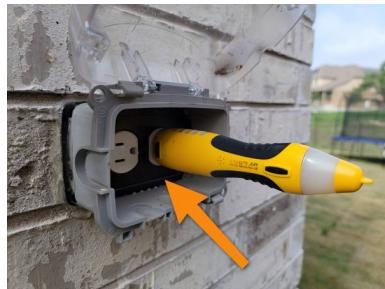
Outlet did not respond to testing. Repair or replacement is recommended.

Recommendation: Contact a qualified electrical contractor.

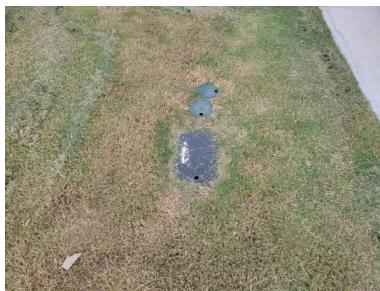
Water Meter Location: Front Yard

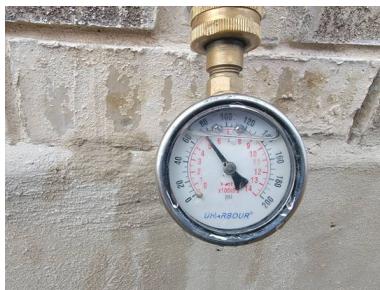
Main Water Shut off Location: Front Yard, Garage Wall

Static Water Pressure Reading: 75

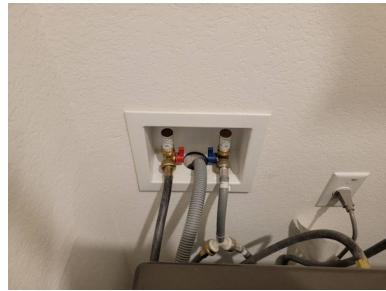
Washing Machine Connected to Valves: The occupant's washing machine was installed at time of inspection. This prevented an evaluation of the hose bibbs for possible leakage, proper function of the drain line, possible damage to the wall behind the washing machine or possible damage to the floor.

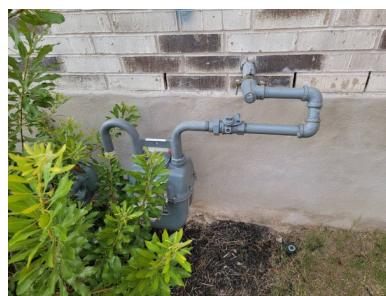
Location of Gas Meter: Exterior

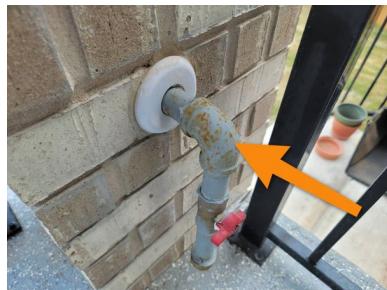
Rear

Areas of Rusting/Damage - Gas: Yes

Recommendation: Contact a qualified plumbing contractor.

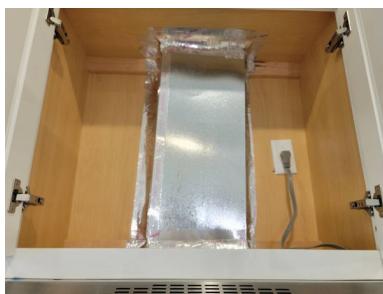
**1: Dirty Filter****● Recommendation**

Dirty filter at time of inspection. Cleaning or replacement of the filter is recommended.

Recommendation: Contact a handyman or DIY project

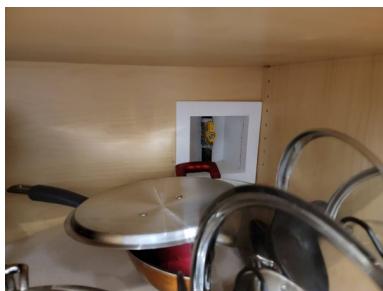
Gas Line Access: Yes

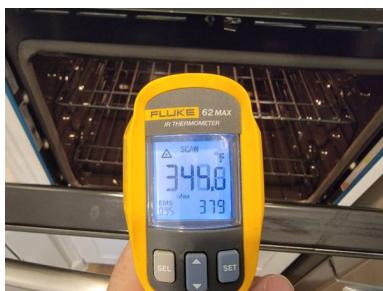
*Oven Heating Within 25 Degrees of 350:* Yes

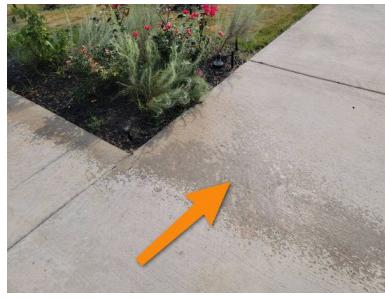
Front

The sprinklers spray the sidewalk, driveway, road, house, and fence and should be redirected or another head installed.

Recommendation: Contact a qualified professional.

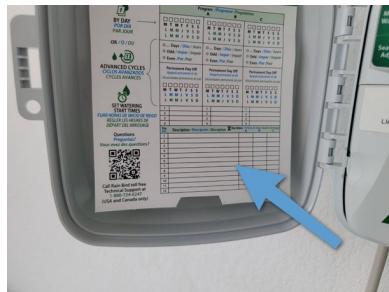
Garage

2: Not Fully Labeled

Recommendation: Contact a qualified landscaping contractor

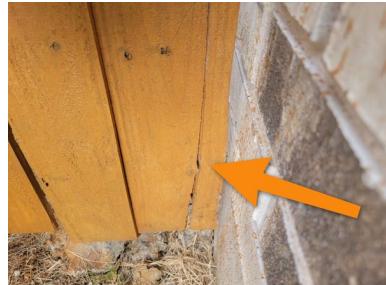
Left Side

Damage noted to the fence around the home. Recommend a qualified fence contractor evaluate and repair.

Recommendation: Contact a qualified fencing contractor

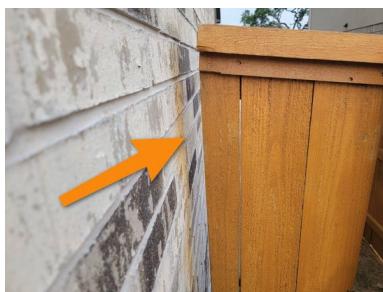
Right Side

The fence around the home was observed to be leaning. Recommend a qualified fence contractor evaluate and repair.

Recommendation: Contact a qualified fencing contractor

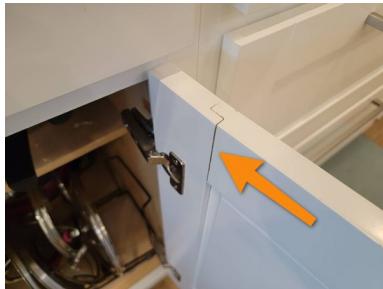
Kitchen

3: Cabinet Damage**⊖ Recommendation**

Recommendation: Contact a qualified cabinet contractor.

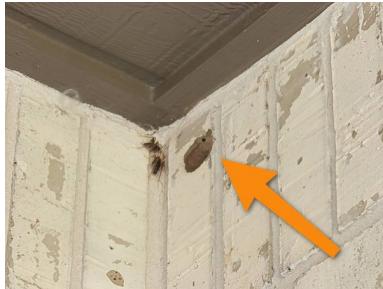
Rear

4: Wasp Nests**⊖ Recommendation**

Recommendation: Contact a qualified pest control specialist.

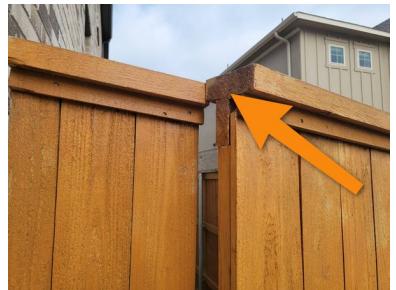
Right Side

5: Gate Not Latching**⊖ Recommendation**

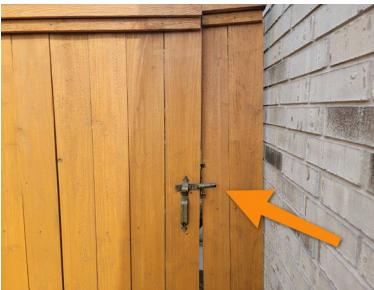
Left Side

The gate does not latch properly. Repair is recommended.

Recommendation: Contact a qualified professional.
