JSTAN PETROLEUM CORPORATION LIM

COMPREHENSIVE JOURNEY RISK MANAGEMENT ANALYSIS REPORT

Route ID: a3c3ec01-48e...

Analysis Date: June 09, 2025

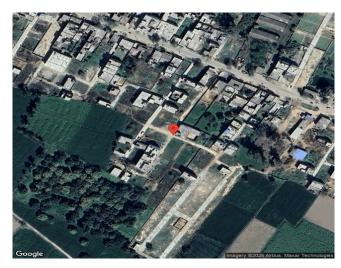
File: satellite_a3c3ec01-48e5-4165-afd4-942977ae3e5b_turn_1.png

- * Turn geometry: 180.0 deg curve
- * Road curvature: Sharp bend visible
- * Terrain context: Aerial perspective
- * Traffic flow impact: Potential bottleneck

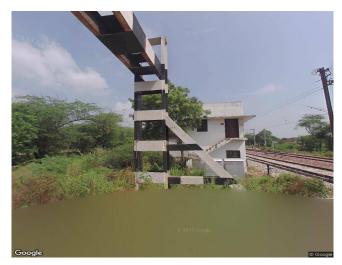
File: streetview_a3c3ec01-48e5-4165-afd4-942977ae3e5b_turn_2_h0.jpg

* Turn angle: 159.6 degrees

* Visibility: Limited due to sharp curve

* Hazard level: CRITICAL

* Max speed: 15 km/h

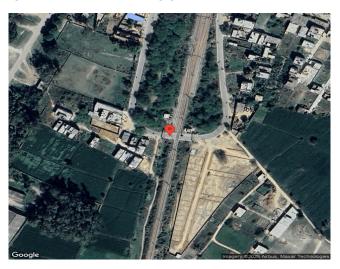
File: satellite_a3c3ec01-48e5-4165-afd4-942977ae3e5b_turn_2.png

* Turn geometry: 159.6 deg curve

* Road curvature: Sharp bend visible

* Traffic flow impact: Potential bottleneck

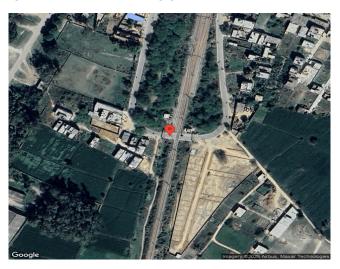
File: satellite_a3c3ec01-48e5-4165-afd4-942977ae3e5b_turn_2.png

- * Turn geometry: 159.6 deg curve
- * Road curvature: Sharp bend visible
- * Terrain context: Aerial perspective
- * Traffic flow impact: Potential bottleneck

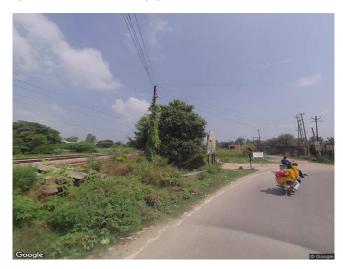
File: streetview_a3c3ec01-48e5-4165-afd4-942977ae3e5b_turn_4_h0.jpg

* Turn angle: 113.0 degrees

* Visibility: Limited due to sharp curve

* Hazard level: CRITICAL

* Max speed: 15 km/h

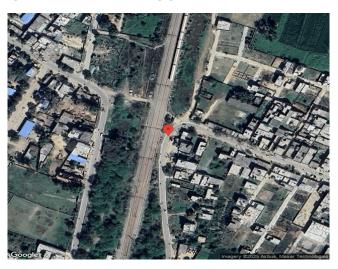
File: satellite_a3c3ec01-48e5-4165-afd4-942977ae3e5b_turn_4.png

- * Turn geometry: 113.0 deg curve
- * Road curvature: Sharp bend visible
- * Terrain context: Aerial perspective
- * Traffic flow impact: Potential bottleneck

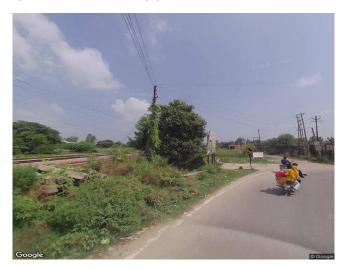
File: streetview_a3c3ec01-48e5-4165-afd4-942977ae3e5b_turn_4_h0.jpg

* Turn angle: 113.0 degrees

* Visibility: Limited due to sharp curve

* Hazard level: CRITICAL

* Max speed: 15 km/h

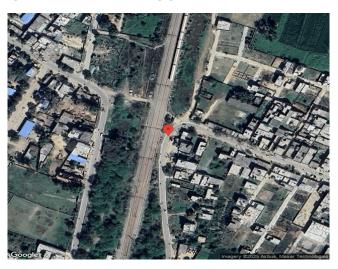
File: satellite_a3c3ec01-48e5-4165-afd4-942977ae3e5b_turn_4.png

* Turn geometry: 113.0 deg curve

* Road curvature: Sharp bend visible

* Traffic flow impact: Potential bottleneck

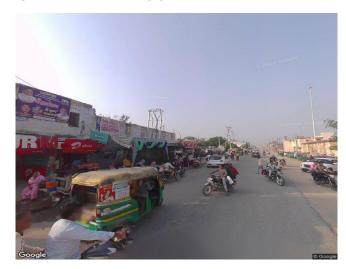
File: streetview_a3c3ec01-48e5-4165-afd4-942977ae3e5b_turn_6_h0.jpg

* Turn angle: 97.4 degrees

* Visibility: Limited due to sharp curve

* Hazard level: CRITICAL

* Max speed: 15 km/h
