Powered by Route Analytics Pro - Al Intelligence Platform

ROUTE ANALYSIS DETAILS

Route ID: af7c8826-2d0...

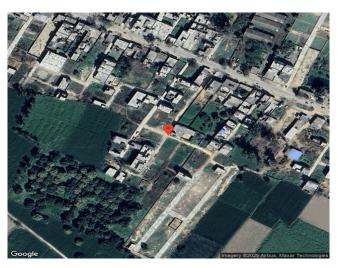
- * Turn geometry: 180.0 deg curve
- * Road curvature: Sharp bend visible
- * Terrain context: Aerial perspective
- * Traffic flow impact: Potential bottleneck

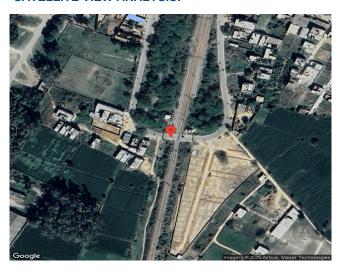
VISUAL EVIDENCE FOR TURN #2:

CRITICAL TURN #2: 159.6 deg - EXTREME BLIND SPOT - CRITICAL RISK			
GPS Coordinates	29.800050, 77.458640		
Turn Angle	159.6 deg (Deviation from straight path)		
Risk Classification	EXTREME BLIND SPOT - CRITICAL Risk Level		
Recommended Maximum Speed	15 km/h		
Safety Distance Required	Minimum 50m approach visibility		
Driver Action Required	Reduce speed, check mirrors, signal early		
Street View Images	2 images available		
Satellite Images	2 images available		
Total Visual Evidence	4 images for analysis

* Turn geometry: 159.6 deg curve

* Road curvature: Sharp bend visible

* Traffic flow impact: Potential bottleneck

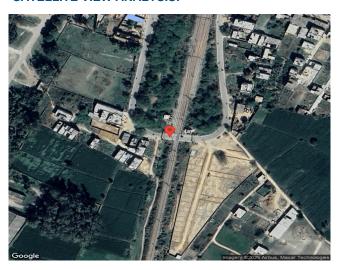
VISUAL EVIDENCE FOR TURN #3:

CRITICAL TURN #3: 159.6 deg - EXTREME BLIND SPOT - CRITICAL RISK			
GPS Coordinates	29.800050, 77.458640		
Turn Angle	159.6 deg (Deviation from straight path)		
Risk Classification	EXTREME BLIND SPOT - CRITICAL Risk Level		
Recommended Maximum Speed	15 km/h		
Safety Distance Required	Minimum 50m approach visibility		
Driver Action Required	Reduce speed, check mirrors, signal early		
Street View Images	2 images available		
Satellite Images	2 images available		
Total Visual Evidence	4 images for analysis

* Turn geometry: 159.6 deg curve

* Road curvature: Sharp bend visible

* Traffic flow impact: Potential bottleneck

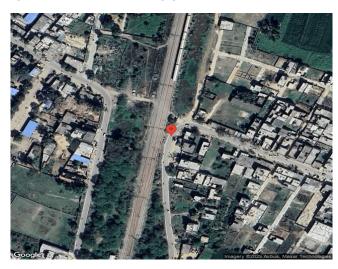
VISUAL EVIDENCE FOR TURN #4:

CRITICAL TURN #4: 113.0 deg - EXTREME BLIND SPOT - CRITICAL RISK			
GPS Coordinates	29.801760, 77.459240		
Turn Angle	113.0 deg (Deviation from straight path)		
Risk Classification	EXTREME BLIND SPOT - CRITICAL Risk Level		
Recommended Maximum Speed	15 km/h		
Safety Distance Required	Minimum 50m approach visibility		
Driver Action Required	Reduce speed, check mirrors, signal early		
Street View Images	2 images available		
Satellite Images	2 images available		
Total Visual Evidence	4 images for analysis

- * Turn geometry: 113.0 deg curve
- * Road curvature: Sharp bend visible
- * Terrain context: Aerial perspective
- * Traffic flow impact: Potential bottleneck

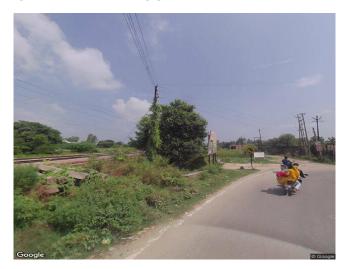
VISUAL EVIDENCE FOR TURN #5:

CRITICAL TURN #5: 113.0 deg - EXTREME BLIND SPOT - CRITICAL RISK			
GPS Coordinates	29.801760, 77.459240		
Turn Angle	113.0 deg (Deviation from straight path)		
Risk Classification	EXTREME BLIND SPOT - CRITICAL Risk Level		
Recommended Maximum Speed	15 km/h		
Safety Distance Required	Minimum 50m approach visibility		
Driver Action Required	Reduce speed, check mirrors, signal early		
Street View Images	2 images available		
Satellite Images	2 images available		
Total Visual Evidence	4 images for analysis

* Turn angle: 113.0 degrees

* Visibility: Limited due to sharp curve

* Hazard level: CRITICAL

* Max speed: 15 km/h

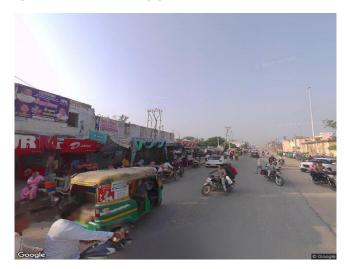
VISUAL EVIDENCE FOR TURN #6:

CRITICAL TURN #6: 97.4 deg - EXTREME BLIND SPOT - CRITICAL RISK			
GPS Coordinates	29.804640, 77.454670		
Turn Angle	97.4 deg (Deviation from straight path)		
Risk Classification	EXTREME BLIND SPOT - CRITICAL Risk Level		
Recommended Maximum Speed	15 km/h		
Safety Distance Required	Minimum 50m approach visibility		
Driver Action Required	Reduce speed, check mirrors, signal early		
Street View Images	1 images available		
Satellite Images	1 images available		
Total Visual Evidence	2 images for analysis

* Turn angle: 97.4 degrees

* Visibility: Limited due to sharp curve

* Hazard level: CRITICAL

* Max speed: 15 km/h

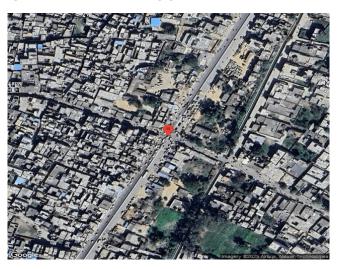
- * Turn geometry: 97.4 deg curve
- * Road curvature: Sharp bend visible
- * Terrain context: Aerial perspective
- * Traffic flow impact: Potential bottleneck

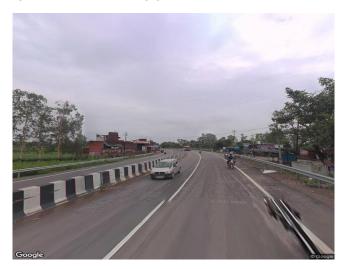
VISUAL EVIDENCE FOR TURN #7:

CRITICAL TURN #7: 75.7 deg - BLIND SPOT - HIGH RISK			
GPS Coordinates	29.625320, 77.439180		
Turn Angle	75.7 deg (Deviation from straight path)		
Risk Classification	BLIND SPOT - HIGH Risk Level		
Recommended Maximum Speed	25 km/h		
Safety Distance Required	Minimum 50m approach visibility		
Driver Action Required	Reduce speed, check mirrors, signal early		
Street View Images	1 images available		
Satellite Images	1 images available		
Total Visual Evidence	2 images for analysis

* Turn angle: 75.7 degrees

* Visibility: Limited due to sharp curve

* Hazard level: HIGH

* Max speed: 25 km/h

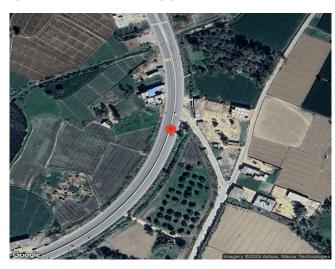
- * Turn geometry: 75.7 deg curve
- * Road curvature: Sharp bend visible
- * Terrain context: Aerial perspective
- * Traffic flow impact: Potential bottleneck
