# CUSTOMER-READY 8D DEMO

## Automotive 8D - CNC Housing Burr at Customer Incoming Inspection

8D-2026-AUTO-001 | Rev.1 | Automotive machining

Northstar Automotive Systems / Aluminum valve housing, part VH-4421 / AH-260418

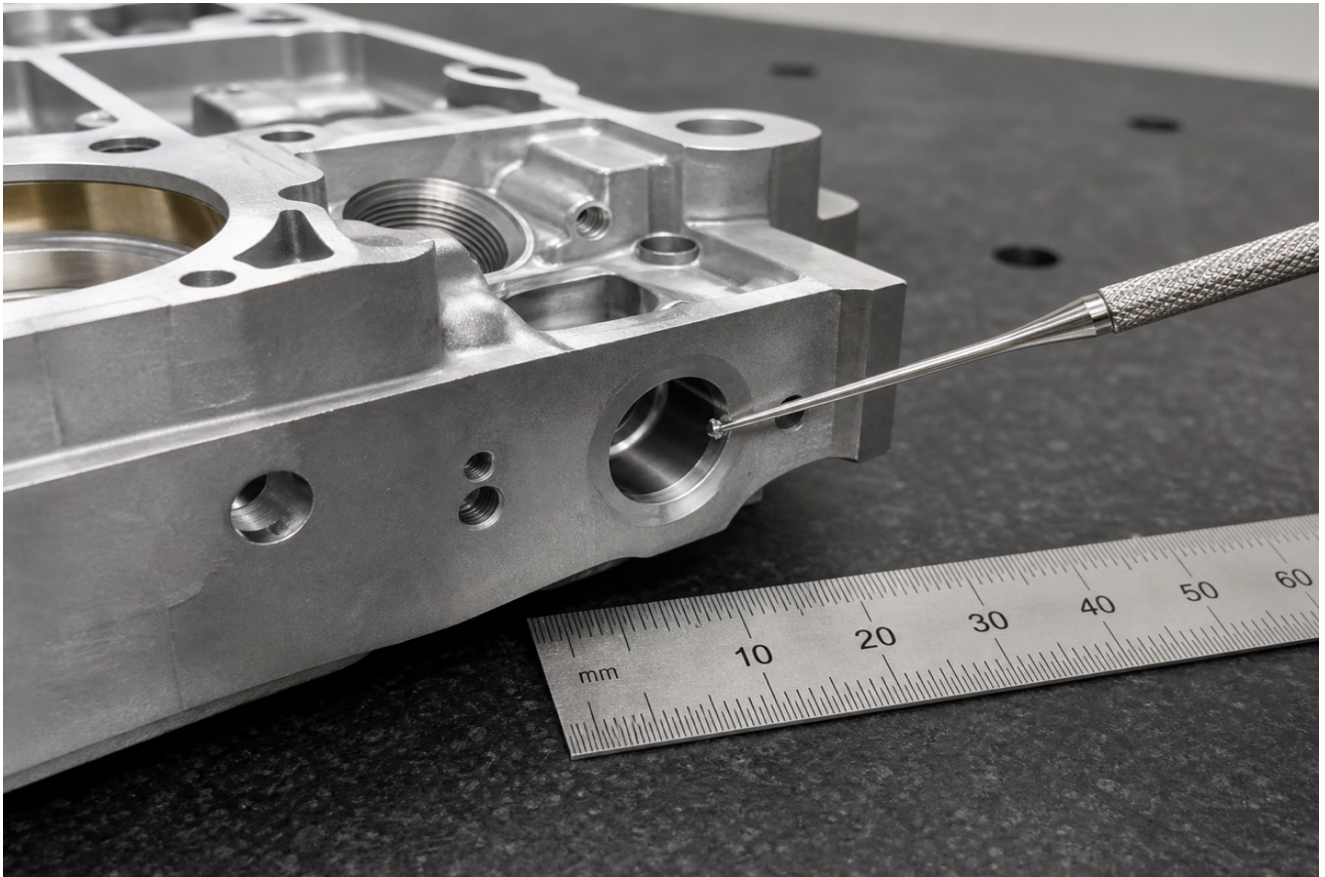
D2-customer-burr-evidence.jpg

The customer found a sharp burr on the oil-channel cross hole of 7 CNC-machined aluminum housings from lot AH-260418. The burr exceeded the agreed visual and tactile acceptance standard and could detach during assembly.

The deburring brush reached end-of-life before the scheduled replacement interval because the actual cross-hole load was higher than the interval study assumed.

Final visual inspection used top lighting only and did not include a borescope angle capable of revealing the cross-hole burr.

Inadequate brush-life control caused the burr; an insufficient final inspection angle allowed escape.

Set brush replacement at 7,500 cycles, add burr-height reaction limit, and require borescope inspection of the cross hole.
