Inspection Report

Samsung SDI Co., Ltd.

Cheonan Plant

Date : July 1~2 , 2021

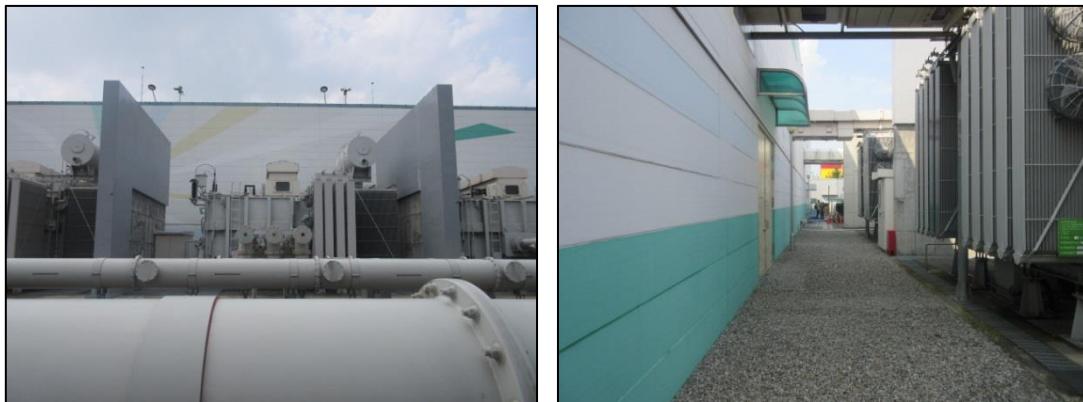
<Main transformers>

Korea Electric Power Corporation (KEPCO) supplies power at 154 kV for SDI Cheonan Plant. Electricity is received from the Seocheonan substation at 154 kV via dual underground lines. The output voltage is then stepped down to 22.9 kV at 4 oil-filled main transformers, 2 of which were installed in 2011. The main transformers are located outdoors adjacent to the 154 kV Building, with concrete fire walls between the 4 transformers. Normally, 2 transformers are in service and other two are for stand-by.

The electricity is stepped down once more at 20 local transformer rooms, and there are 5 oil-filled and 39 mold-type local transformers.

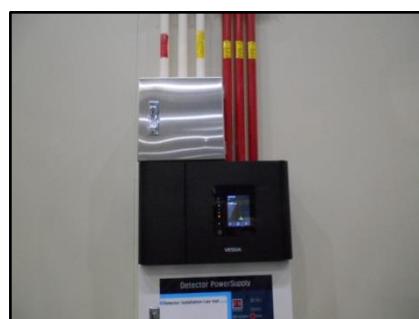
<VESDA system in M Line>

The air sampling-type detectors, VESDA (Very Early Smoke Detection Apparatus), are provided in the charging-discharging rooms and aging rooms of the M1 Battery Formation Building and M2 Building.

In the M2 Building, VESDA has been installed for both common plate process areas and Dry room areas.
