# VEHICLE INSPECTION REPORT

AI-Powered Body + Engine Sound Analysis · June 16, 2026 at 11:10  
Physical Defect Detection (7-class YOLO + Severity Model) + Engine Knock Audio Classification

| Make / Model | LEXUS LEXUS-SUV-TEST | Year | 2024 |

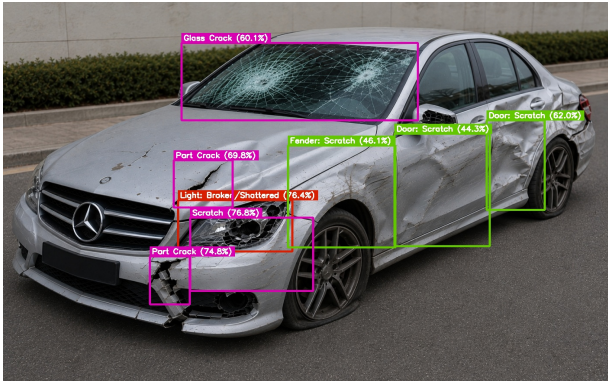
Annotated Images — Dual Model Detections

The inspection detected: Light — Lamp Crack, Door — Scratch, Fender — Scratch, Scratch, Part Crack, Glass Crack. Safety-critical damage identified on Light — Lamp Crack, Glass Crack requires immediate attention.

**Light — Lamp Crack** ■ **Safety-Critical** (Severe, 80.2% confidence)  
Damaged lights reduce road legality — replace before driving at night.

**Door — Scratch** (Moderate, 65.1% confidence)  
Inspect door seals and hinges — repair to prevent water ingress.

**Fender — Scratch** (Severe, 88.7% confidence)  
Exposed metal will oxidise — treat and repair at nearest opportunity.

**Door — Scratch** (Minor, 48.7% confidence)  
Inspect door seals and hinges — repair to prevent water ingress.

**Scratch** (Moderate, 76.8% confidence)  
Scratches expose bare metal — treat with touch-up paint to prevent rust.

**Part Crack** (Moderate, 74.8% confidence)  
Consult a qualified technician for assessment and repair.

**Part Crack** (Moderate, 69.8% confidence)  
Consult a qualified technician for assessment and repair.

**Glass Crack ■ Safety-Critical** (Moderate, 60.1% confidence)  
Glass cracks compromise structural integrity and visibility — replace immediately.

- 1. Damaged lights reduce road legality — replace before driving at night.
- 2. Inspect door seals and hinges — repair to prevent water ingress.
- 3. Exposed metal will oxidise — treat and repair at nearest opportunity.
- 4. Scratches expose bare metal — treat with touch-up paint to prevent rust.
- 5. Cracked component detected — assess structural impact and repair.
