# VEHICLE INSPECTION REPORT

AI-Powered Body + Engine Sound Analysis · June 07, 2026 at 16:37  
Physical Defect Detection (7-class YOLO + Severity Model) + Engine Knock Audio Classification

| VIN / Registration | WDDZF8DBXRA765432 | Mileage | 45000 |
| Make / Model | MERCEDES-BENZ MERCEDES-BE<br>NZ-SEDAN-TEST | Year | 2024 |

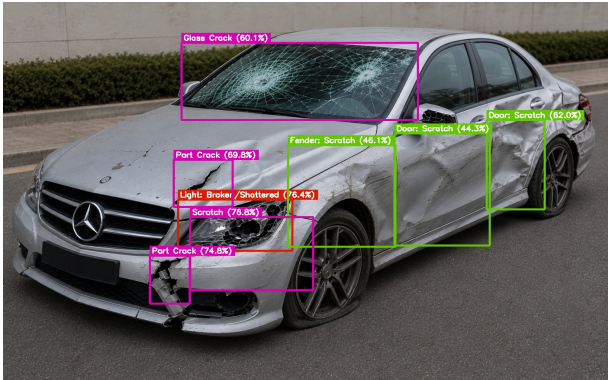
Annotated Images — Dual Model Detections

- Light — Lamp Crack ■ Safety-Critical** (Severe, 80.2% confidence)  
Damaged lights reduce road legality — replace before driving at night.
- Door — Scratch** (Moderate, 65.1% confidence)  
Inspect door seals and hinges — repair to prevent water ingress.
- Fender — Scratch** (Severe, 88.7% confidence)  
Exposed metal will oxidise — treat and repair at nearest opportunity.
- Door — Scratch** (Minor, 48.7% confidence)  
Inspect door seals and hinges — repair to prevent water ingress.

**Scratch** (Moderate, 76.8% confidence)  
Scratches expose bare metal — treat with touch-up paint to prevent rust.

**Part Crack** (Moderate, 74.8% confidence)  
Consult a qualified technician for assessment and repair.

**Part Crack** (Moderate, 69.8% confidence)  
Consult a qualified technician for assessment and repair.

**Glass Crack ■ Safety-Critical** (Moderate, 60.1% confidence)  
Glass cracks compromise structural integrity and visibility — replace immediately.

- 1. Damaged lights reduce road legality — replace before driving at night.
- 2. Inspect door seals and hinges — repair to prevent water ingress.
- 3. Exposed metal will oxidise — treat and repair at nearest opportunity.
- 4. Scratches expose bare metal — treat with touch-up paint to prevent rust.
- 5. Cracked component detected — assess structural impact and repair.
