# Industrial Technology Research Institute Internship

## ITRI Intern

## 7/4/2025 MLCC X7R Dielectric Analysis

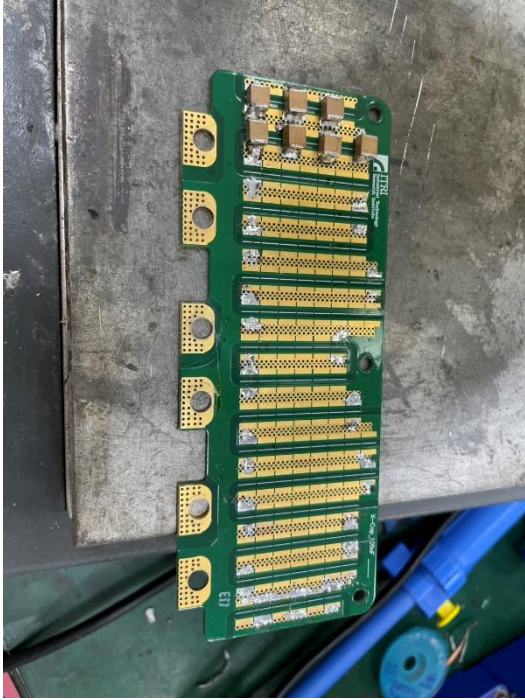
Figure 1 First stage testing

*Figure 1* shows the PCB with capacitors installed during the early stage of testing. *Figure 2* presents an IR image captured during testing of column 2, demonstrating uniform thermal distribution. *Figure 3* shows the PCB after installation of all five columns, with no visible damage or discoloration. *Figure 4* provides an IR image taken during the final test of column 5, again showing no abnormal temperature rise.

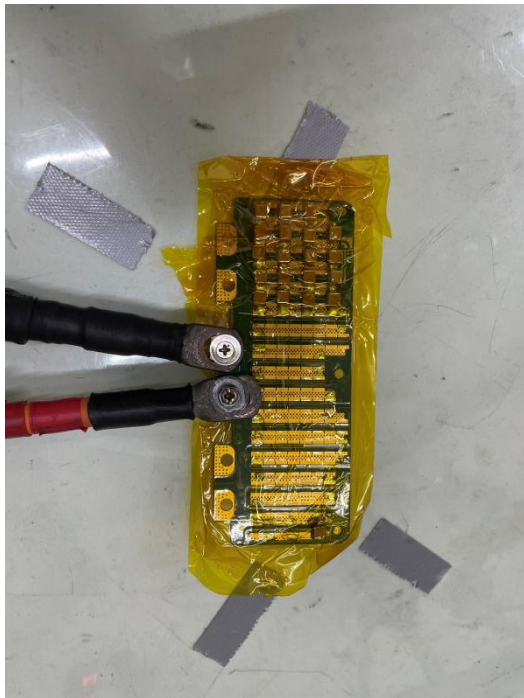
Figure 5 Installation of the last column

When we installed capacitors in column 6, we observed unexpected behavior: as the voltage increased to 60 V, a small current began to flow—something that had not occurred during testing of the previous rows. This raised concerns about a possible short circuit, capacitor failure, or PCB layout issue. To investigate, we desoldered and measured the four capacitors from column 6 individually. One of them showed a slightly lower capacitance value ( $0.45\ \mu\text{F}$ ), compared to the expected value of around  $0.48\ \mu\text{F}$ . To determine whether the abnormality originated from the capacitor or the PCB, we re-soldered this specific capacitor onto the last column of the PCB and repeated the test. After re-testing, we determined that the current behavior was due to the startup characteristics of the power supply, not the capacitor or PCB. The earlier observation was therefore identified as a false alarm.

Figure 5 presents the power supply current behavior observed during the 60 V ramp-up. Figure 6 shows the reinstallation of the slightly out-of-spec capacitor on the last column for further verification.

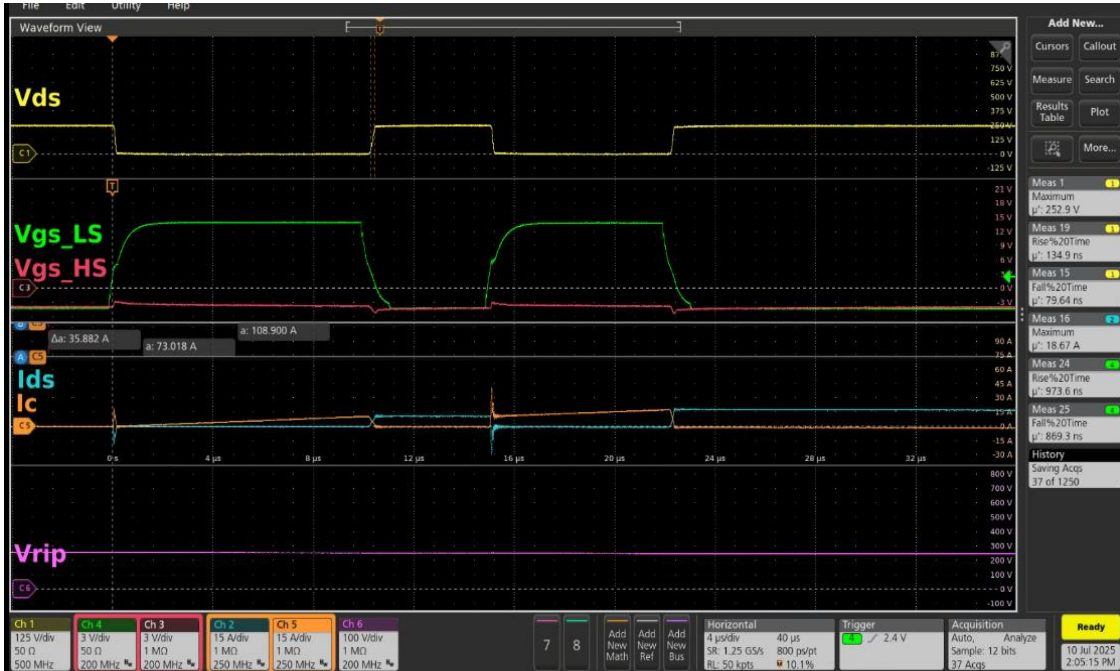
Figure 15 to Figure 17 show the measured waveforms for 200 V, 450 V, and 600 V, respectively. Table 2 summarizes the observed peak drain-source voltage and the capacitor's current for each voltage level under the new pulse configuration.
