Siderope O-ring Remediation

April 11, 2024; V4

1 Introduction

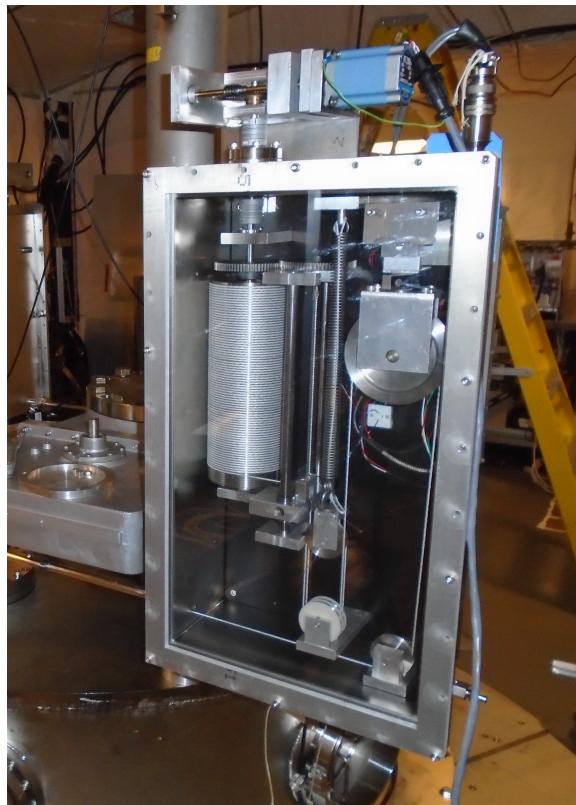
Figure 2: One of the motor boxes with an acrylic window installed to see the interior mechanisms.
