Renewing Motor Box Seals

Ryan Bayes

February 22, 2024

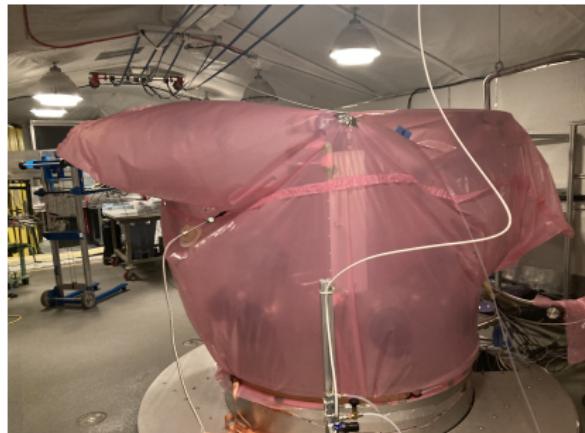
- ▶ Know that the UI radon seal is not great
- ▶ Leak rate is significantly reduced through the used of nitrogen bags
 - ▶ Isolation bag around full UI has produced low radon monitor rates (before pump)
 - ▶ Isolation bags around problematic features reduced rate relative to none
- ▶ Main sources are;
 - ▶ North siderope motor box
 - ▶ East rope extension box
- ▶ Both require o-ring require o-ring replacement
 - ▶ Reduce nitrogen use by the experiment
 - ▶ Restore functionality of North Motor box (bag cuts off access)

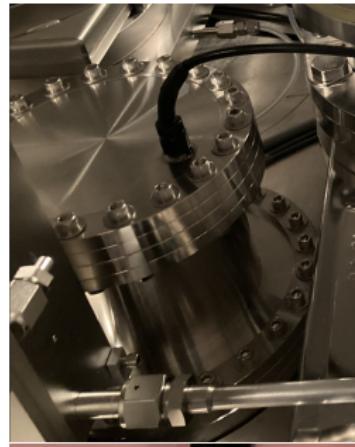
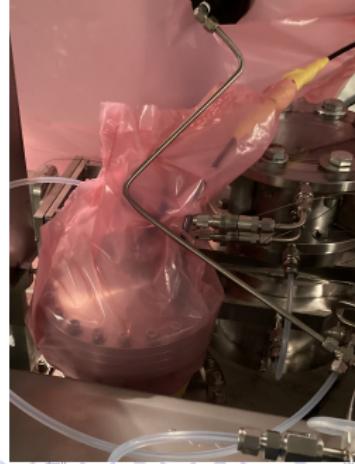
Neck Tube Radon Mitigation

- ▶ HV feedthroughs are "known" to be radon permiable
 - ▶ Attempted isolation test but inconclusive
 - ▶ Two isolation bags clearly hold pressure
 - ▶ Two others are not so obvious (but that may be a flow problem)
- ▶ Seal cannot be improved without completely changing the connection plate
- ▶ May need another attempt at isolation bags
- ▶ Increased pressure could improve isolation measure (get that by removing the large bags)
- ▶ Could improve the material; use aluminized mylar
