Nicolas De Fer's *L'Amerique* Wall Map: A Look into Ethical Concerns Resulting from Past Restoration

Presented at the Book and Paper Group Session, AIC's 39th Annual Meeting, May 31–June 3, 2011, Philadelphia, Pennsylvania.

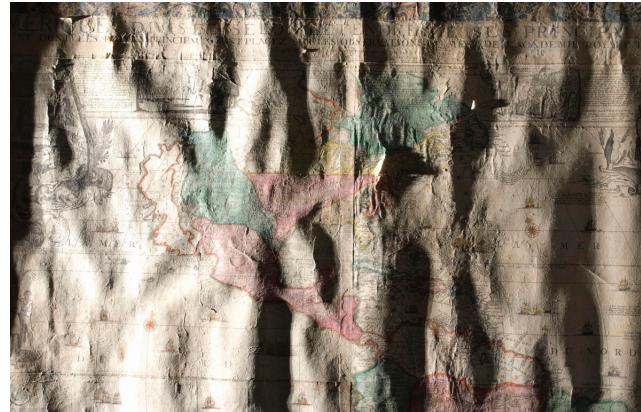
Fig. 1. LAC's 1739 Edition of *L'Amerique* (R1-2000/1739) under raking light, before treatment

The backing paper of the untreated 1739 edition was not original. It was a single sheet of acidic, machine-made paper, which needed to be removed for the long-term preservation

of the map. In addition to the acidic backing, there was overall cockling and an opaque substance had been generously applied to the tears and losses in the map and text panels (fig. 4). The opaque had also been used to cover complete rows of text, which had been misaligned during past restoration. As a result, the substance would need to be removed to view the original text beneath.

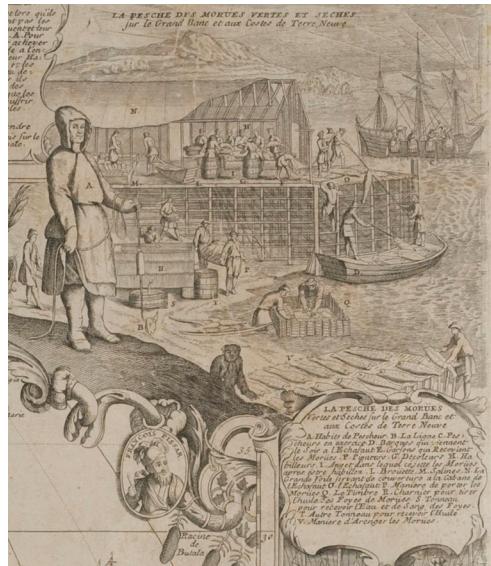
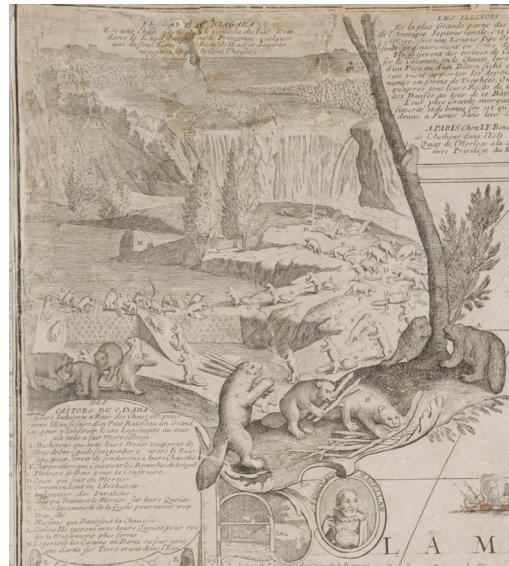
Fig. 2. The decorative vignette of a 17th century Newfoundland cod fishery

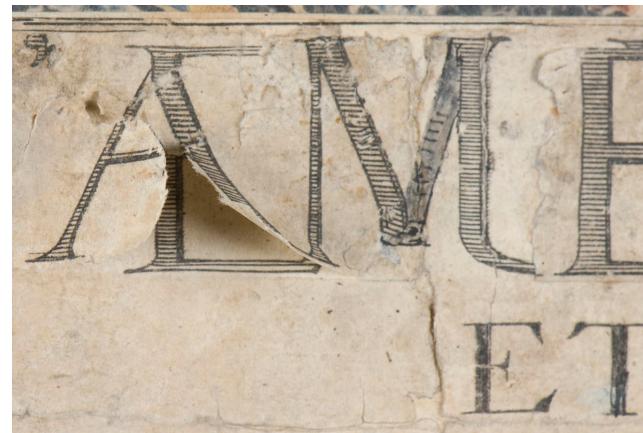
Fig. 9. The U in the word Europe below has become part of the letter M in the word L'Amerique

Conservators consulted LAC's 1698 edition of de Fer's *L'Amerique* Map and found similar cut edges around the word *Amerique* in that title banner. When viewed with transmitted light, the word *Europe* was visible beneath *L'Amerique*, just as it had been in the 1739 edition. To determine if only these two

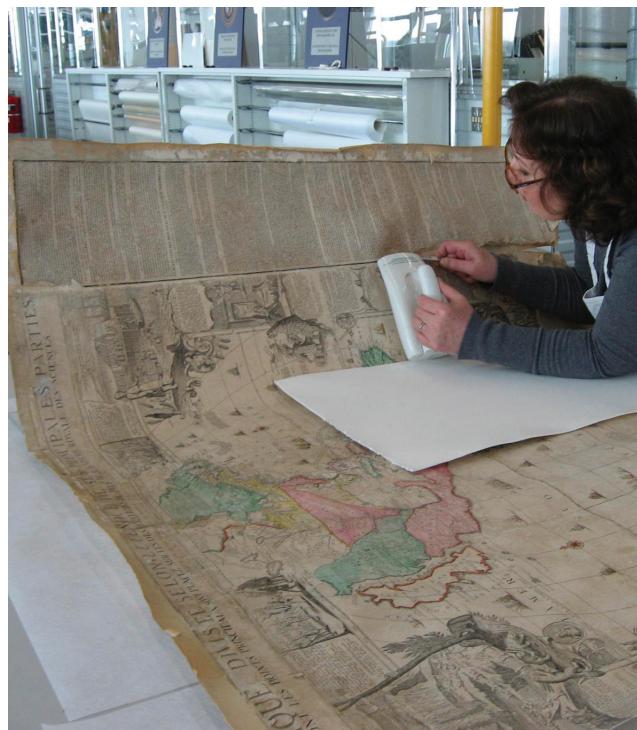
Fig. 10. Using steam on the overlap to allow safe separation of the text panels from the map

Conservation treatment began with the humidification of the overlapping seam along the right side of the map (fig. 10). The overlap was gradually lifted with a spatula, allowing the text panel to be safely cut from the map without damaging the overlapping margin, as had occurred to the left text panel during past restoration. The right text panel was then separated into two sections. The remaining text panels were also removed and separated in the same manner. All the text panels were then pre-treated with alcohol, and immersed in water baths to aid in the backing removal. Light brushing during bathing aided in the reduction of the opaque

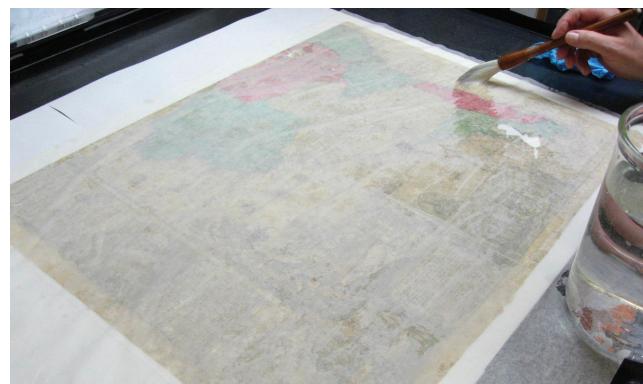
Fig. 11. Washing a central panel of the map on the suction table, through a layer of facing tissue

The central panels were then safely washed on the suction table. Warm water was gently sprayed and dabbed through a layer of facing tissue to protect the watercolours (fig. 11). Once all the panels were washed, they were sized with a warm 1% solution of gelatine in water, applied by brushing through a layer of facing tissue.

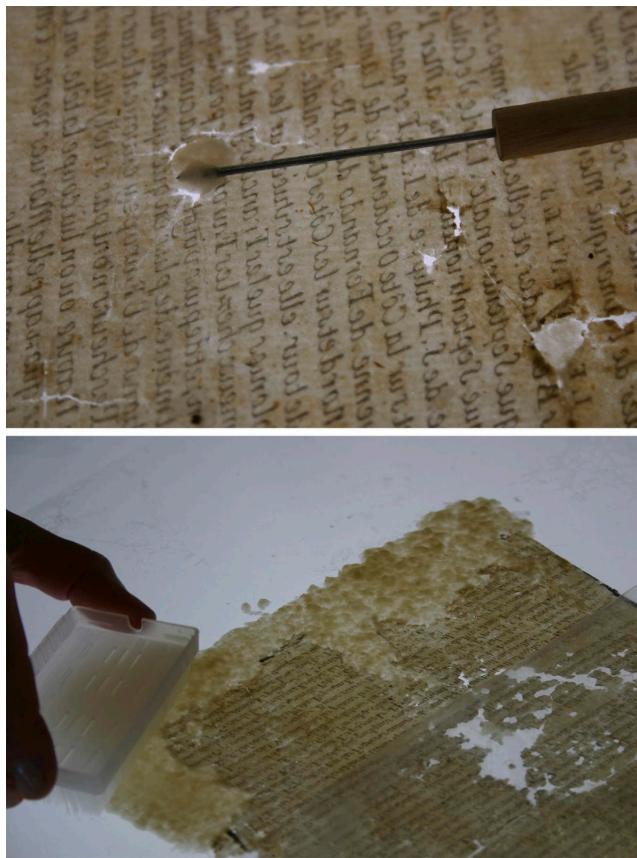
Fig. 12. Applying pulp infills by hand to the more damaged areas.

The two sections of the right text panel were the least damaged of all the panels, allowing them to be leaf cast. All of the remaining panels were more heavily damaged, so the same leafcasting pulp was applied by hand (fig. 12). The wet pulp infills were blotted, partially dried and lined with a thin Japanese tissue, using wheat starch paste as an adhesive. Any overlapping margins which had been trimmed from the panels during past restoration, were re-created with the infill pulp and lining tissue.

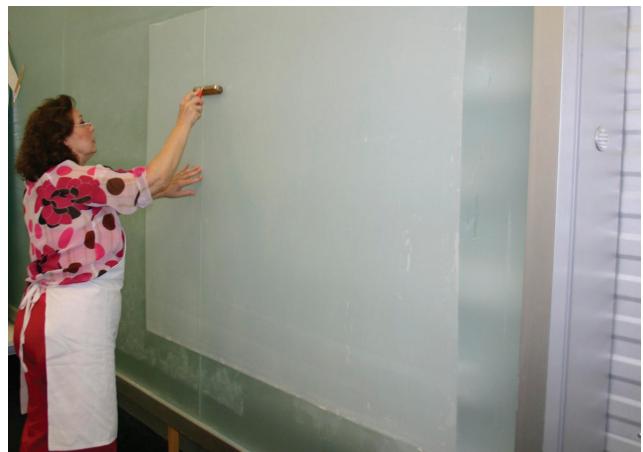
Fig. 13. A pasted-out sheet of Terylene being smoothed onto the glass surface of the light wall

An oversized sheet of Terylene (also known as Dacron or sailcloth) was sprayed with water, and then pasted out with wheat starch paste. The Terylene was then transferred to the vertical light wall, used for work on oversized documents (fig. 13). Sheets of Kizukishi paper were pasted out with wheat starch paste and added to the Terylene, rolling them with a brayer to remove any air bubbles. The sheets of Kizukishi were allowed to dry on the Terylene.

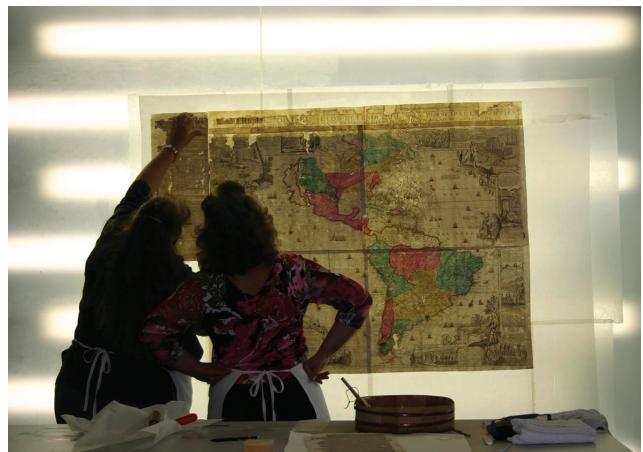
Fig. 14. Assembling the map and text panels onto the first lining

The assembled and dried center panels of the map, were first humidified with a damp brush, then pasted out with wheat starch paste. Paste was also applied to the Kizukishi sheets already on the wall. The center panels of the map were then transferred to the light wall and rolled out with a brayer. The title and side text panels were added in the same manner, followed by the bottom text panel (fig. 14). Alignment of the panels was a result of extensive measurement and photo documentation. Following discussions with the archivist, it was decided to return the marbled paper border to the map. Though the border was not originally

part of the map, it was not obscuring any of the textual information and could easily be removed if necessary. Once the map and text panels had been assembled on the light wall, the marbled paper border was added.

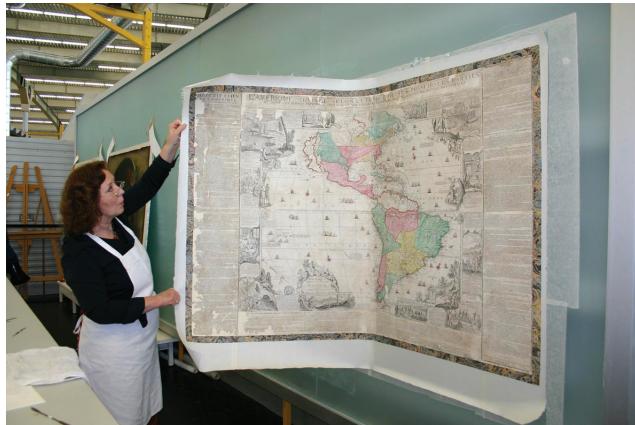
Fig. 15. Removal of the map, first lining and the Terylene from the light wall

When dry, the Terylene sheet was peeled from the light wall and placed face down on the table (fig. 15). The Terylene was then separated from the verso, by carefully sliding hands between the Terylene and the thin Kizukishi paper of the first lining. To allow the map to return to its original dimensions, it was rehumidified prior to the second lining. With the map still face down on the table, sheets of Kurotani #52 were adhered to the verso of the first lining with wheat starch paste (fig. 16). Large margins of the Kurotani paper were pasted to the table, providing tension to the map while drying.

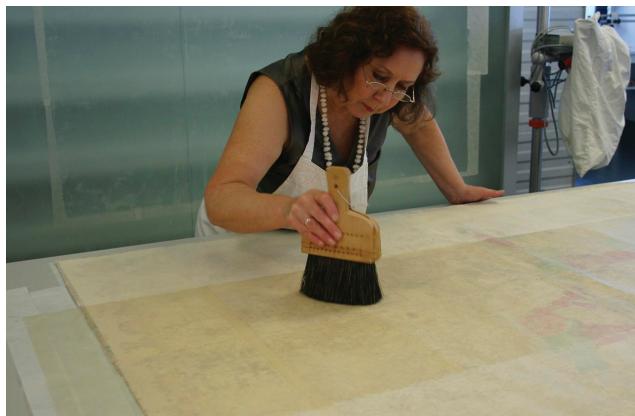
Fig. 16. Applying the sheets of the second lining to the verso of the map

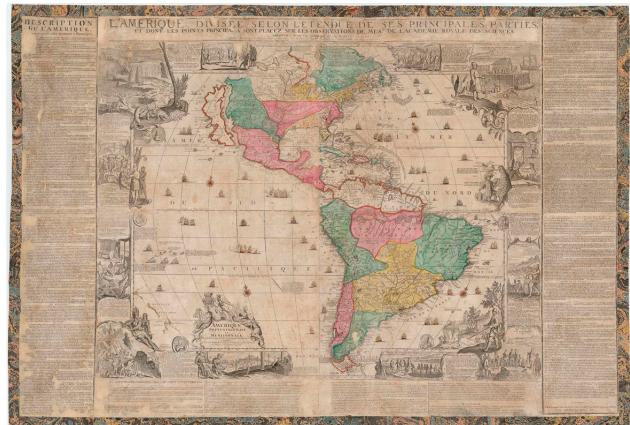
Fig. 18. After Treatment photo of the 1739 edition of LAC's *L'Amerique* map (R/1-2000/1739)

the map, the missing information has been printed from the scanned copy. The printed panels are now stored with the map as reference panels, making this *L'Amerique* map a much more complete source of information (fig. 18).
