REALIGNING THE RIVER CHERWELL A PRACTICAL PERSPECTIVE

JANE MOON Senior Geomorphologist

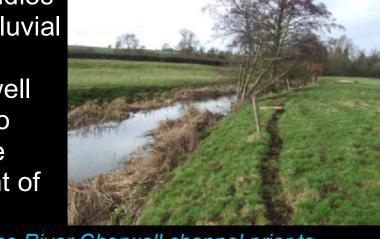
(3) Section of the River Cherwell channel prior to realignment (Source: River Cherwell Geomorphological Assessment and Design Advice. Feb 2011. Atkins)

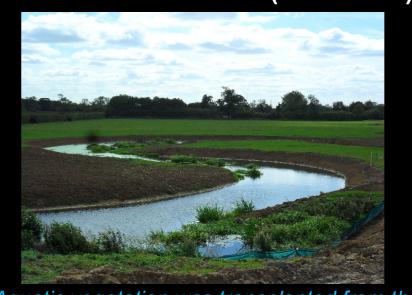
(7) Aquatic vegetation was transplanted from the original River Cherwell channel into the new realigned channel. The reedbeds in particular have established well.

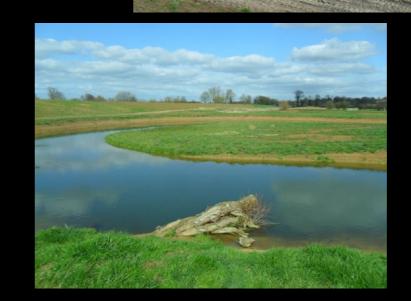
(9) Course Woody Debris (CWD) was retained onsite and used to try and vary the flow within what is largely an impounded reach due to a downstream structure.

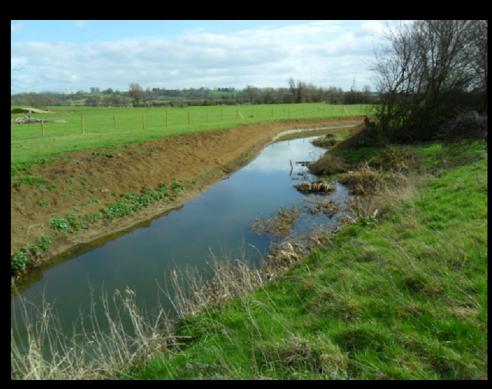
(12f) Aquatic vegetation was infilled behind the CWD (14) Vegetation is starting to establish and grow on the new channel banks.
