### **Altus Packaging Investigation Report**

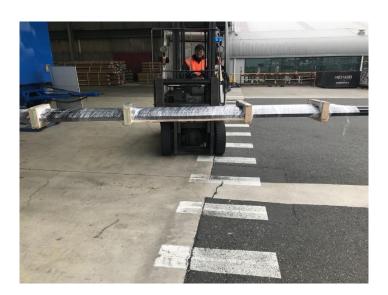
## Trial 1

To reduce the length of the runners and replace the strength with the over wrap. What we found was that during the stages of assembly an excess of tape had to be used to hold the metal onto the base cleat. While traveling along the conveyor, the weight of the metal would slide the cleat out of position. Previously the runners would keep the cleats in location during transport along the conveyor belt. This was a challenge aligning the cleat.

When the unsupported side cleat went into the over wrapper it slightly dropped before being caught by the wrap. This confirms that we need the runners in order to be assured that the cleat aligns in the correct place each time.

The forklift needed the middle runners to protect the metal from the forks. The ends of the runners were removed and the over wrap provided adequate strength holding the metal together.

2 cleats had strapping and the other two had screws and no strapping. The wrapping provided sufficient tension on the two cleats without strapping. Different thickness over wrap provide different weight load capability's and even more so when it's over wrapped. However one of the cleats was not stable and provided a lot of movement.

We found that the runners were necessary to provide accurate cleat placement during the assembly process and are necessary for making the assembly process consistent and efficient. The wrapping adds adequate support for the metal when wrapped even more so when wrapped more than once. From this trial we found that a base is necessary to make an efficient assembly & wrapping process.

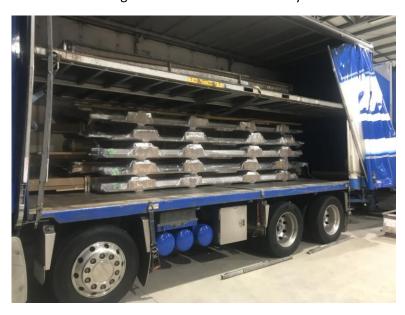
The pack located on the top has been outside in the rain exposed to the elements for 5 months. The rain has found gaps in the cardboard causing some areas to get wet. The case below it was left in the rain for 1 week and was completely unaffected from the elements. The cases below it were made the previous day and had been sitting outside for a little over a day.

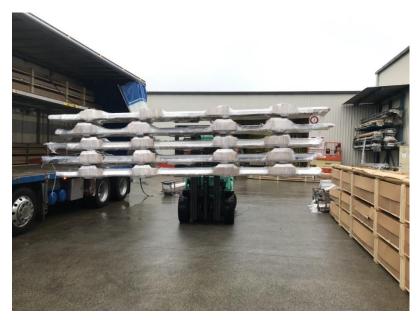
# **Delivery Rotorua**

On delivery, the cardboard cases held up sufficiently with minimal movement. Due to the over wrap plastic providing sufficient grip during transport the cases did not move from its initial position. Bradnams Rotorua took positively to the cardboard case trials and encouraged the idea. They found that the wooden bases took up too much room and when asked the question to Bradnams Rotorua about reusable bases they said they had no space to put them and preferred if they could bin the cardboard. The bases are left on the street in hopes people pick them up as firewood or are cleared out weekly. In regards to backloading- the truck driver said that he didn't have any space and is giving him extra handling work when he already drives the forklift to unload himself.

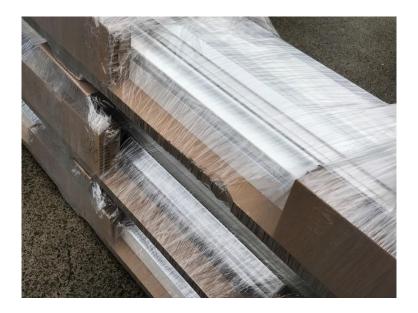
# Damage

The places that seemed to take the most damage were the underside of the bases and the side cleats.

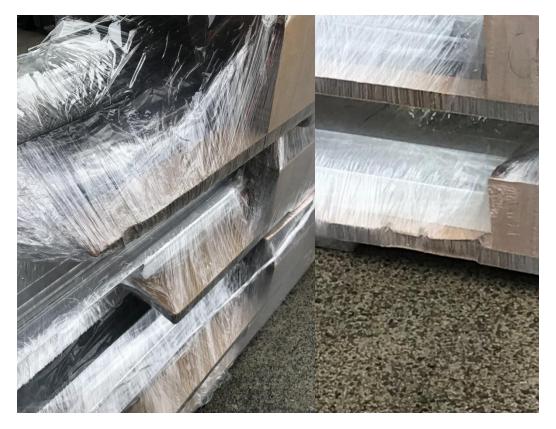
The most places that water absorption occurs seems to be the corners of the bases and where the forks press against on the underside. It was found that the cardboard cases worked with a positive results.

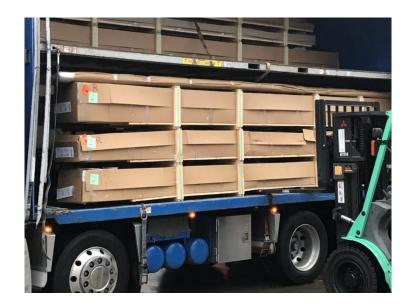
# Compared to the wood cases

According to the truck driver, large cases like this are incredibly hard to unload at some franchises that don't have forklifts. In one particular situation he said they had to unload it by hand and so used straps to lower the large case from the top shelf. This is extremely dangerous especially for the

Mainfreight driver. When the larger case is at the top it cases extreme pressure on the runners causing flex. Bradnmas Rotorua have said they have a large amount of reports of twist on the mullion fins and other extrusions.

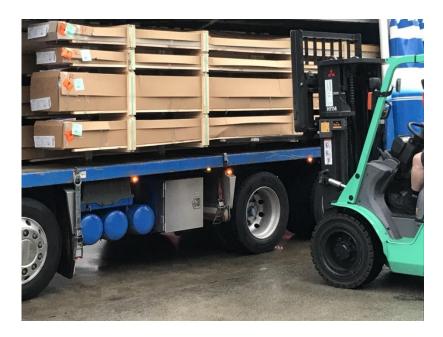
When packing larger cases in the middle, flex on the bottom runners occur. Each case contains different extrusions, the case height does not relate to the weight. Just because one case is bigger does not mean it weighs more and so stacking from largest to smallest isn't necessary correct.

The flex on the bottom runners was caused by an excess of weight from an overweight case packed at the top. The case that was larger had a large amount of polystyrene in it in order to keep it rigid. It also started falling sideways as he started lifting the cases. The truck driver said taller cases are more likely to tip regardless of wood or cardboard.

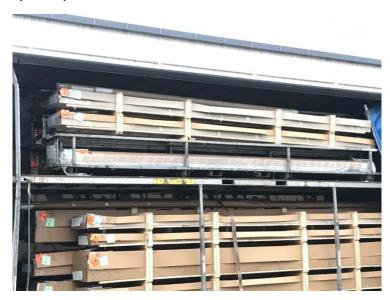
# Wooden cases on top of skips

When the correct wooden jigs aren't used, the cases tend to fall onto the metal in the metal skip. The bases usually go on top upside down but since most aren't straight they don't use them so a jig either has to be cut or supplied. In this case the truck driver only used one jig and was just balancing on the skip.

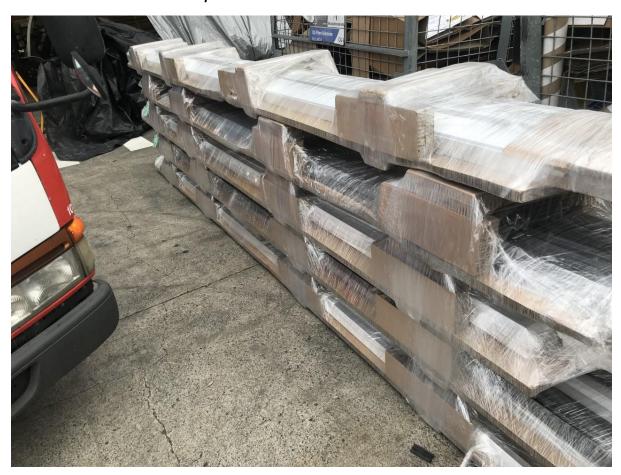
# Cardboard Arrival back to Te Rapa

Upon arrival, the cases were all in one piece, with the biggest damage occurring on the side cleat. The cardboard on the side cleat
