Coleambally Irrigation Cooperative Limited MEERA Analysis

- FINAL REPORT
- December 2011

Sinclair Knight Merz ABN 37 001 024 095 Level 11 452 Flinders St Melbourne VIC 3000 Australia PO Box 312 Flinders Lane Melbourne VIC 8009 Australia

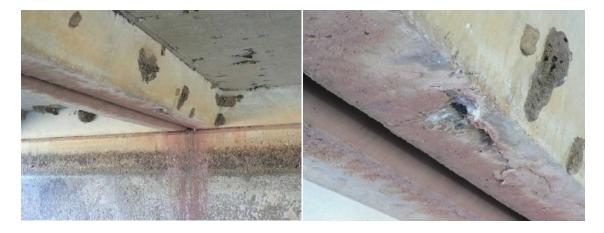
Figure 5-1 Asset IF0268 Road bridge/regulator

5.1. Concrete Condition

A number of sites showed concrete "cancer" or spalling. This was most evident on road bridges on the soffit (underside) of the main beams on combined regulating structures. This is to be expected as the beams flex and concrete is in tension allowing micro cracks to occur. Air and moisture from flow turbulence spray or high humidity enters the cracks, which along with the calcium chloride in the concrete, results in corrosion of the embedded steel reinforcement causing it to expand and spall the cover concrete. CICL has undertaken repairs at affected sites to prevent further deterioration of the concrete. The defects are not extensive and will have been affected by construction practices and variations in the cover to the reinforcement, concrete mix and quality on the day of manufacture.

Some of the major combined road bridge and regulators on the Main Canal have mixed asset conditions. The bridge beams have deteriorated due the concrete type and ingress of moisture whilst the underlying regulator foundation and walls were in very good condition. In these cases, it is expected that the bridge beams will be replaced on the original abutments and piers, which appear to be quite sound and the life of the asset should reach that given in the previous table.

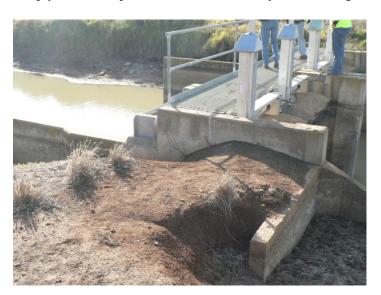
The first issue relates to access onto regulators. Whilst the regulators have been mechanised with Rubicon Flume Gates and operate remotely or automatically, there is still a need for operators and maintenance staff to access the work platform and control equipment. The key issue is excessively high steps or awkward access to the platform as shown in Figure 5-2. These should be upgraded to comply with Occupational Health and Safety Act and Regulations.

■ Figure 5-2 Regulator 4 (Site IF0101) showing difficult access to the walkway

Another safety issue is with regulators attached or part of road structures where there is a risk to operator safety and comfort, especially with high speed traffic. There is also a potential risk to Flume Gates from wide farm machinery. It is suggested that CICL consider the relocation of the regulator when replacement is required. Other infrastructure upgrade programs such as the Northern Victoria Irrigation Renewal Program (NVIRP) are separating the relatively few combined road culvert/regulators primarily for safety reasons.

The separation of regulating structures nominally 20 m upstream from road bridges will also result in drier ambient conditions under bridges which is expected to extend the bridge life.
