FINAL INSPECTION REPORT

Client Name:	CBGKT		
Inspection No.:	INS/TH-64/7915		
Report Date:	May 7, 2021

Vendor/Supplier Name:	GAIA Corporation (Thailand)	Factory Name:	GAIA Corporation (Thailand)		
Product Description:	EXAMINATION Gloves	Approved Sample:	X	YES	NO
Product PO:	N/A	Reference Sample:		YES	X
Product Item/Style:	Nitrile Powder Free	Combined Sample:	YES	X	NO
Inspection Date:	05/04/2021	Previous Inspection No.:			
Inspection Location:	Chonburi, Thailand	Service Performed:	FINAL RANDOM INSPECTION		
Inspector Name(s):	Mr. Apirak S.	IFI Version:	N/A

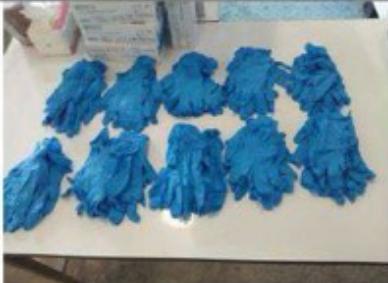
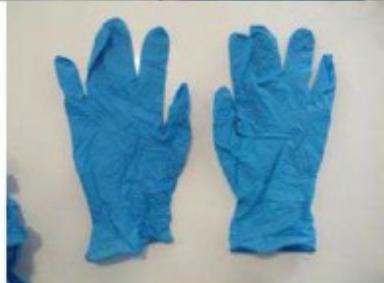
Check Weight

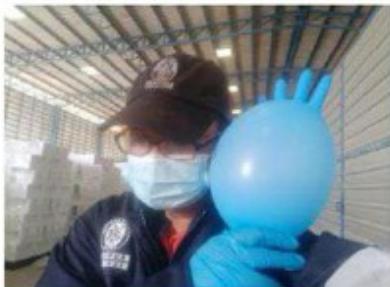
Check Air Leakage

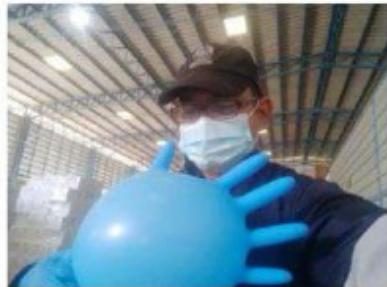
Check Air Leakage

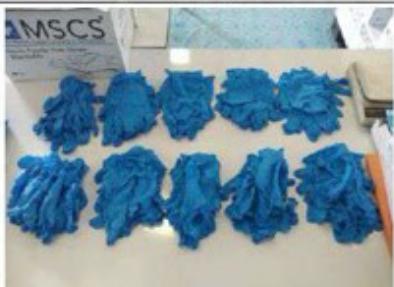
Check Quantity

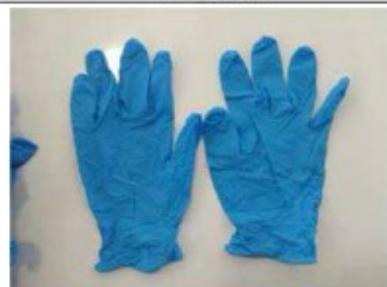
Check Quantity

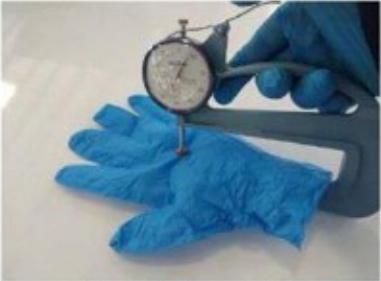
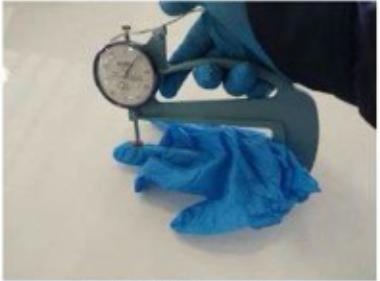
Check Thickness palm	Check Thickness finger

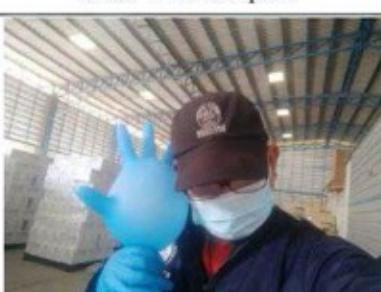
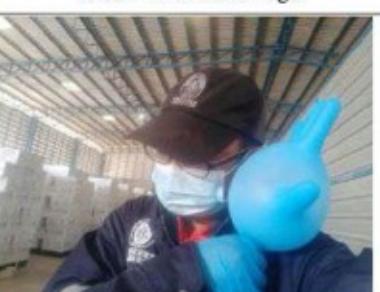
Check Air Leakage	Check Air Leakage

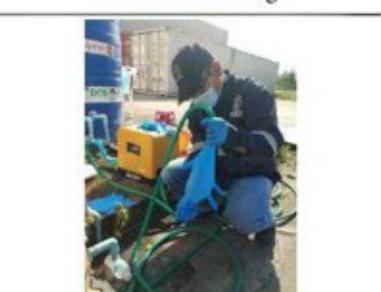
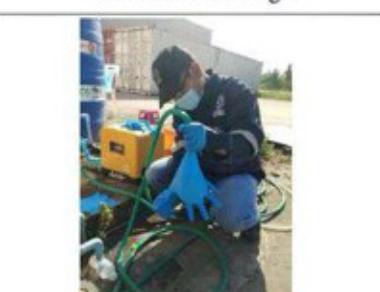
Check Water Leakage	Check Water Leakage
