**Reserve Study**  
**Tower Crossing Condominium Association**

# RESERVE STUDY REPORT

## Tower Crossing Condominium Association Glenview, Illinois

DATE OF REPORT: NOVEMBER 18, 2022

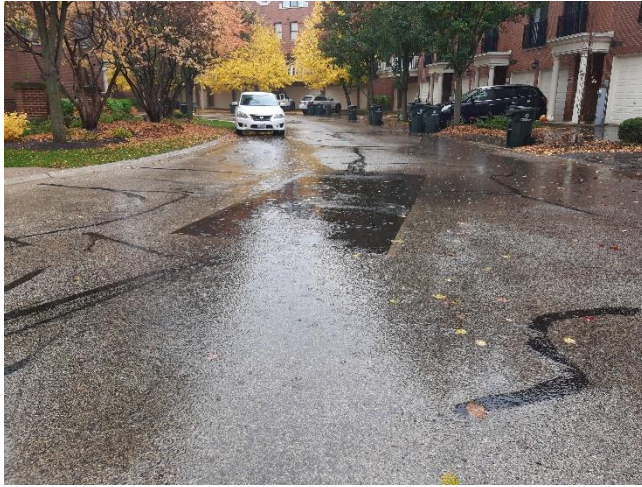
- Street sections repaired.
- Street cracks filled.
- Driveway section replaced.

Asphalt street repair on Admiral Court

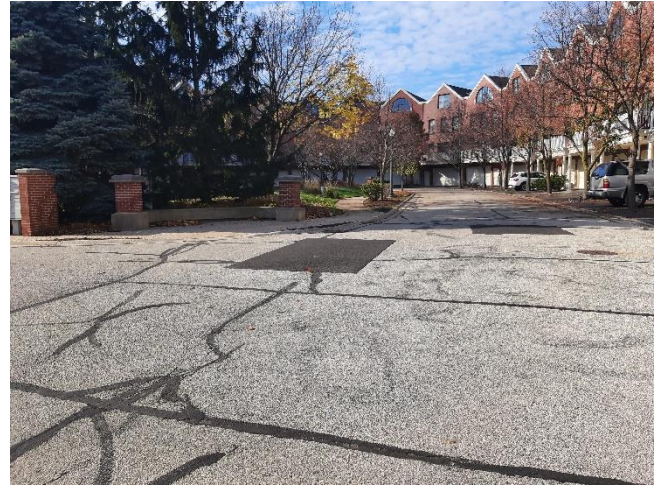
Asphalt street repair on Valor Court

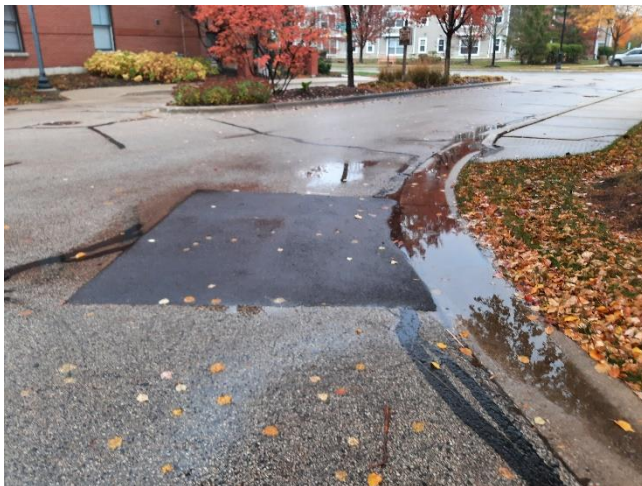
Asphalt section repair at entrance to Admiral Court

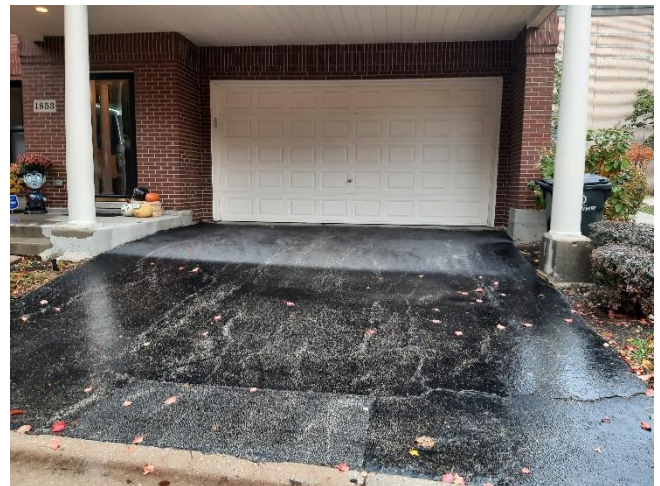
Driveway along Admiral Court with asphalt section replaced

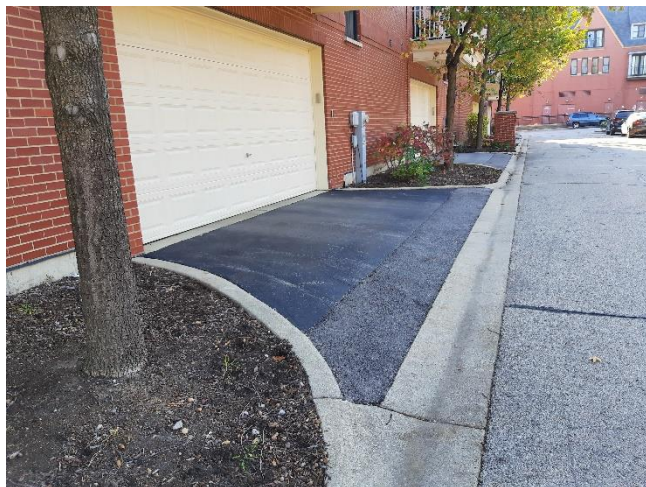
Driveway along Patriot Blvd with asphalt section replaced

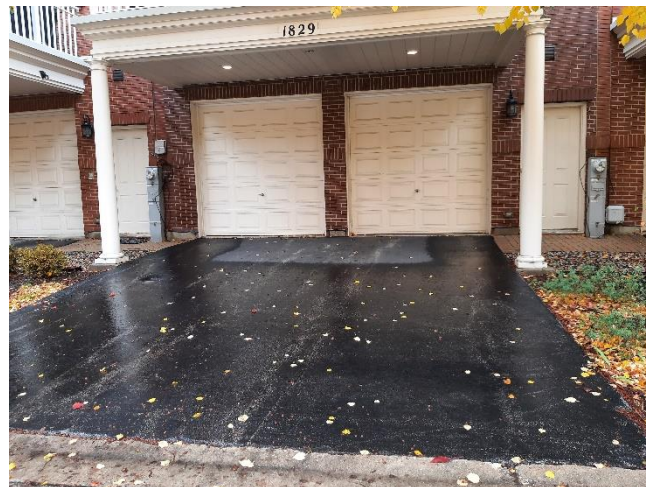
Typical driveway on Admiral Court

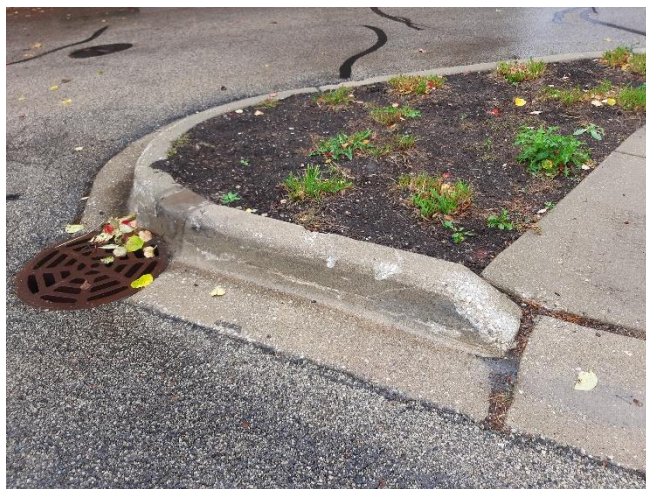
Typical catch basin on Admiral Court

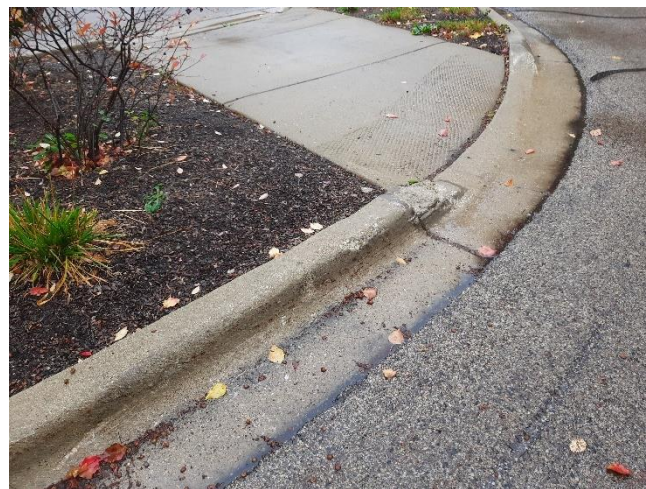
- Sections of curb cracked or broken due to vehicle strikes.
- Heaved sidewalks possibly due to freezing of underlying soil.
- Porch stairs and stoops exhibiting cracks and spalled concrete.

Broken concrete due to vehicle strikes

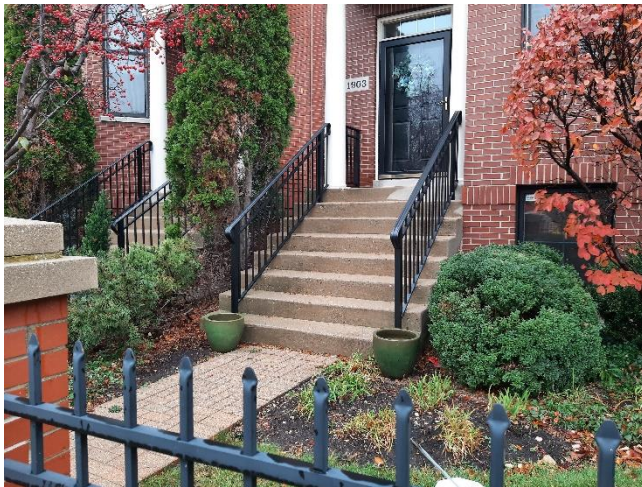
Typical porch and walkway on Admiral Court

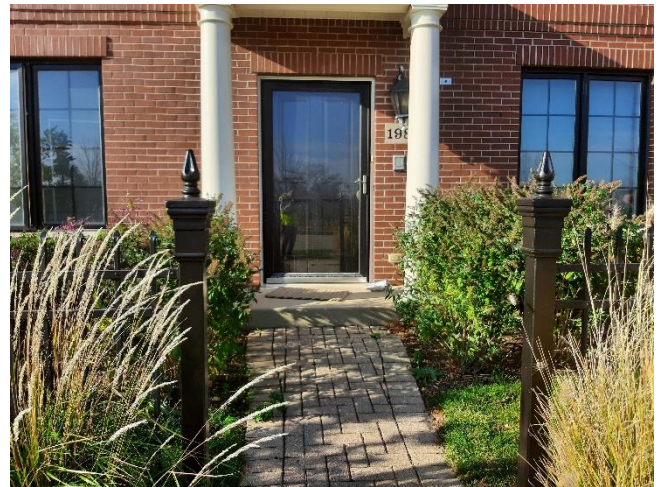
Typical porch and walkway on Patriot Blvd

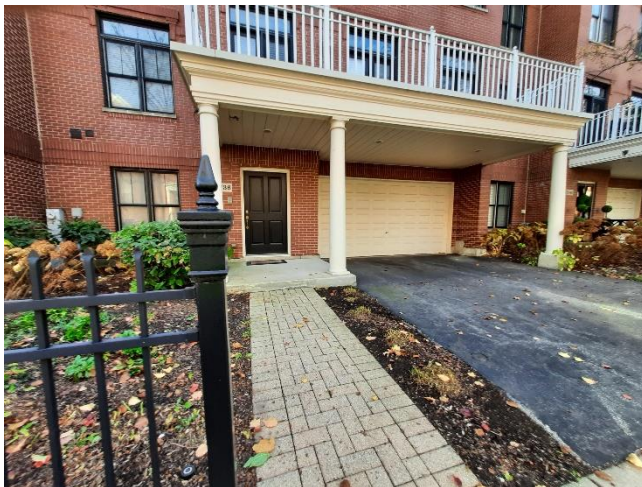
Typical porch and walkway on Valor Drive.

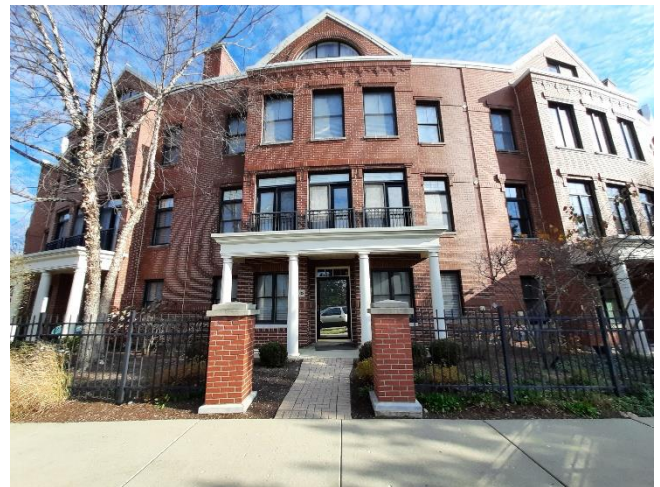
Porch and walkway on Valor Court.

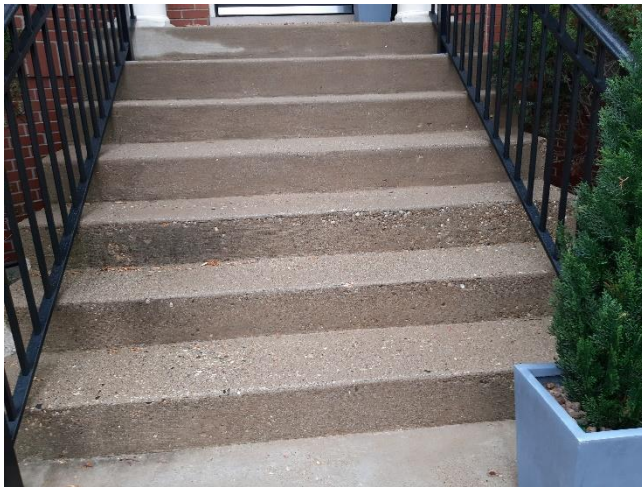
Porch stairs exhibiting cracks and spalled concrete

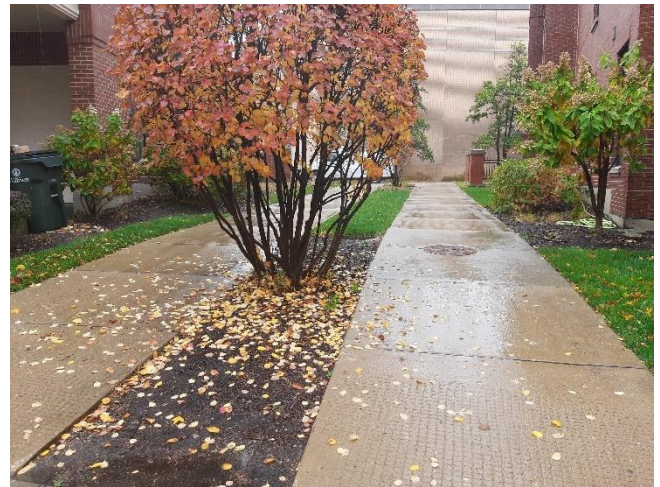
Typical sidewalk

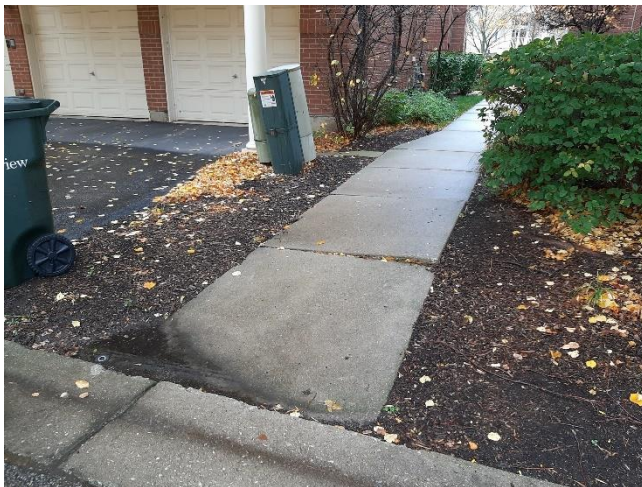
Sidewalk heaved possibly due to freezing of underlying soil

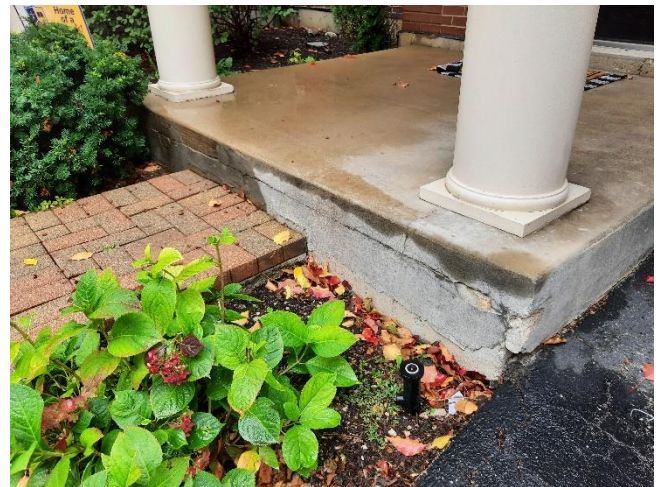
Porch stoop with cracked slab

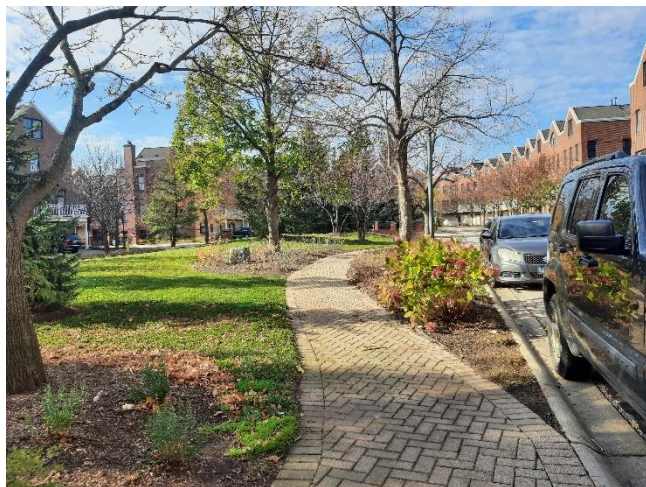
Brick paver unit walkway

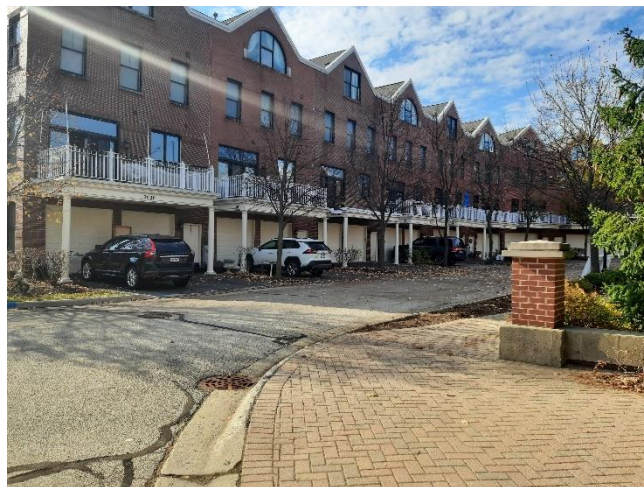
Brick pavers at common area

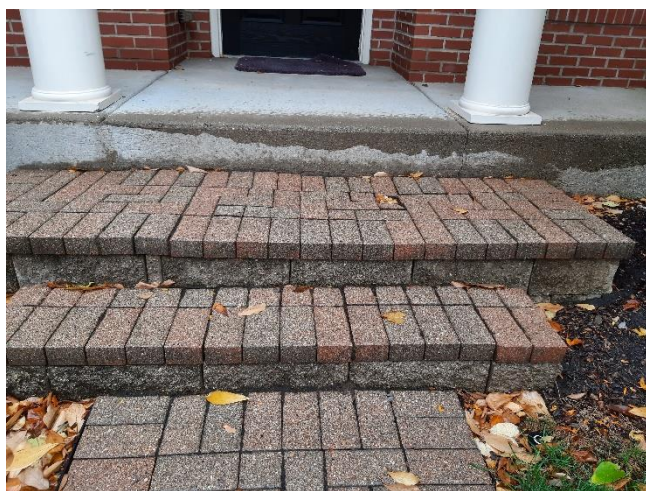
- Loose brick pavers.
- Loose mortar joints.

Brick pavers with loose mortar joints

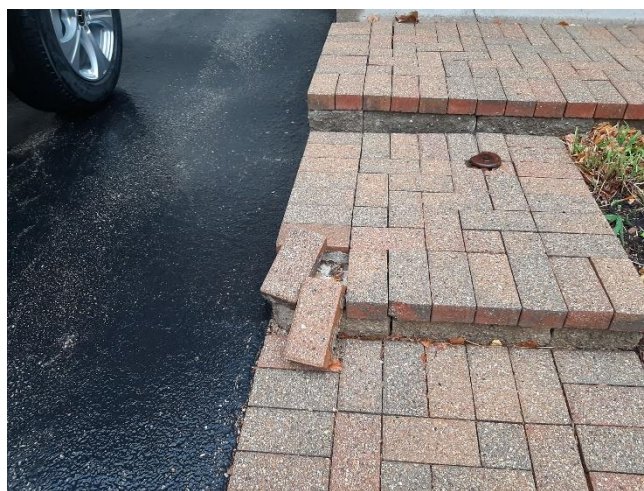
Brick paver walkway with loose pavers

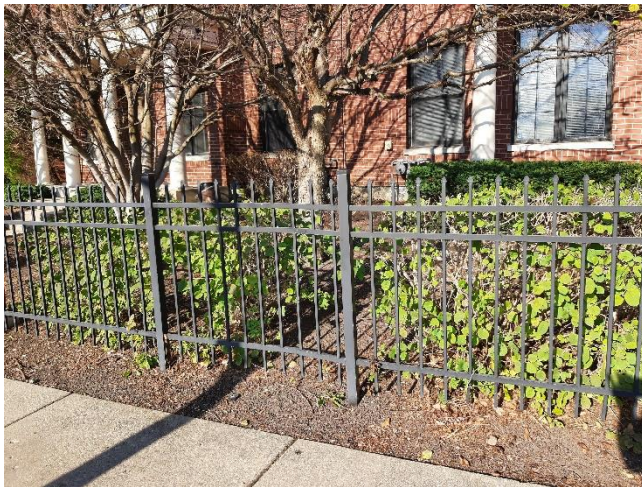
Typical aluminum fence

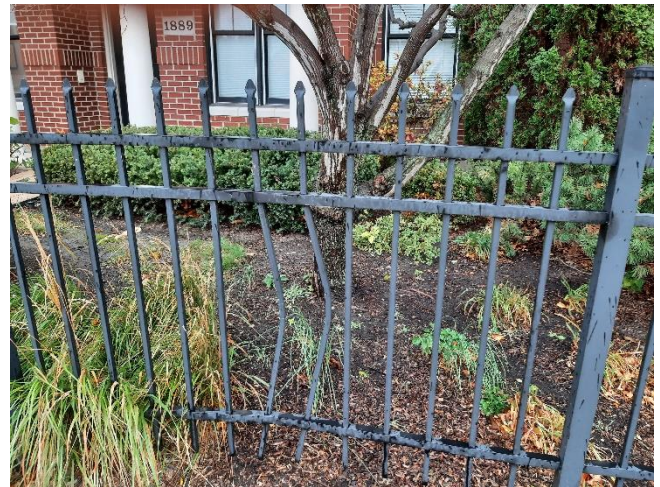
Aluminum fencing is installed at the front elevations of the units throughout the property including the railings at the stairs. The fencing is constructed primarily of painted aluminum. The fencing was observed to generally be in satisfactory condition, however localized areas of corrosion and deterioration were noted. Porch railings have been painted and railings have been set in epoxy, which addressed corrosion at the base of the posts. Additionally, we noted bulged sides resulting in loss adhesion of the factory finish. This condition may be due to freezing of trapped water inside the posts.

- Bent or damaged fencing with faded oxidized paint.
- See photograph section of this report for examples of observed deficiencies.

Damaged aluminum fence with faded oxidized paint

Based on the observed conditions, known history, and expected useful life, funding has been allocated for wholesale replacement of the fencing from 2034 through 2035. Please refer to the table below for a summary of the element quantities, present day cost, and remaining useful life as well as to Exhibits 2A (3% inflation rate) and 2B (5% inflation rate) for the estimated expenses and scheduling.

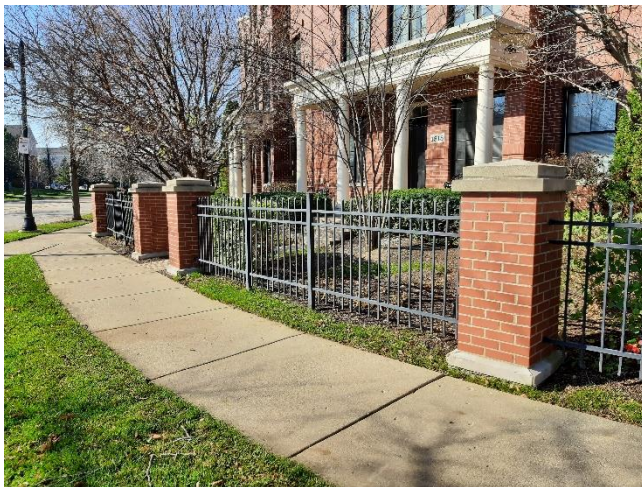
Masonry column with aluminum fence

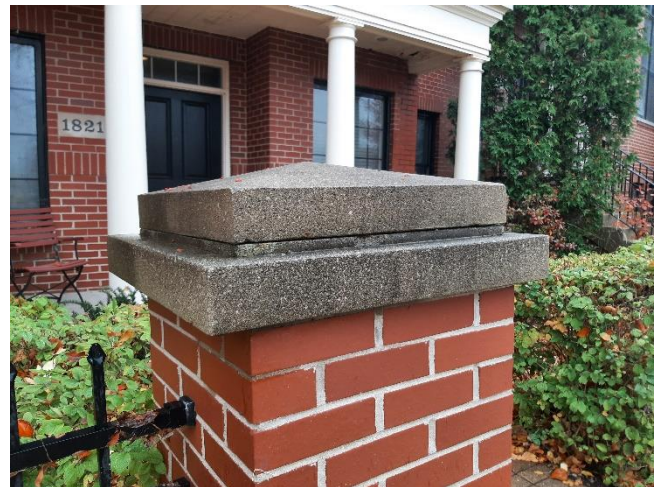
- Missing mortar at capstone of column.
- Missing mortar base of column.

Missing mortar at capstone of column

Based on the observed conditions and expected useful life, funding has been allocated for periodic tuckpointing and repairs to the monuments, columns, and mailbox enclosures in 2027 and every five years thereafter. Funding has been allocated for the entrance monument signage in 2032. Please refer to the table below for a summary of the element quantities, present day cost, and remaining useful life as well as to Exhibits 2A (3% inflation rate) and 2B (5% inflation rate) for the estimated expenses and scheduling.

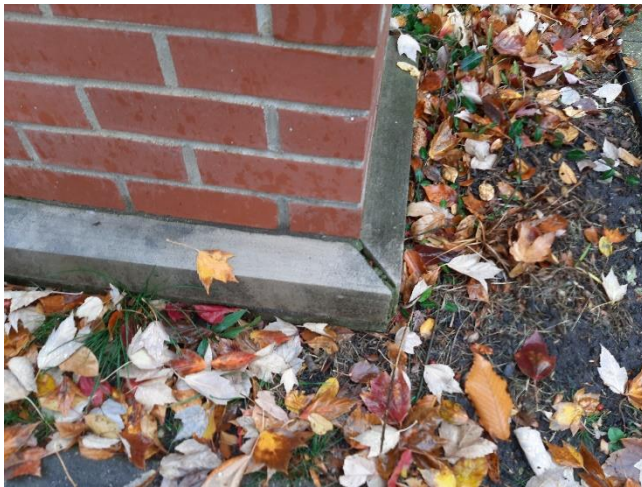
Missing mortar at base of column

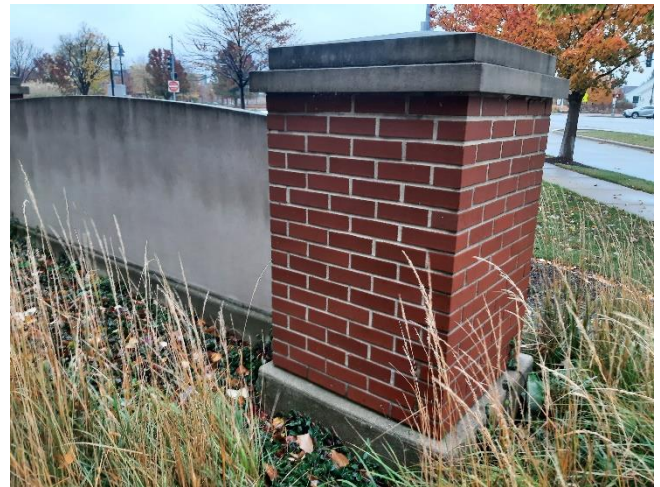
Masonry column and view of back of the property identification signage

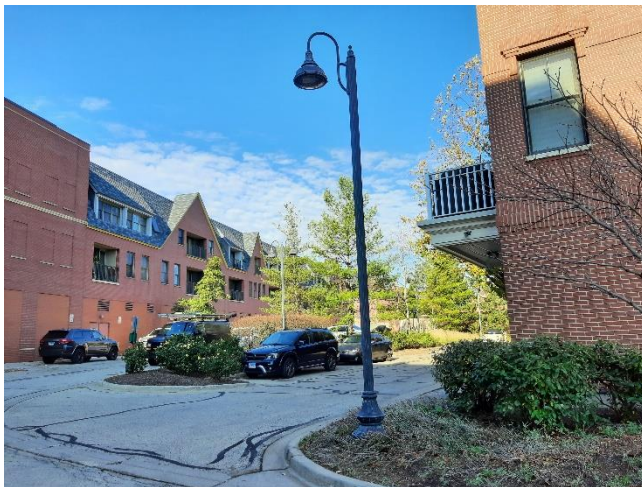
Light post and fixture

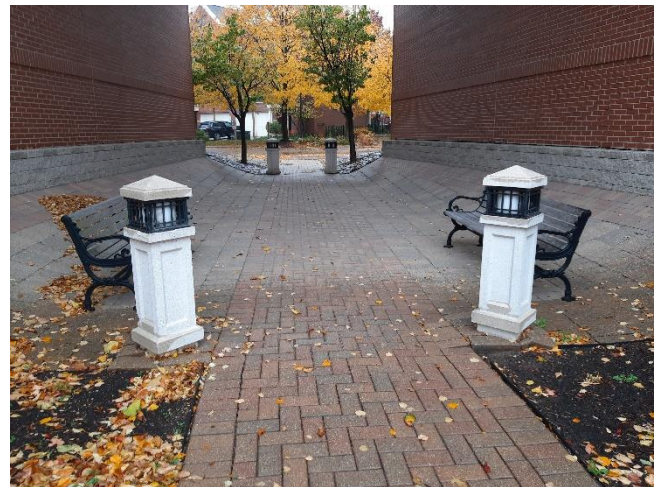
Bollard lighting

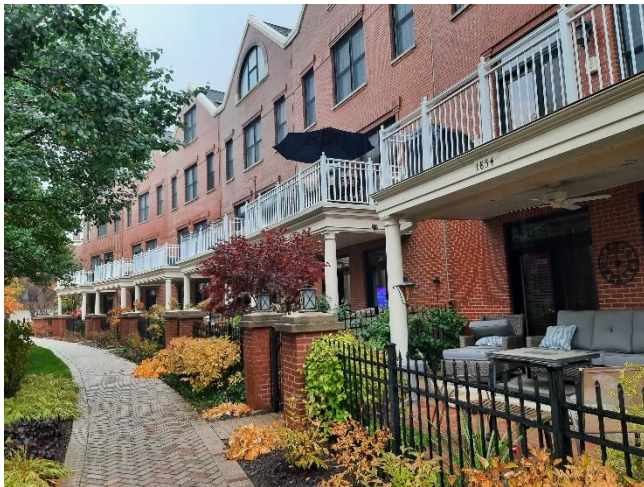
Building overview along Admiral Court

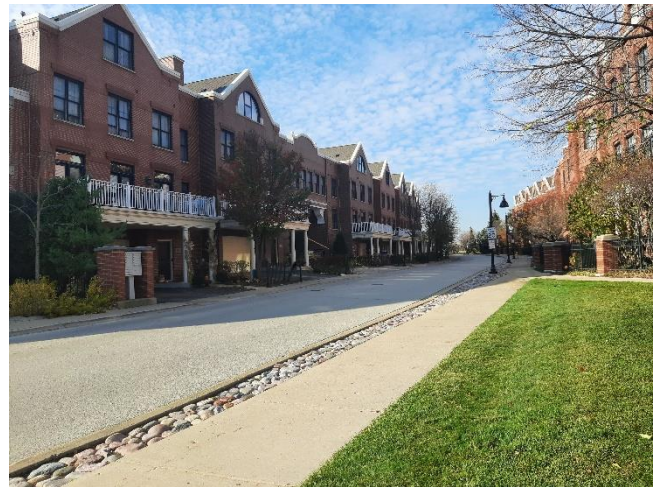
Building overview along Valor Drive

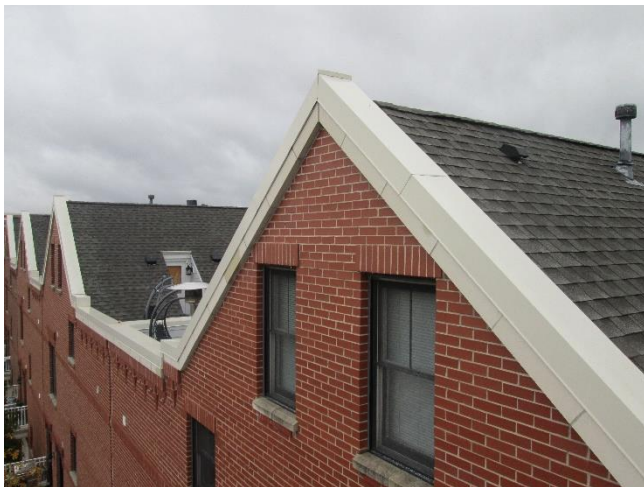
Overview of laminated architectural shingles on sloped roofs

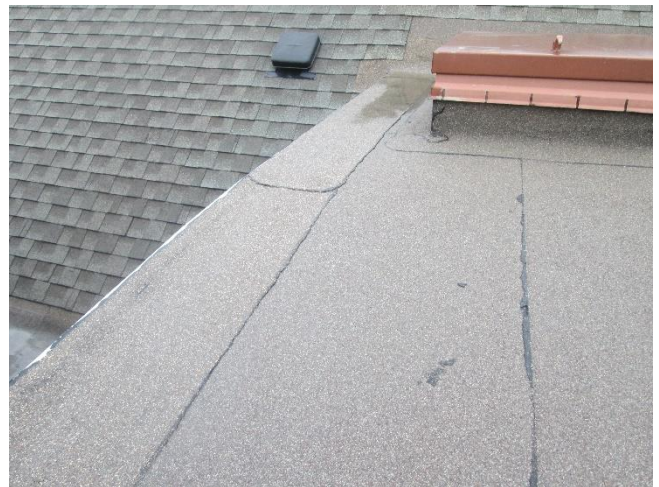
Typical modified bitumen flat roofs.

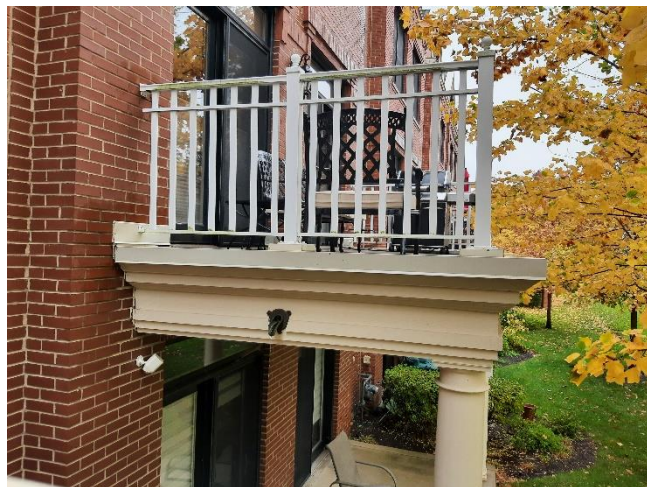
Overview of downspout on balcony system

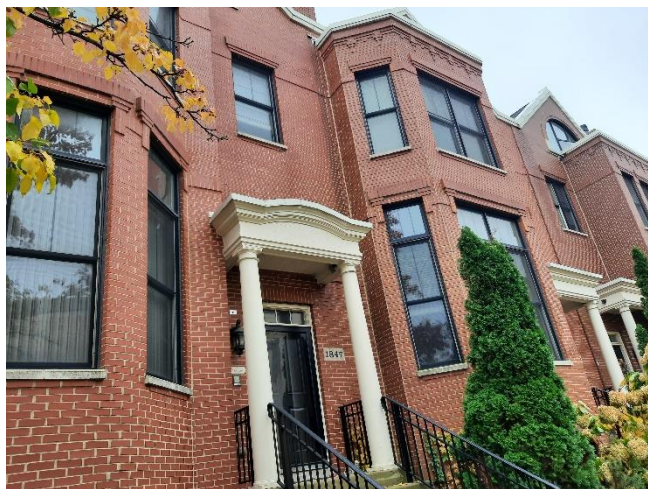
Overview of masonry facade along Admiral Court

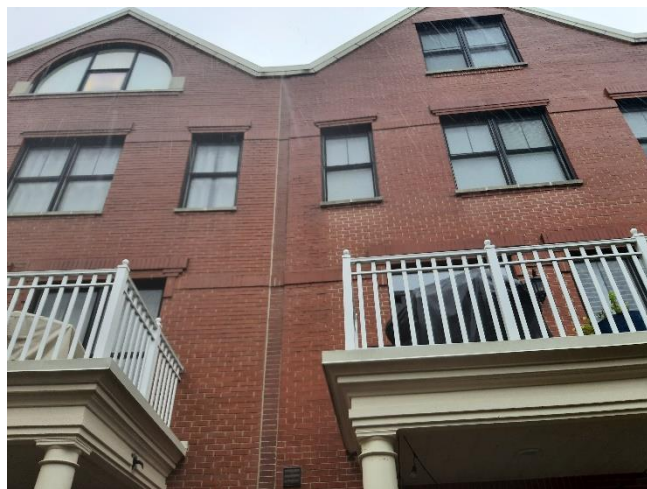
Façade exhibiting recent tuckpointing.

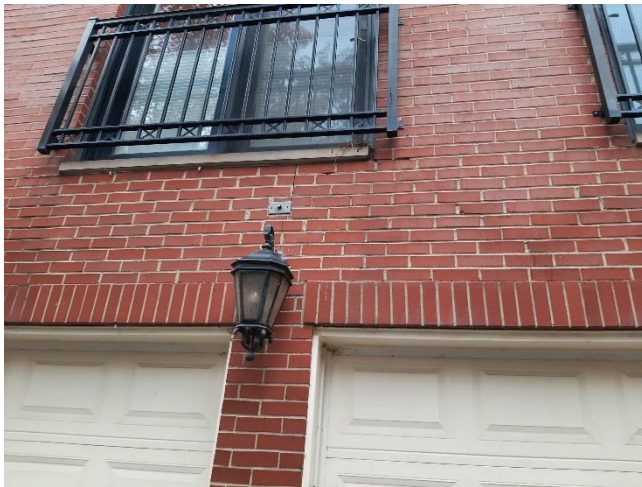
Missing mortar and sheer crack in masonry

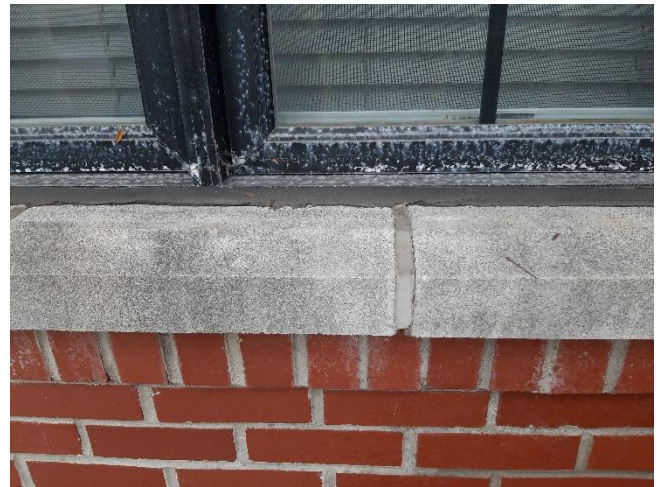
Typical sealants around windows

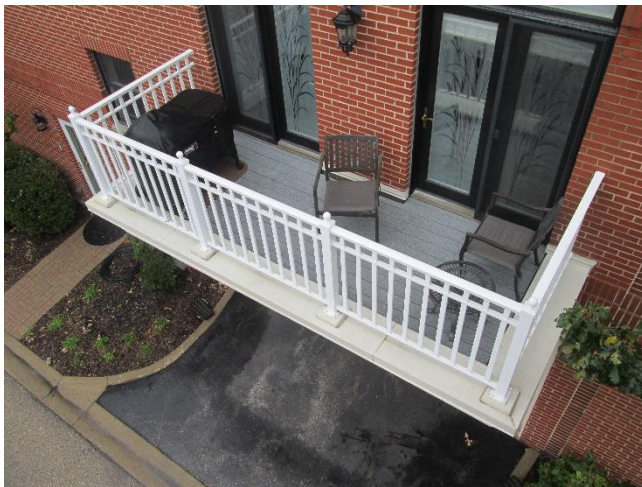
Overview of balcony system

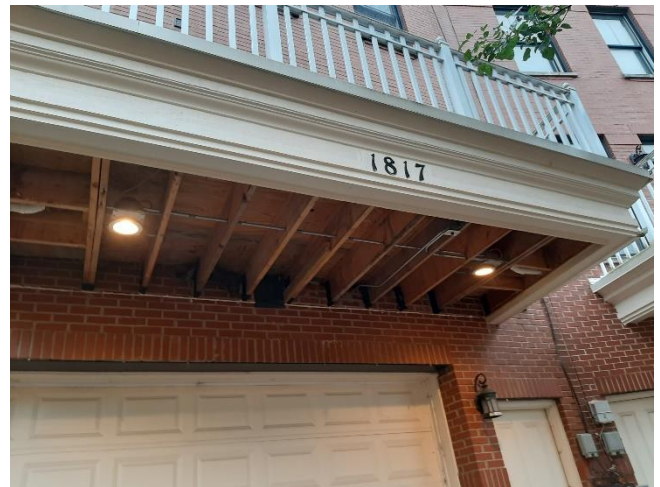
Missing wood soffit showing existing balcony drainage system

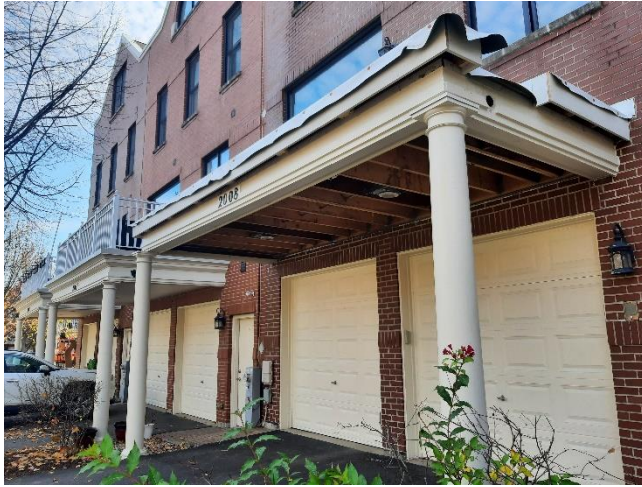
Balcony roof system replacement underway
