**STRUCTURAL INTEGRITY RESERVE STUDY  
REPORT**

High Point Place Condominium Association, Inc.  
2100 West First Street  
Fort Myers, FL 33901

SOCOTEC Project Number 3113-013.01

April 2023

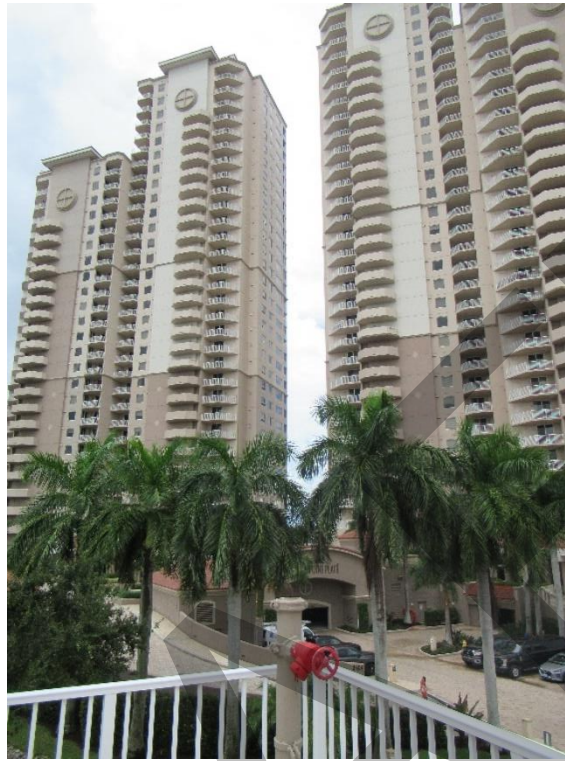
South elevation of Towers 1 and 2.

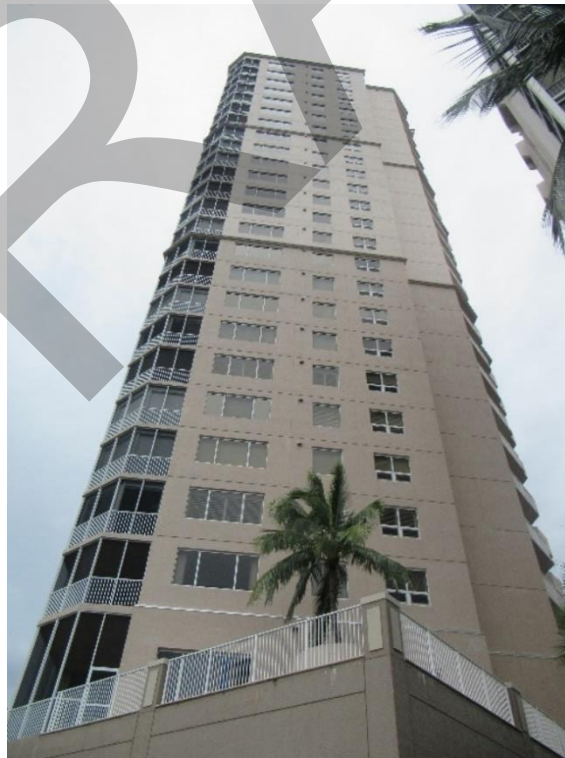
West elevation of Tower 1.

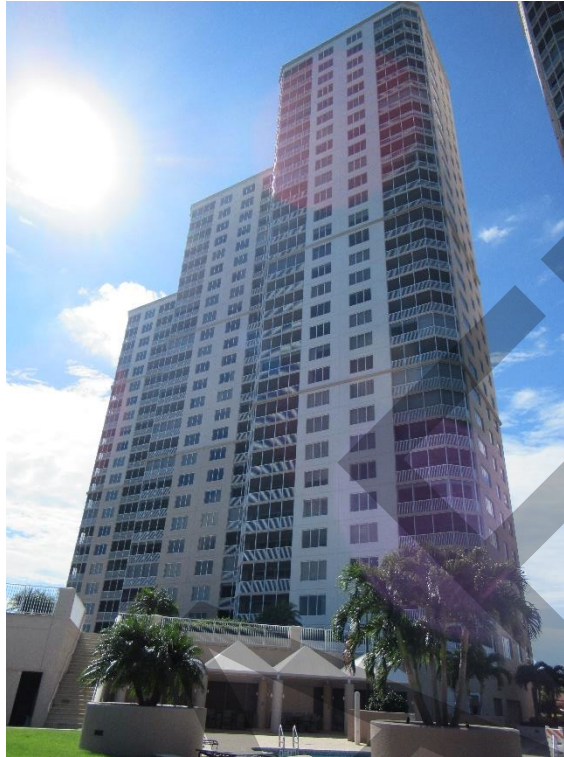
North elevation of Tower 2.

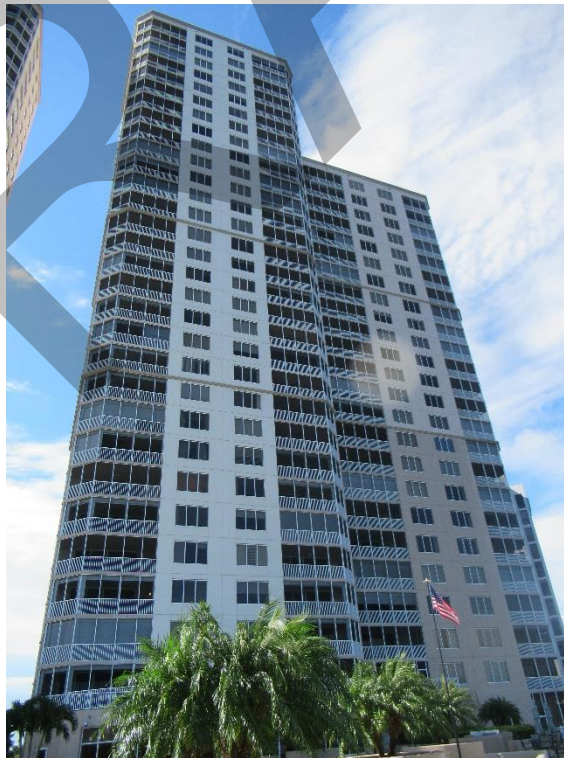
North elevation of Tower 1

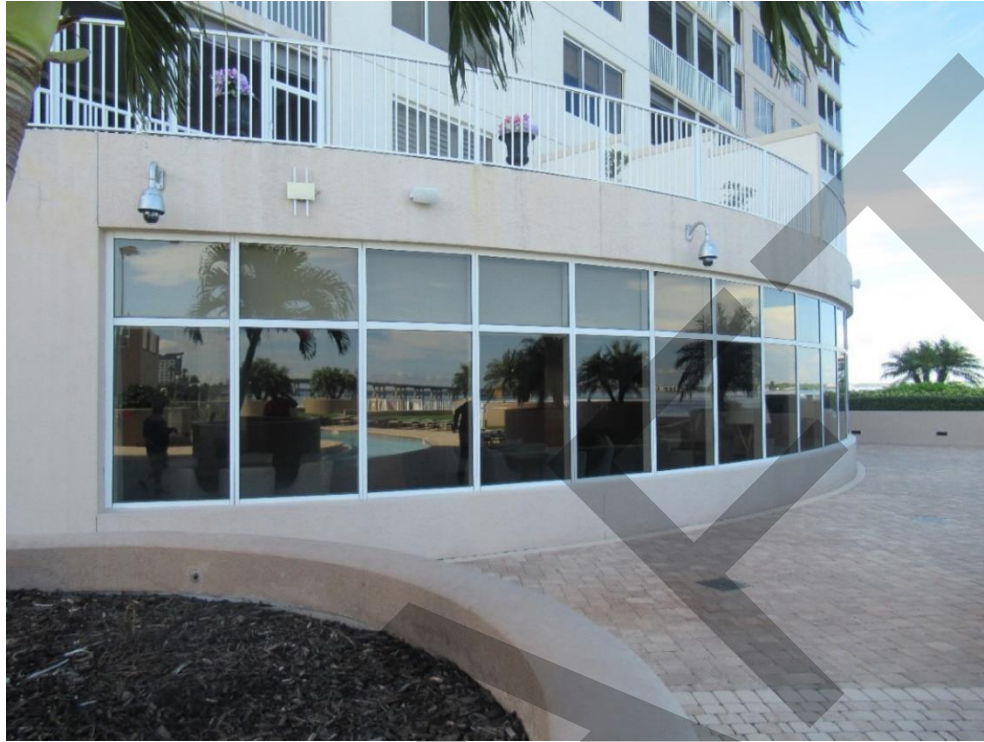
Common Area Windows - We assume all Association-owned windows are original components. The common area windows are located in the lobbies, office, gym, and social rooms at the High Point Place Condominium. With an anticipated useful life of approximately 30 years for windows, we estimate the next replacement date to be 2036 or as needed.

Common area windows on the level 3 pool deck.

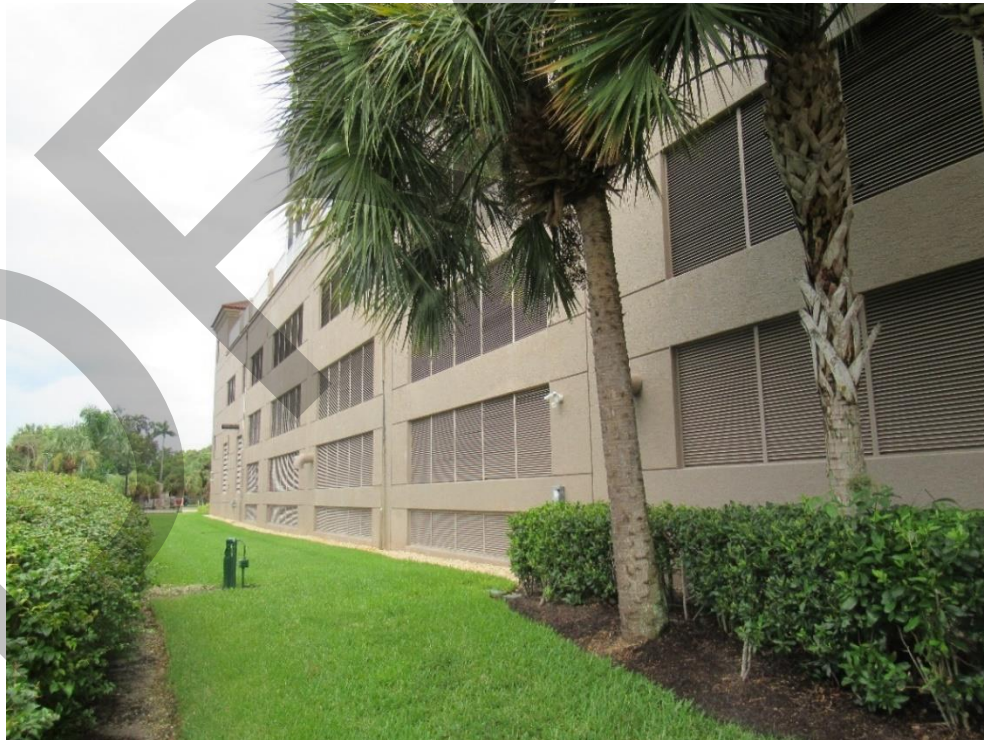
North elevation of parking garage.

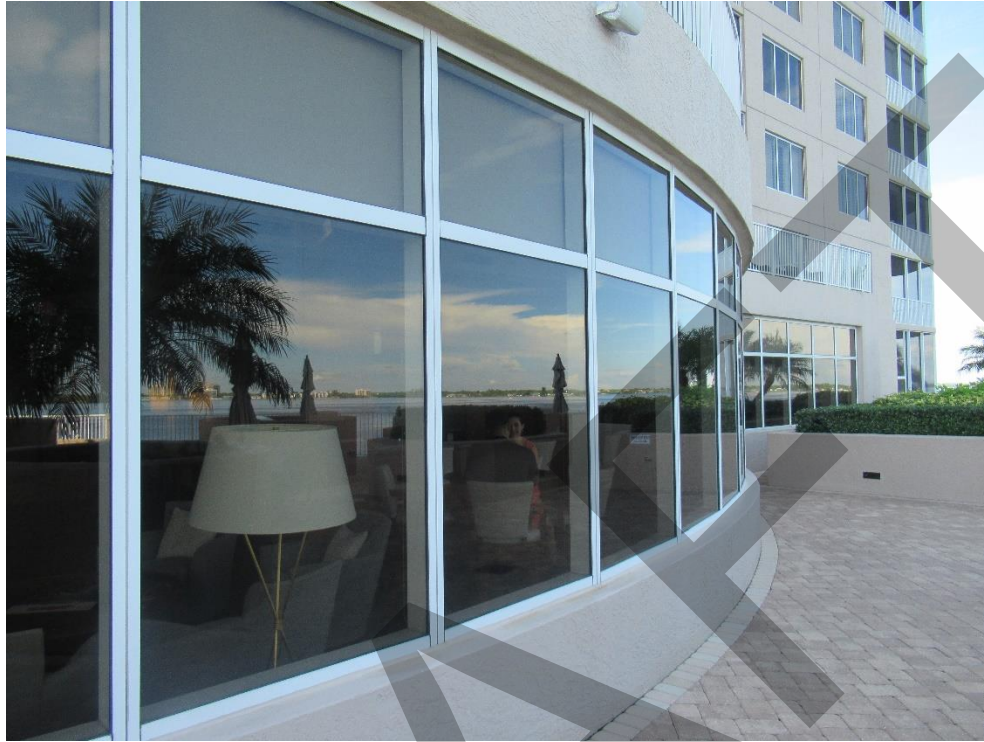
Common area windows on the level 3 pool deck.

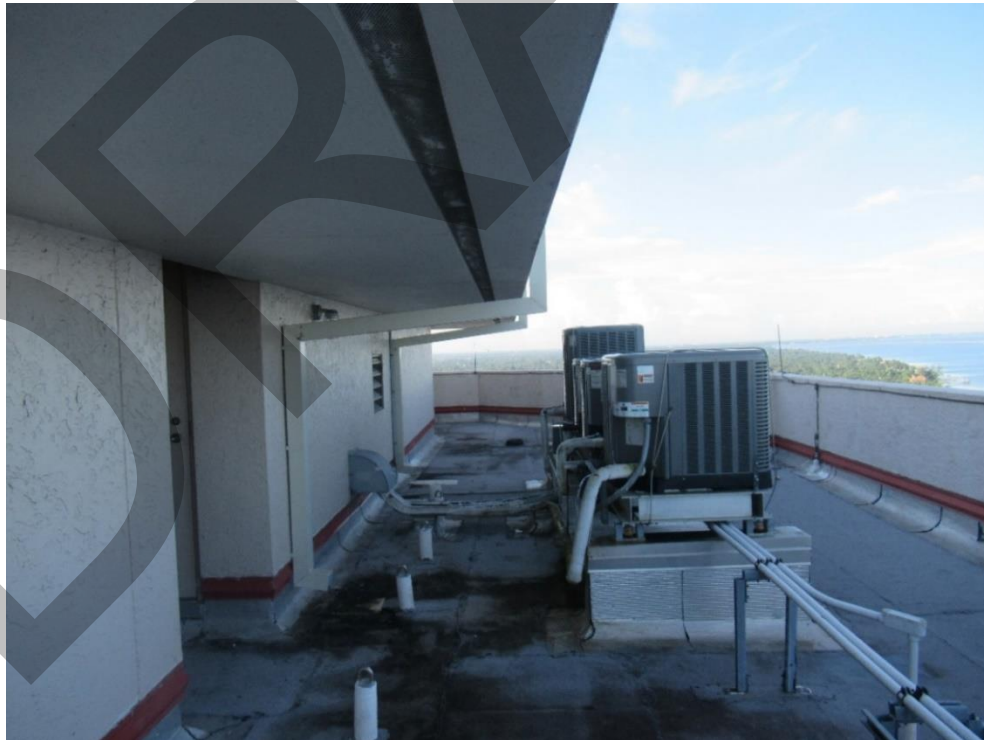
Modified Bitumen - Several areas of the condominium roofs at the High Point Place Association are covered with a modified bitumen membrane and granular cap sheet. This type of roof system typically has a useful life of 20 to 25 years under normal operating conditions and periodic maintenance. The modified bitumen systems on the main roofs of the condominium towers and buildings appear to be in fair to good condition for their age with several areas of discoloration observed at the time of our site visit. In total, the modified bitumen roof system covers Tower 1, Tower 2, Building 1, and Building 2 with approximately 7,500, 11,250, 990, and 885 square feet of total roof area, respectively. We recommend these modified bitumen membranes be scheduled for replacement circa 2039 based on a typical 20-year useful life.

Tower 1 modified bitumen flat roof.

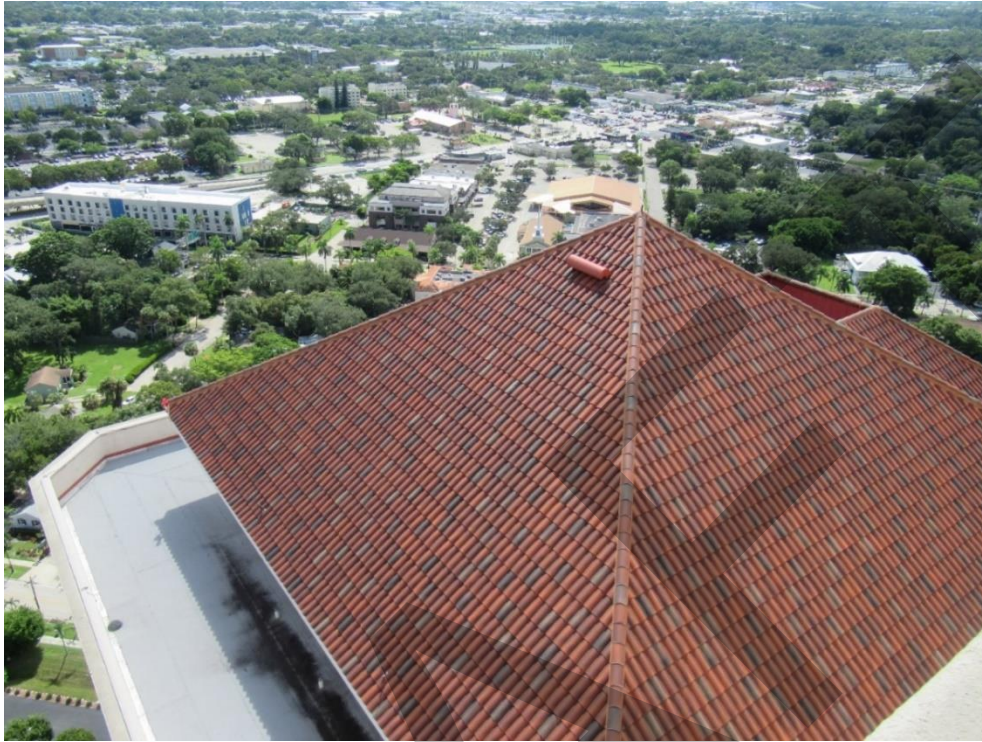
Tower 2 roof.

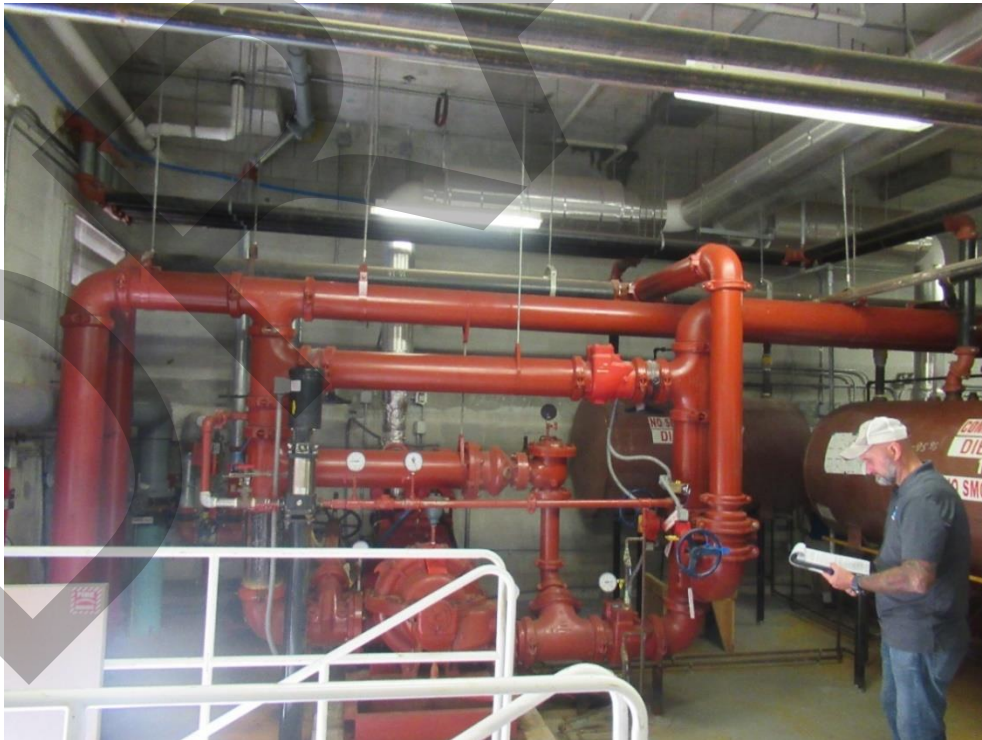
**Emergency Fire Pumps, and Controls** - The emergency fire pumps systems and their respective control panels are located in a mechanical room located on the ground level of the condominium towers. We understand the emergency fire pumps, and control panels are original components with typical useful lives of 30 years. Therefore, we anticipate the replacement year to be around

2036 for these components. These items were observed to be in fair condition for their age at the time of our site visit.

Overview of fire pump room.

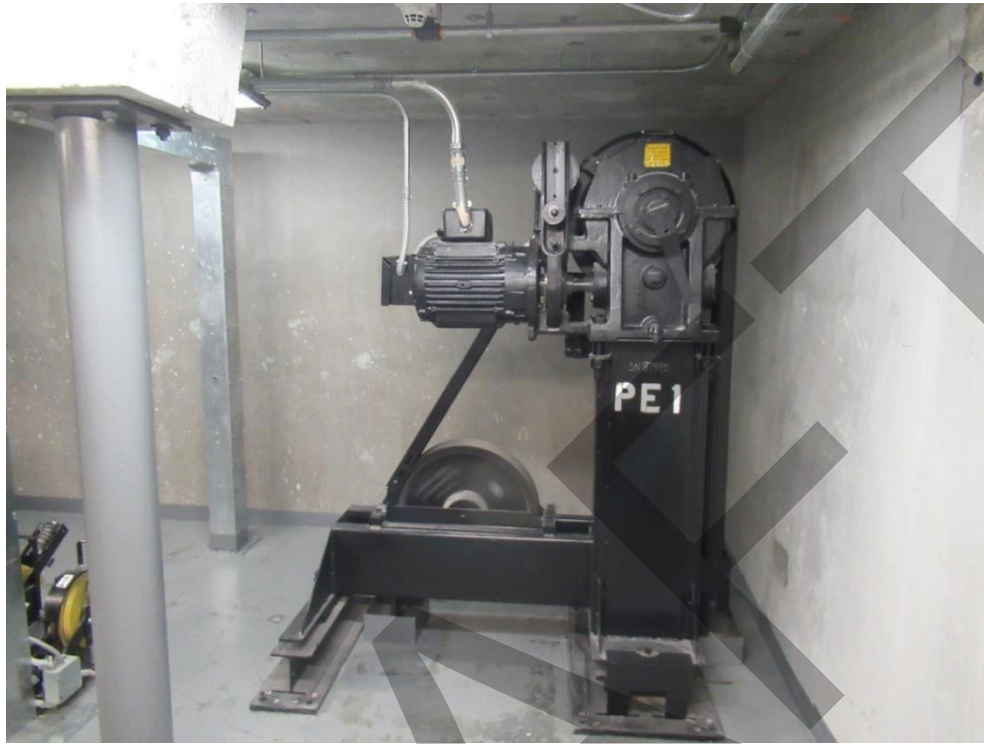
Overview of Tower 1 elevator room.

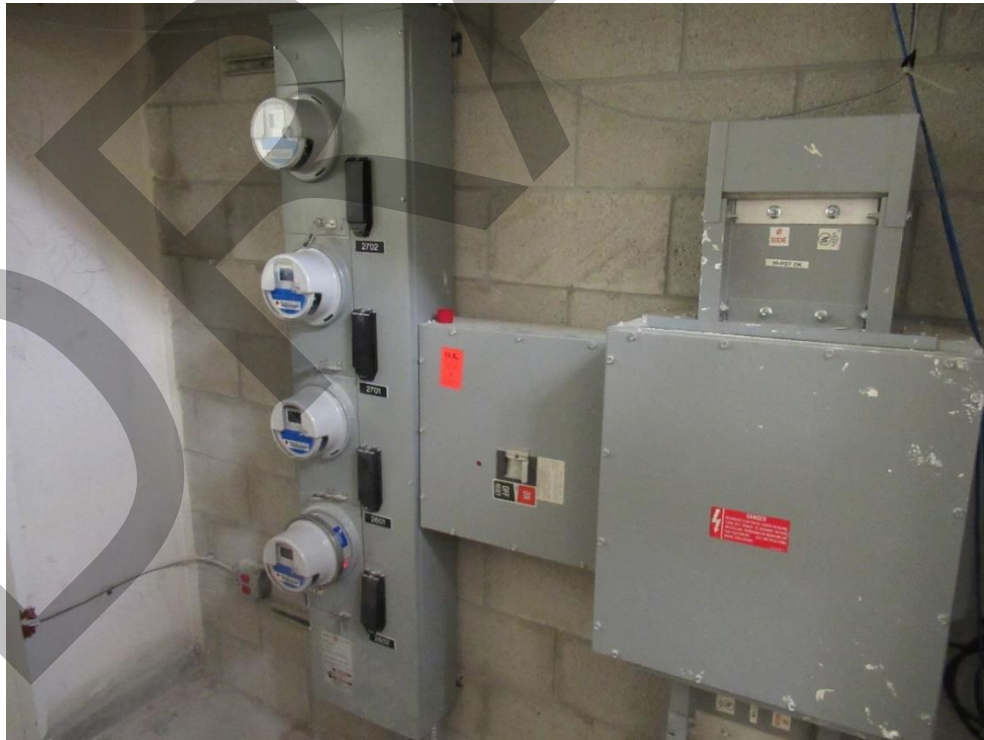
Tower 1 level 27 electric room.

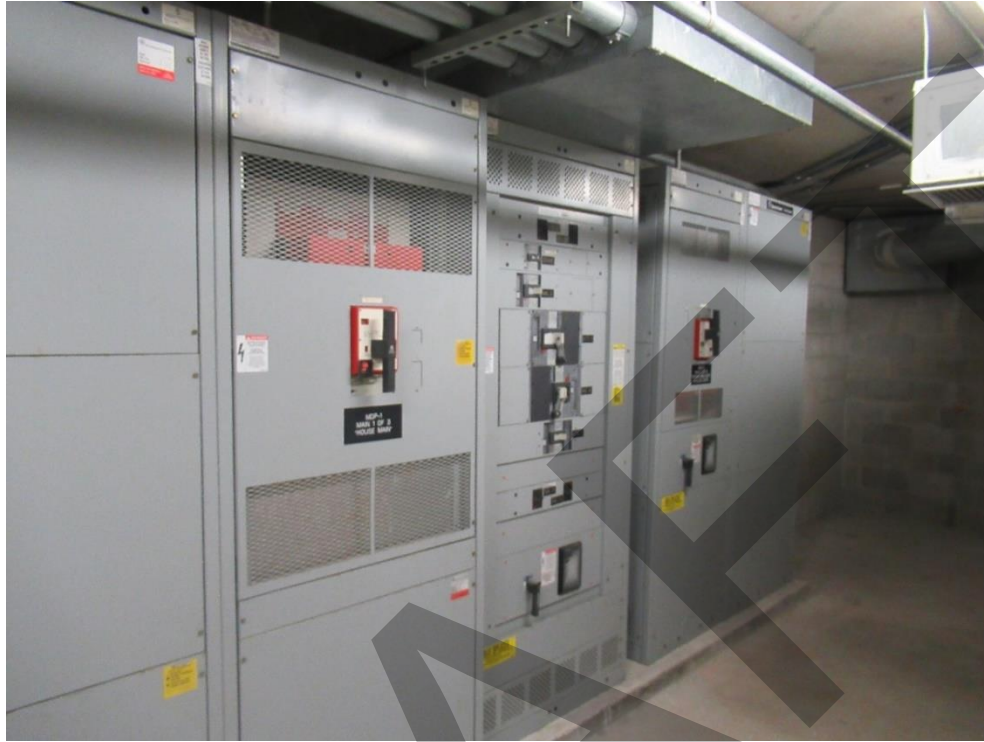
**Electrical System** – Currently there are no indications of any deterioration or issues with the electrical system for the building. Localized breaker panels and branch circuits are typically replaced during common area or individual unit renovations as required to accommodate the renovation. A reserve has been included for periodic replacement/upgrades of major electrical system components such as main service panels and feeder lines.

Tower 1 main electric room.

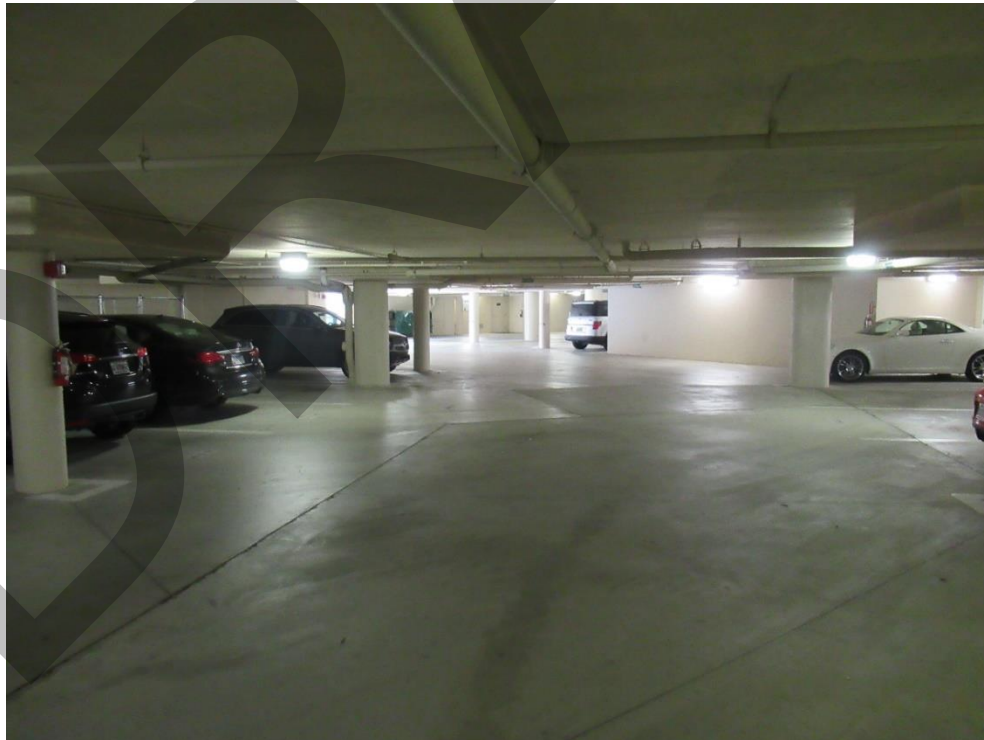
Concrete Frame - The load bearing structural members include cast-in-place concrete elements with post-tension cable and conventionally reinforced decks. Exterior walls consist of stucco covered concrete and masonry walls. These types of primary structural members typically have a useful life of 100 or more years when properly maintained/repared. However, during the life of this type of structure it is common for periodic maintenance to be required to correct localized deterioration. No signs of significant damage or deterioration were observed during our site visit. We have included a reserve item for completing required periodic maintenance to the cast-in-place concrete structural elements.

Structural members at the level 1 parking garage.

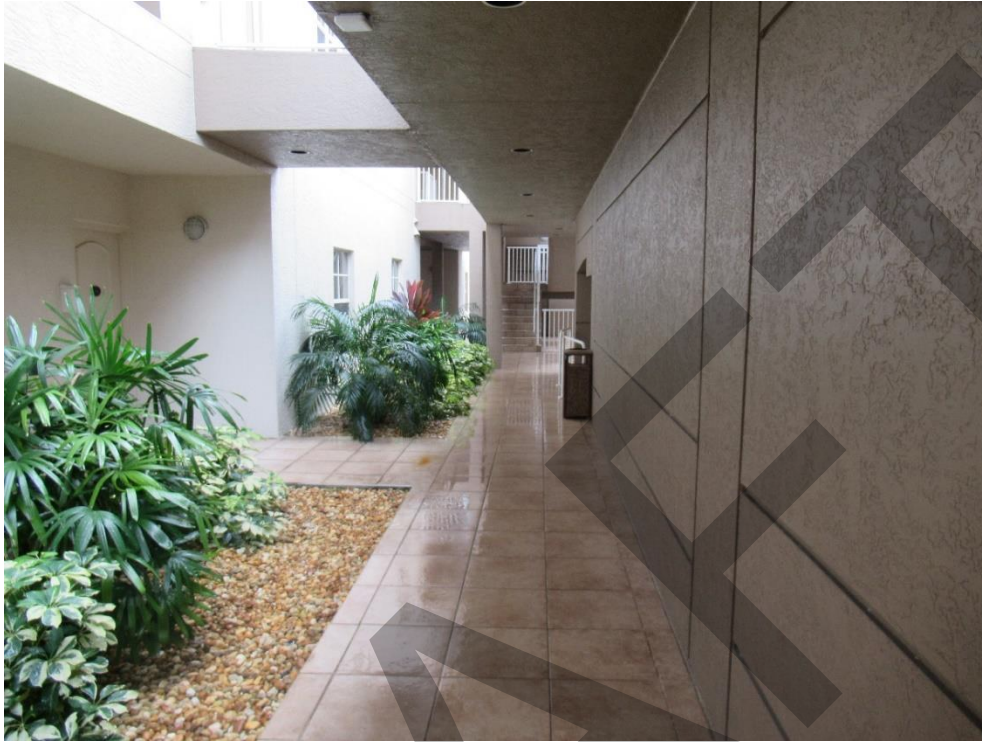
City Homes level 1 walkway.

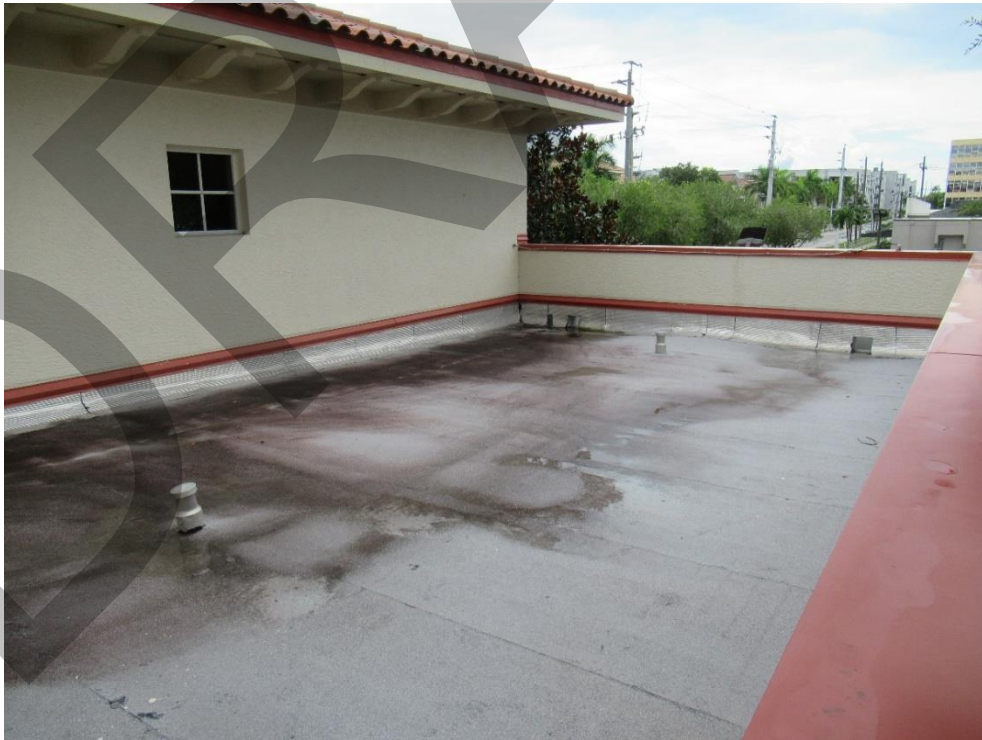
City Homes modified bitumen flat roof.
