# **The 2011 off the Pacific coast of Tohoku Pacific Earthquake and the seismic damage to the NPPs**

**4<sup>th</sup> April, 2011**

**Nuclear and Industrial Safety Agency (NISA)  
Japan Nuclear Energy Safety Organization (JNES)**

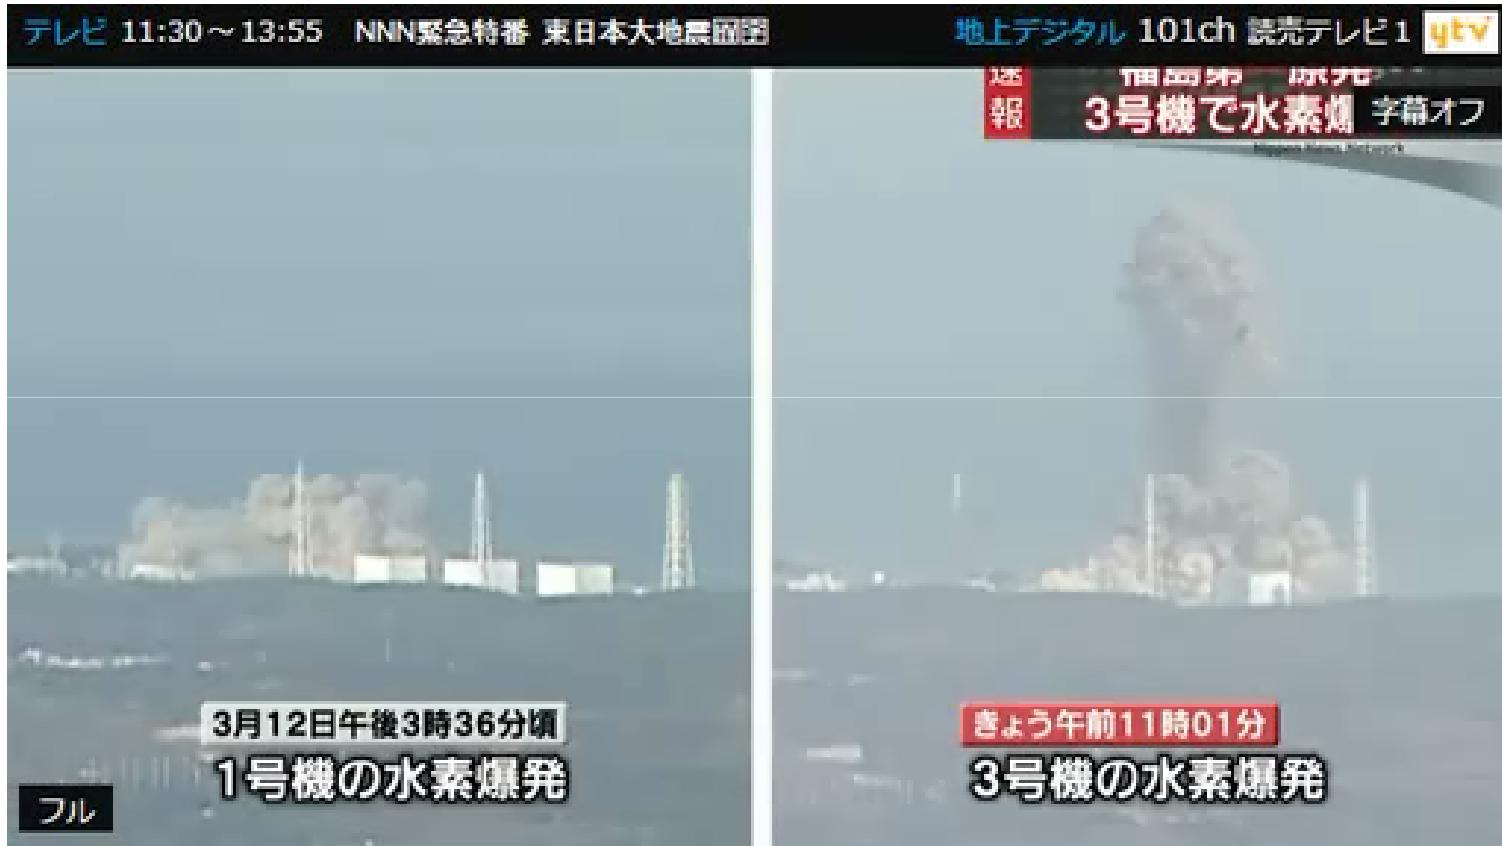
**Unit 1**

**Unit 3**

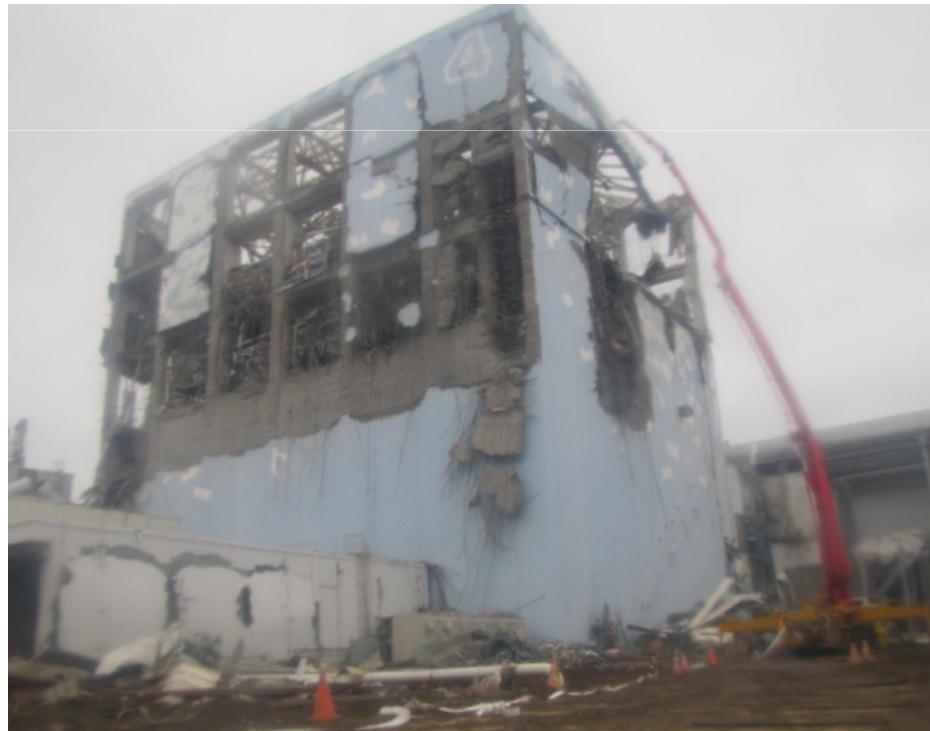
**Photo: Water spray into the SFP in Unit 4 using concrete pump truck**
