2019 Tech Talk - Fall 2018 Dewax Outage to Clean DWO Recovery Exchangers

June 2019

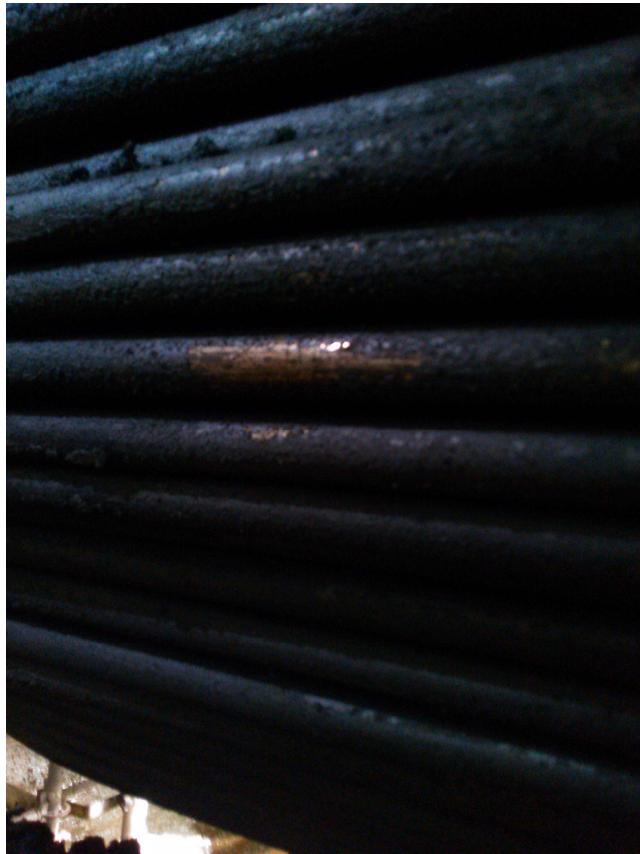
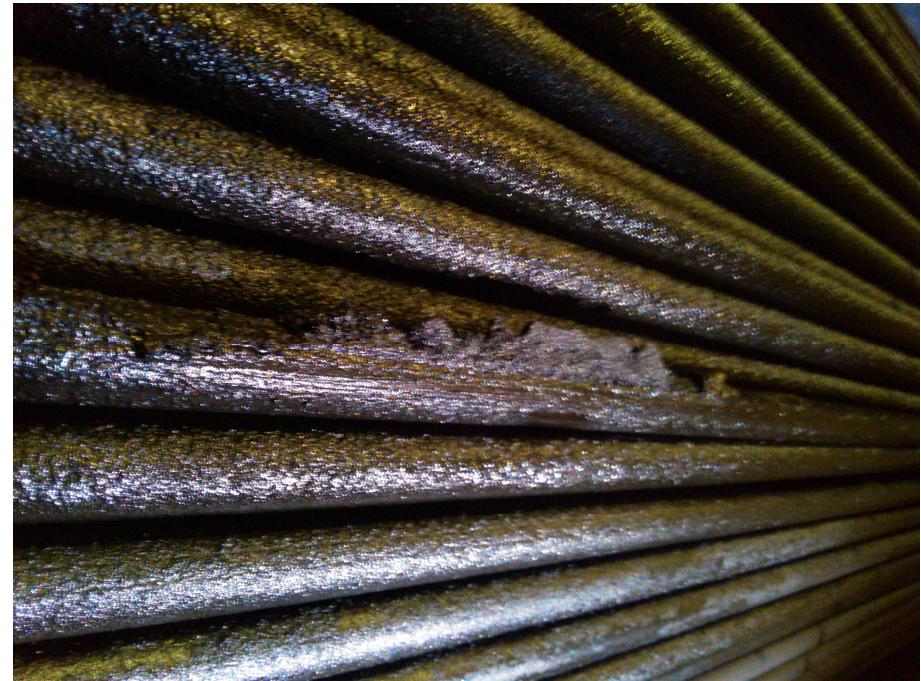
- **E322 – history of shell side fouling, varying success with cleaning methods**
 - 2005 – Shell ID had thin black oily product coating all surfaces. Half an inch of watery black sludge. Tube ODs have thin black oily coating. Tube ID's quite clean.

- Thin black film on the process side of all exchangers
- E322 Shell Side (Process) Fouling

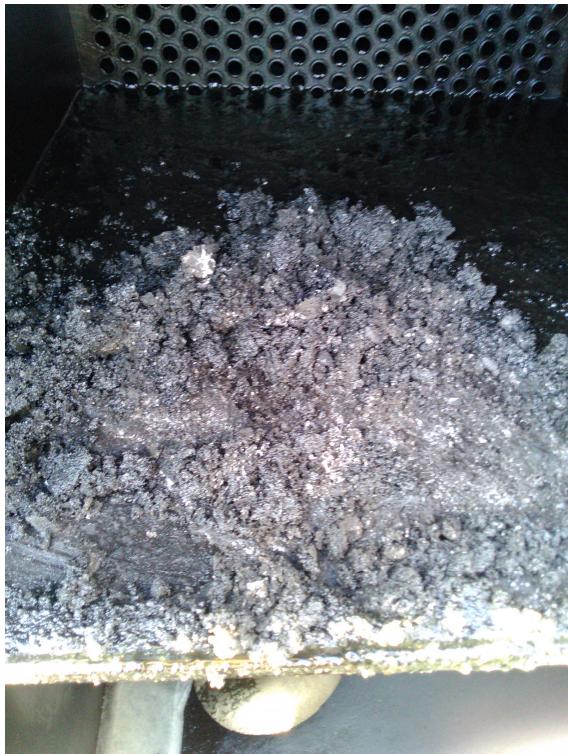
- E318 Tube Side

- **E318 – scale, not cleaned since 1995**
 - Tube OD thin hard scale (1991), Bucket of black magnetic scale in channel (1981)
- **E320 – light oily film/fouling**

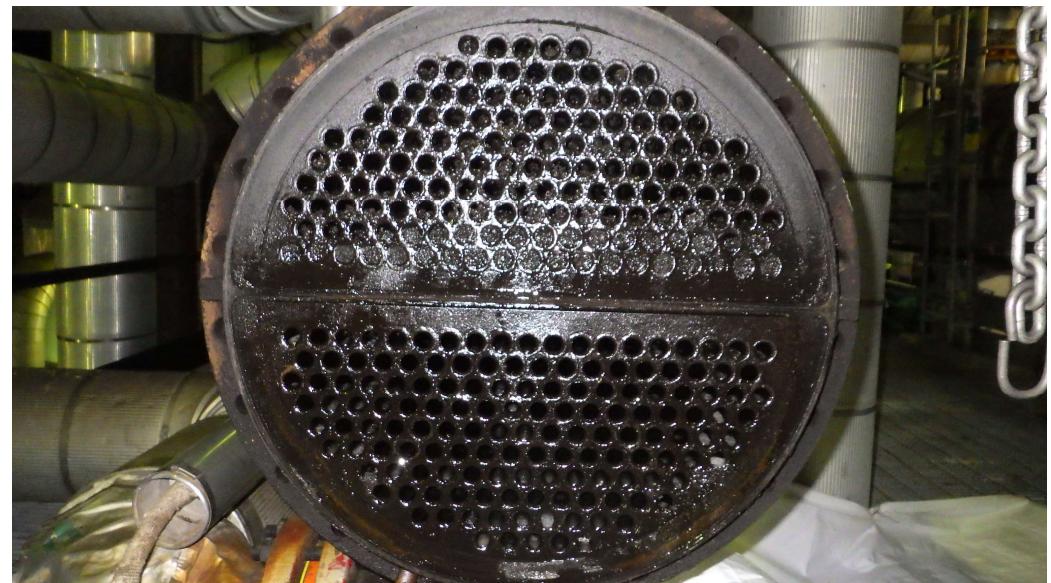
- E340 Tube Side

- 2015 – Thin oily film. External deposit on Tube ID, HP water wash unable to clean.
 - Shell ID light oily film (1991), Tubes light oily deposit, HP water wash (1984)
