**PNGRB INVESTIGATION COMMITTEE  
REPORT**

**MAJOR FIRE INCIDENT**

**IOC-MATHURA REFINERY**

**EFFLUENT TREATMENT PLANT –  
INFLUENT SUMP**

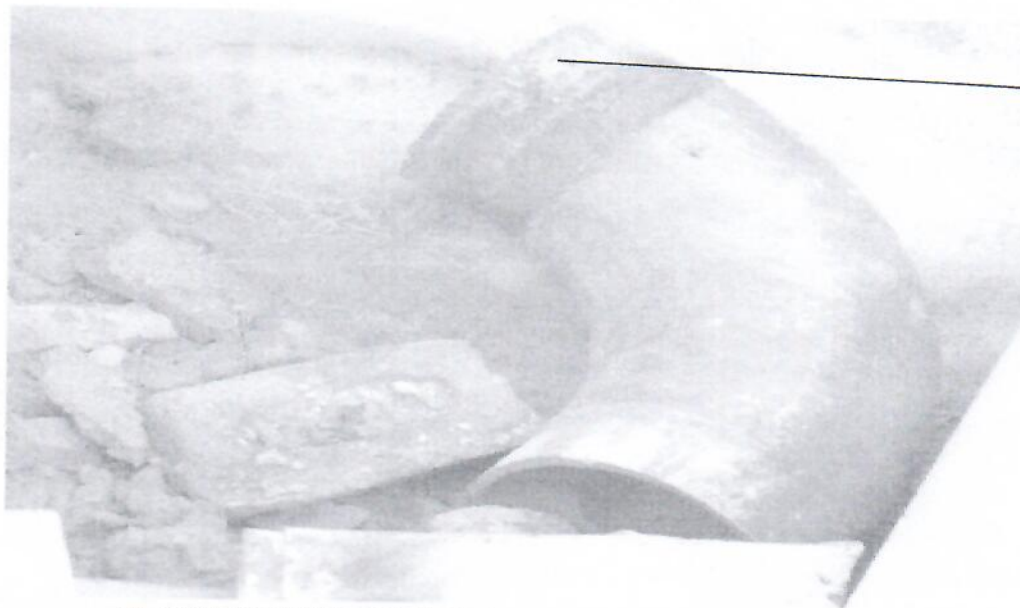
The left over elbow of the existing spent caustic line was removed by gas cutting in the presence of ETP Manager at around 11.00hrs on 7<sup>th</sup> Jan 2020 for fixing the prefabricated spool piece.

ETP Manager admitted that the existing spent caustic line was not positively isolated (by providing a spade downstream of the block valve) and line was not water flushed before gas cutting. Gas cutting of the pipe was carried out using the common hot work permit taken at ETP area .

PORTION WHERE  
GAS CUTTING WAS  
DONE

ELBOW WHICH WAS GAS CUT AND REMOVED
