## LAPORAN HASIL UJI

Nomor Analisa : 0710/KMN/2024

Nama Contoh : CARTON BOX COOPEX RI 6 X 20 X 25 G

## TEST REPORT

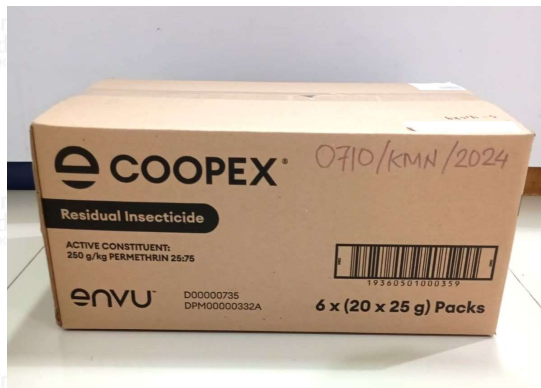
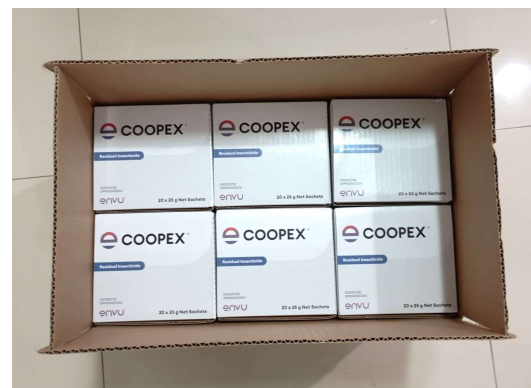
Gambar contoh uji :

CARTON BOX COOPEX RI 6 X 20 X 25 G dalam kondisi baik . struktur bahan Kotak karton gelombang (KKG) *single wall* dengan karakteristik sesuai pada poin 4.

Bagian permukaan bawah : KKG baik, isi : baik  
Bagian permukaan atas : KKG baik, isi : baik  
Bagian sisi panjang : KKG baik, isi : baik  
Bagian sisi pendek : KKG baik, isi : baik  
Bagian sudut : KKG deformasi, isi : inner box deformasi 1 buah

Contoh uji Kemasan **tidak memenuhi** ketentuan dan persyaratan yang ditetapkan untuk transportasi *dangerous goods* dengan kriteria *Packing Group III*.

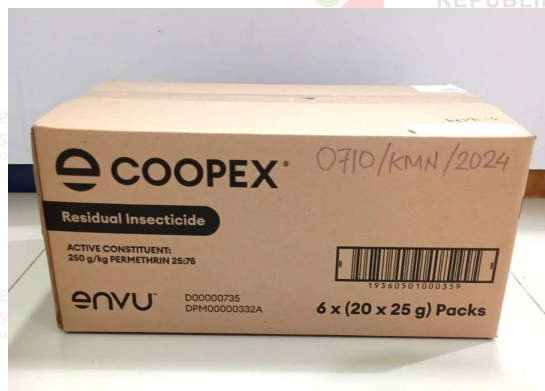
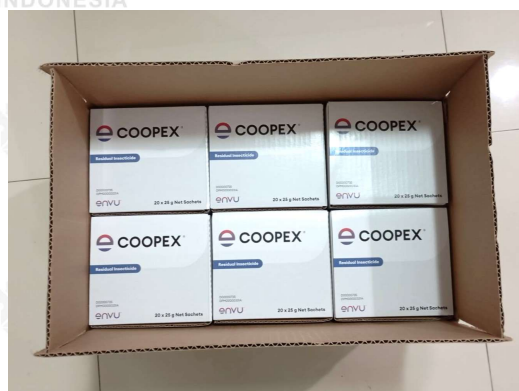
Picture :

CARTON BOX COOPEX RI 6 X 20 X 25 G in a good condition, composed of single wall corrugated fibreboard boxes and characteristic see point 4.

On a corner : corrugated box : deformation, content : inner box deformation 1 pcs

The presented packaging **not meet** the performance test prescribed for the transport of dangerous goods of the packing groups III.
