FORT UNION NATIONAL MONUMENT

PHASE FOUR TECHNICAL REPORT

UNIVERSITY OF PENNSYLVANIA

CENTER FOR ARCHITECTURAL CONSERVATION

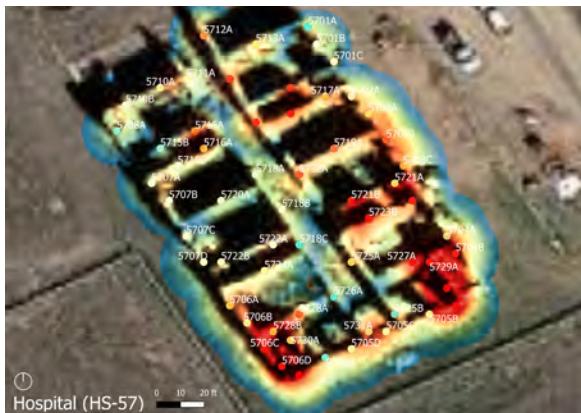
Figure 9- High risk, high density risk scenarios in the Hospital (HS-57) in the lower right and left corners of the building.

The most catastrophic of the four risk scenarios is high-risk/high-density where a significant portion of standing walls exhibit moderate to severe risk, are at or near full height, and are surrounded by similar walls in close proximity. This scenario is best found in the southwest and southeast corners of the Hospital (HS-57), where most of the original walls are intact and full height. Given the layout of the building in plan, these walls are placed within close proximity to

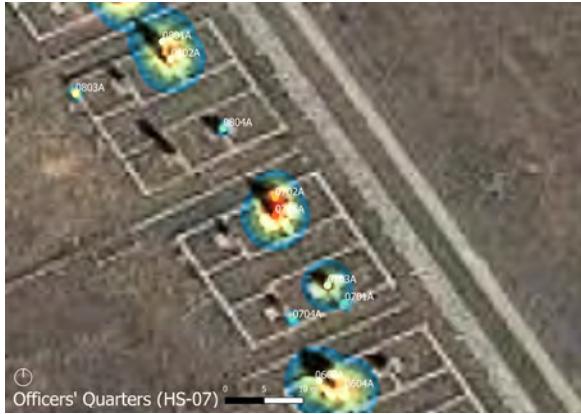
Figure 11- High risk, low density wall sectors in one of the Officers' Quarters (HS-07). These wall sectors can be seen in Photo 7, to the right.

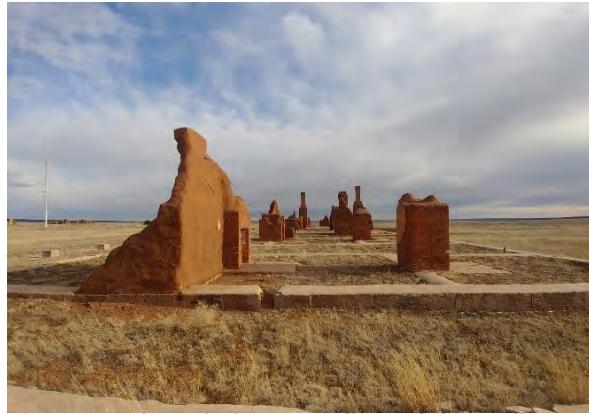
Figure 12- The sole free-standing adobe wall sectors of Officers' Quarters HS-07.

During the survey process, missing architectural elements (for which specific survey categories applied) were given an "NA" denoting that the element was missing and did not apply. ("NA" is distinct from "0" which indicates that the element is present but is considered a minor or negligible vulnerability to the wall sector.) As a result, wall sectors that did not contain openings or wall edges would naturally score lower than wall sectors that did. For example, a freestanding wall sector without any junctions to adjacent walls can only score a maximum of 25 points in-

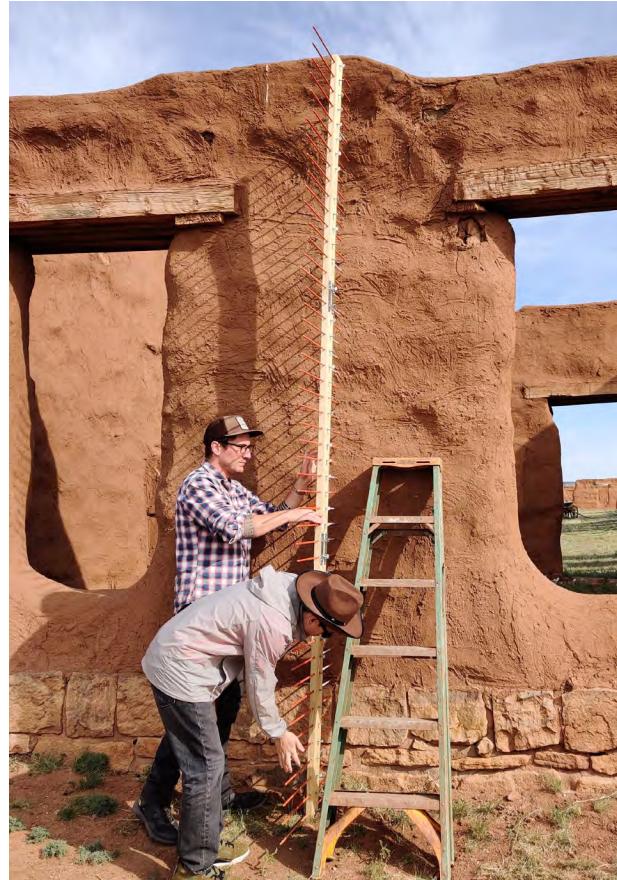
Figure 13- CAC team members carrying out wall profile survey during the summer of 2019. Within this wall segment, the most visibly compromised location was chosen for the profile, where there is a noticeable shift in planarity between the two window openings.

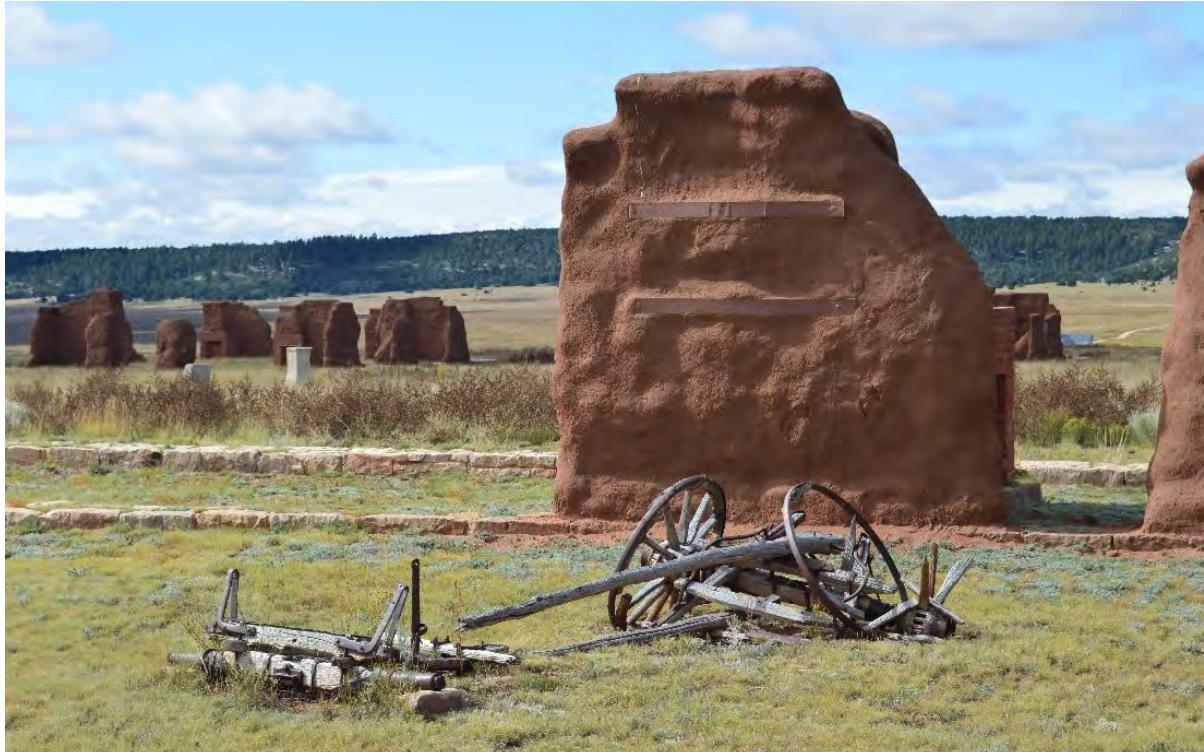
Figure 22- A photo of wall sector 3629-A illustrating the distinctive coving deterioration pattern in the top third of the elevation. Wall sector 3629-A is east facing, historically exposed, and presently unprotected.

For historically exposed walls, a generalized erosion pattern exists in the upper third of the wall sector where wind velocities would be greatest (Figure 18). Many historically unexposed wall sectors, however, have become exposed, explaining the similarity between the two categories (Figure 19, Figure 21). In both categories, the surface displays localized loss in the uppermost portion of the top third of the wall which would be directly below the wall cap. This 'coving' pattern suggests that soil-amended caps perform as designed yet cause differential erosion patterns directly below them. This can lead to dangerous top-heavy upper wall sections.

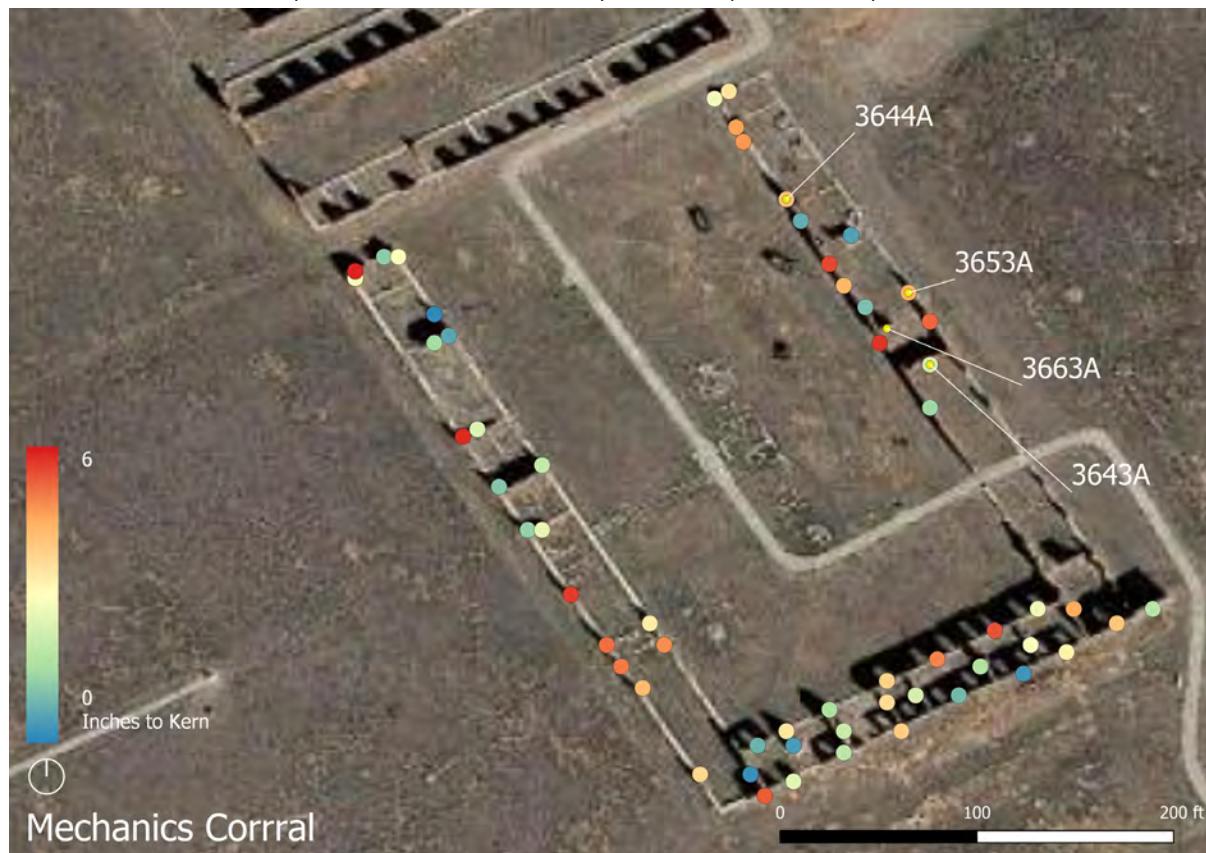
Ultimately, of the four wall sectors which ranked among the top 5% most-at risk walls of the entire Third Fort, the independent structural analysis of the profilometry data correlated with the

Figure 24- This figure depicts the Mechanics' Corral and the results of the wall profilometry structural analysis. Of the top 5% most at-risk walls across the entire Third Fort, four are located in the Mechanics' Corral and are highlighted with leaders. The "inches to kern" metric used for this illustration is an indication of how out of plane a wall section is, and the details of this term and the methodology used to calculate it can be found in Appendix G.

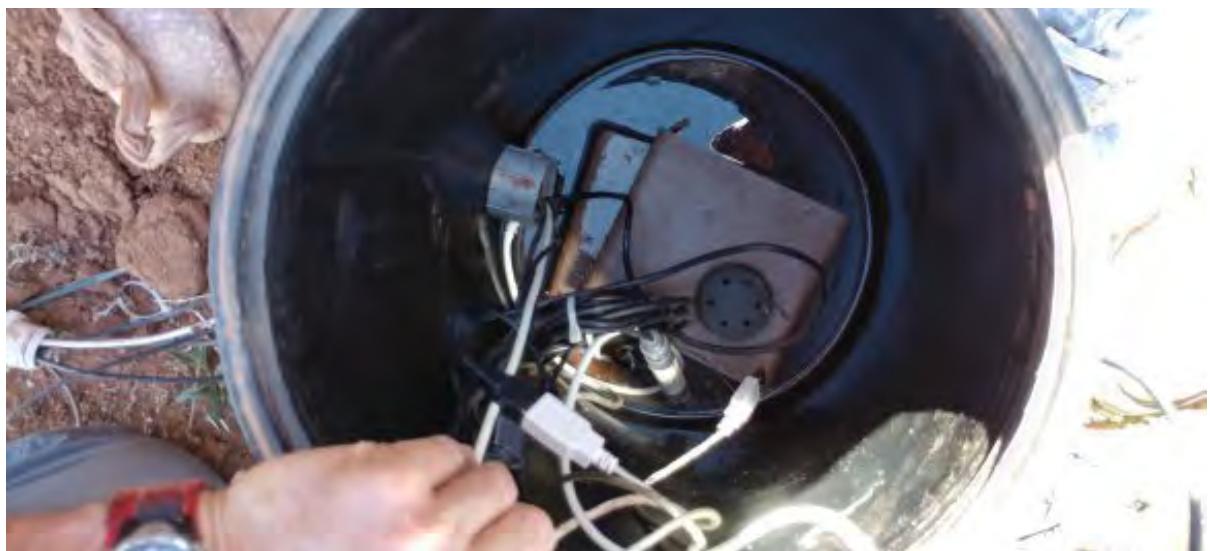
Figure 25- The pilot data-logging system in the “weather-proof” enclosure after several seasons of continuous use and exposure. Despite efforts to weather seal the enclosure, standing water and condensation were still observed causing much of the system to malfunction.

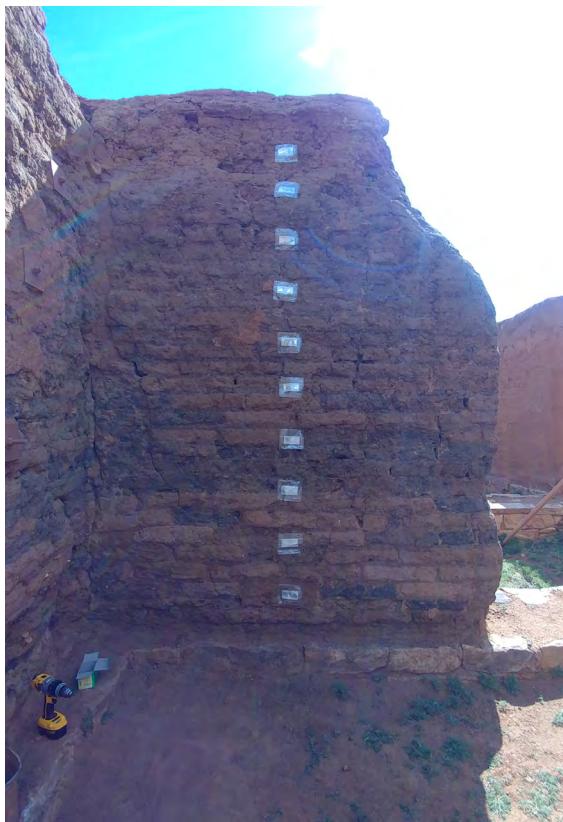
Figure 27- 10 passive RFID tags were installed on the east face of wall sector 5732A. The tags were spaced 12" apart, beginning from the top of the stone foundation. This, and other walls of the hospital, were re-coated later in the summer of 2019.

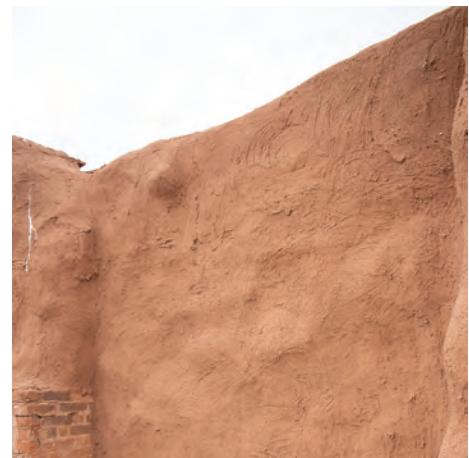
LEVEL 1

Roughly 1/3 of half the upper wall section is lost.

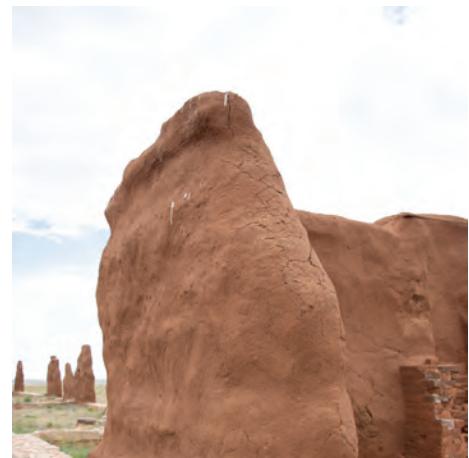
LEVEL 3

Roughly 2/3 of half the upper wall section is lost.

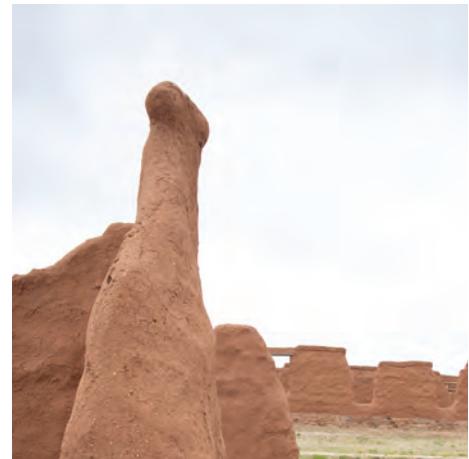
LEVEL 5

More than 2/3 of half the upper wall section is lost.

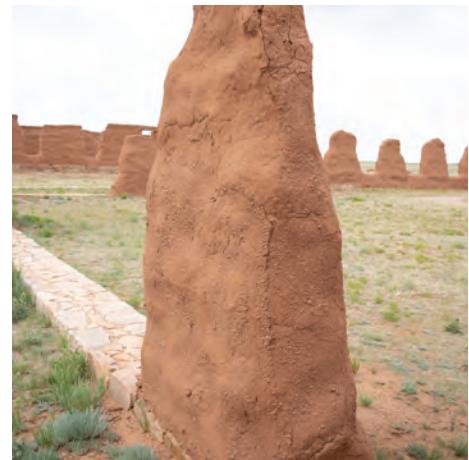
LEVEL 1

Less than 1/3 of half the mid wall section is lost.

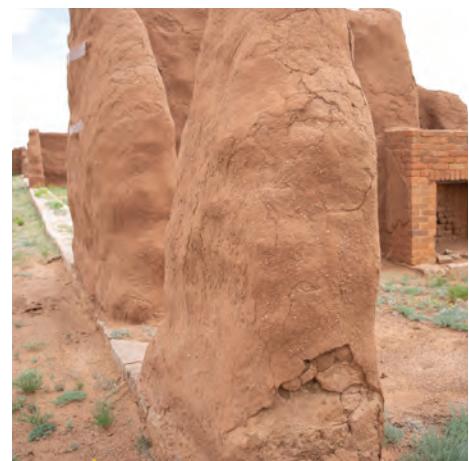
LEVEL 3

Loss of roughly one wythe, or between 1/3 and 2/3 of half of the wall section is lost.

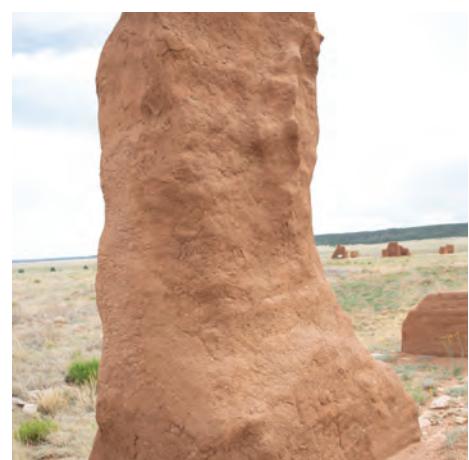
LEVEL 5

Loss of roughly two wythes or more than 2/3 of half the wall section is lost.

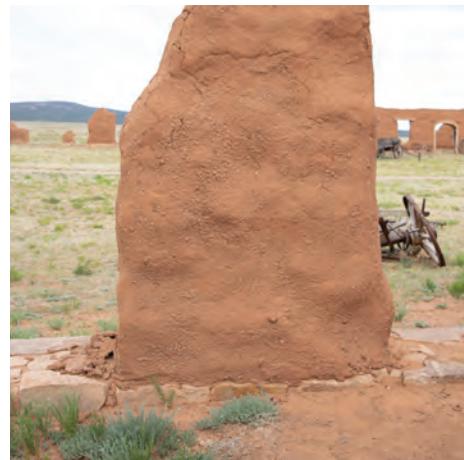
LEVEL 1

Approximately 1/3 of the lower wall face is lost, usually in the form of a concavity.

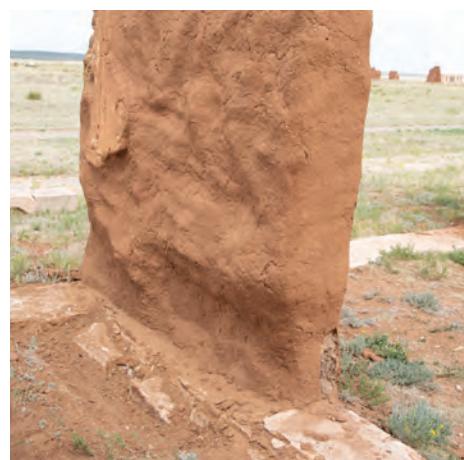
LEVEL 5

Approximately two wythes or more than 2/3 of the lower wall face is lost, usually in the form of a concavity.

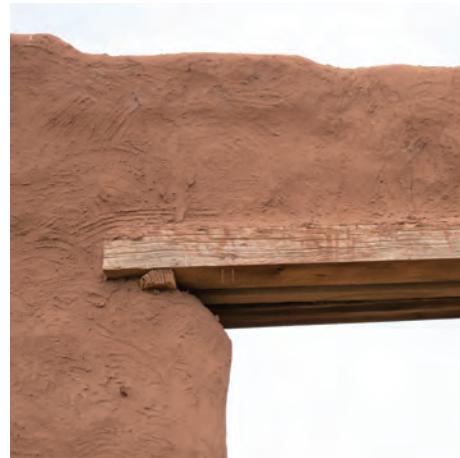
LEVEL 1

The wooden lintel components are slightly out of horizontal or vertical plane or bending; or the surrounding adobe exhibits some signs of differential loss.

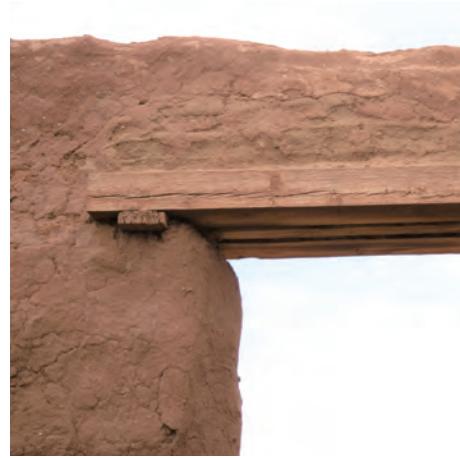
LEVEL 3

The wooden lintel components are out of plane, shows some cracking, and/or displacement. The surrounding adobe exhibits signs of structural distress and differential loss.

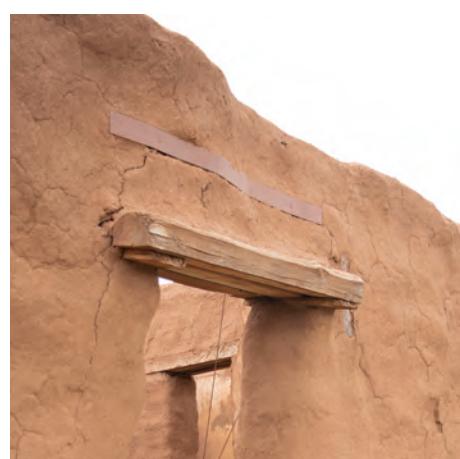
LEVEL 5

Hairline and wide cracks are visible. The structural capacity of the lintel is significantly diminished due to loss of surrounding adobe and/or wooden elements and these components are seriously in threat of collapsing.

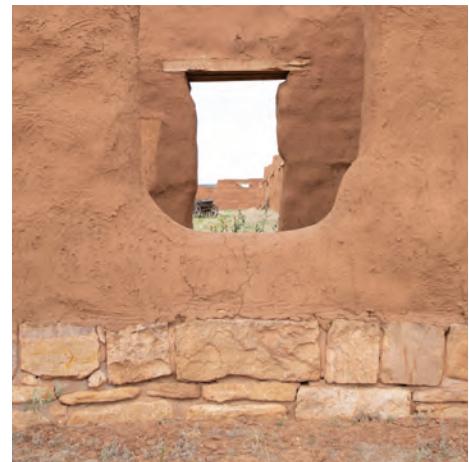
LEVEL 1

Approximately 1/3 of the sill has slightly diminished in shape, either in elevation or section. The corners are rounded, but the sill maintains a similar profile to the original squared corners.

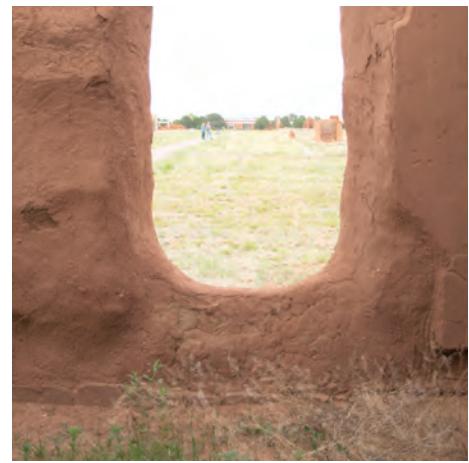
LEVEL 3

The sill has deformed to a semi-rounded shape in elevation. In section, erosion has extended to approximately two-thirds of half of the wall section.

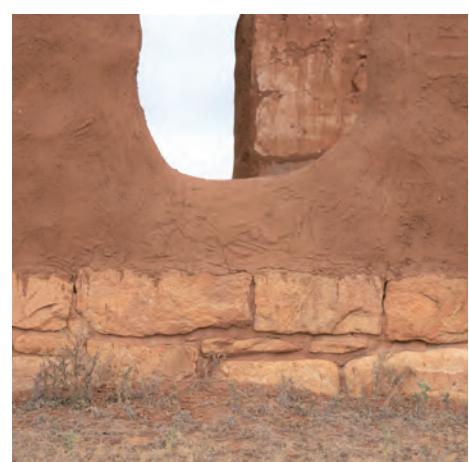
LEVEL 5

The sill has completely lost its shape in elevation and erosion has extended to half of the wall section.

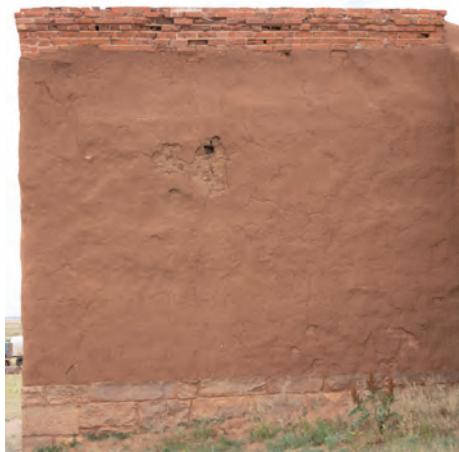
LEVEL 1

The surface of the shelter coat displays few to multiple hairline cracks. The shelter coat is still able to protect most of the adobe masonry from water intrusion.

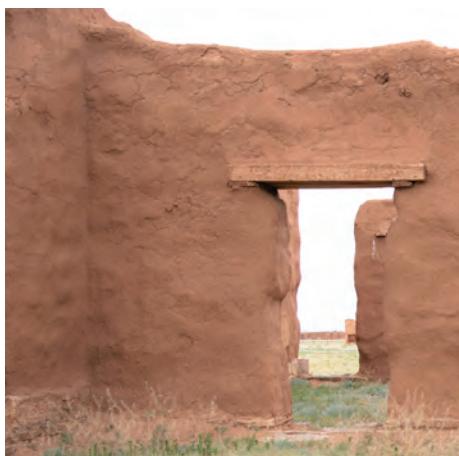
LEVEL 3

The surface of the shelter coat displays several hairline cracks and a few wide cracks. It is questionable as to whether the shelter coat is effectively protecting the adobe masonry from water intrusion.

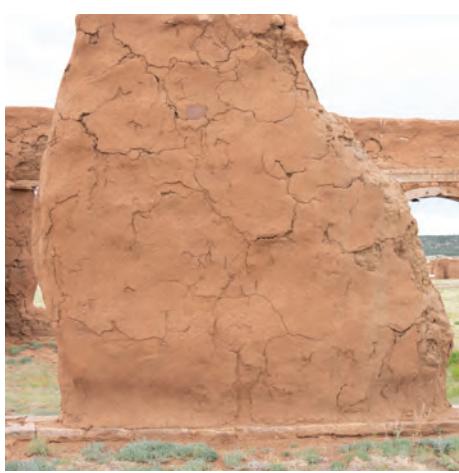
LEVEL 5

The shelter coat displays extensive cracks, both wide and hairline, mostly forming crack networks with or without associated detachment. These cracks are likely paired with shelter coat loss. The shelter coat is not effectively protecting the adobe masonry and is allowing water intrusion.

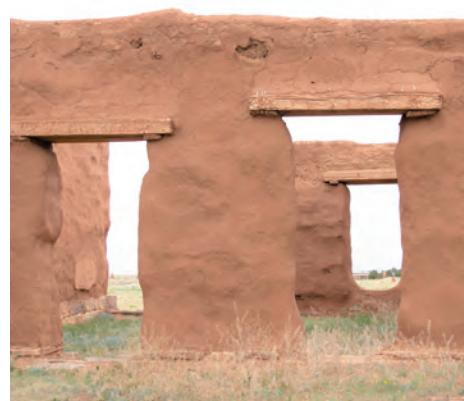
LEVEL 1

The surface of the shelter coat exhibits a few small areas of loss but is generally intact. This loss is paired with some hairline cracks.

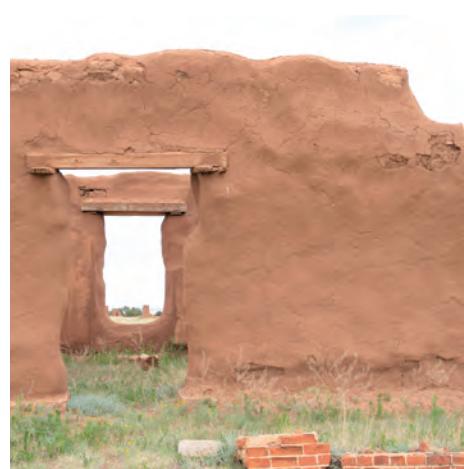
LEVEL 3

The surface of the shelter coat exhibits several moderately-sized areas of loss and is not effectively protecting the adobe wall from water intrusion.

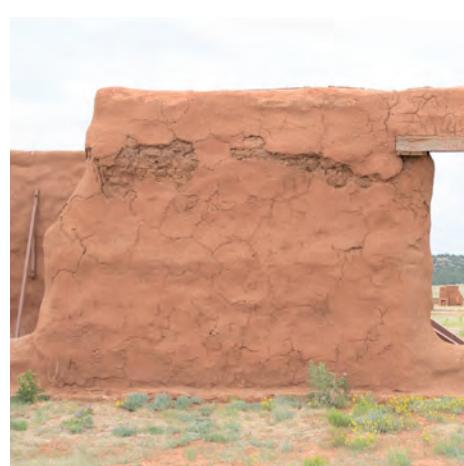
LEVEL 5

The shelter coat exhibits several extensive areas of material loss. This loss is paired with both hairline and extensive cracks forming networks that surround the shelter coat loss.

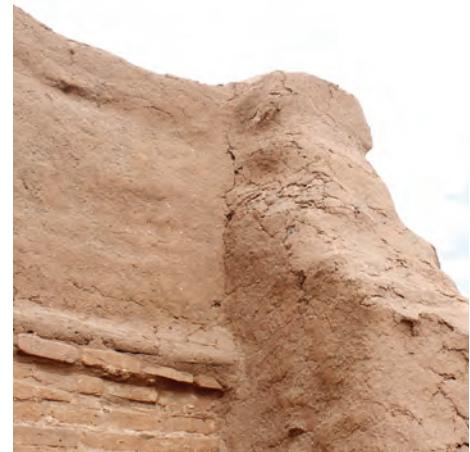
LEVEL 1

Hairline crack(s) evident on one side of the wall intersection. These cracks can be found on any height of the whole wall.

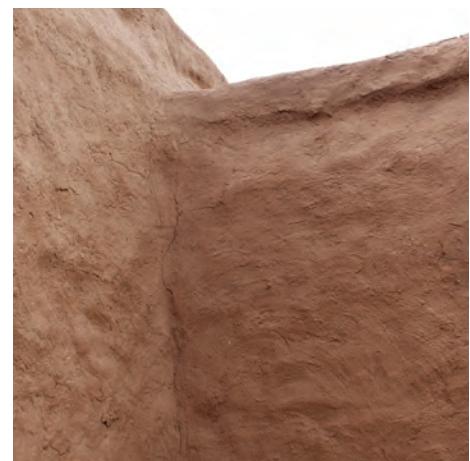
LEVEL 3

Hairline crack(s) evident on both sides of the wall intersection.

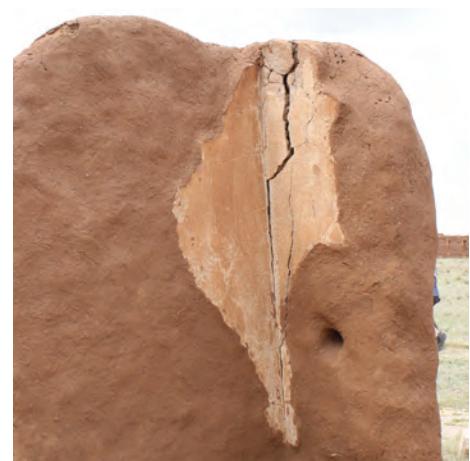
LEVEL 5

Wide cracks are evident and connect on both sides of wall intersection. This severity of a wall junction crack is usually paired with wall separation and displacement. This cracking may also be identified as a structural crack.

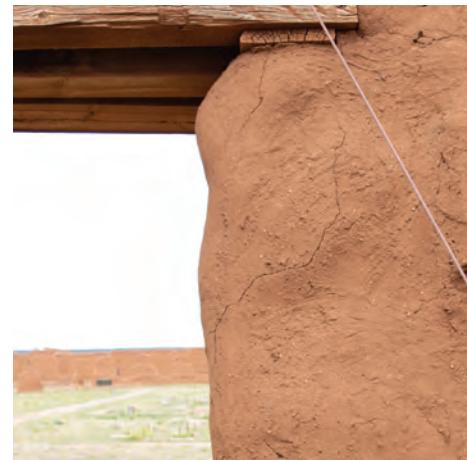
LEVEL 1

A long crack (vertical, horizontal, or diagonal) is apparent on one face of a wall.

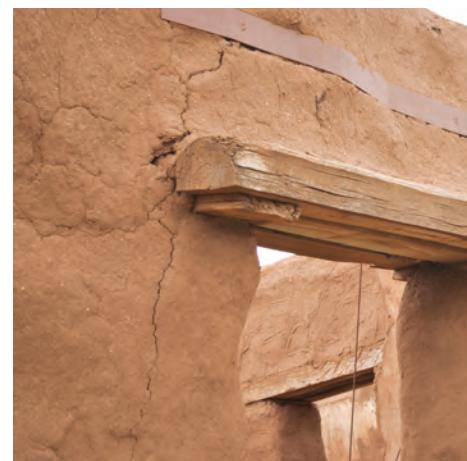
LEVEL 3

A long crack (vertical, horizontal, or diagonal) is apparent on both sides of wall. It may be surrounded by hairline cracks.

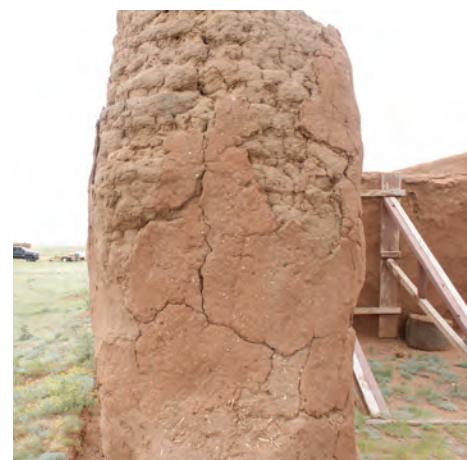
LEVEL 5

One or more deep, long cracks (vertical, horizontal, or diagonal) accompanied by apparent hairline cracks. The wall likely shows displacement. Structural cracks are likely to follow adobe wythes.

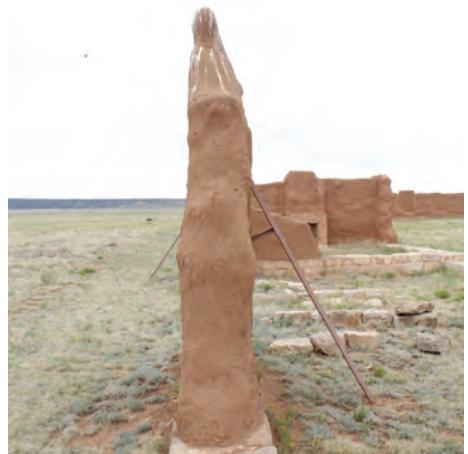
LEVEL 1

Wall segment demonstrates slight lean and does not align with stone foundation. A brace might be in place to prevent further movement.

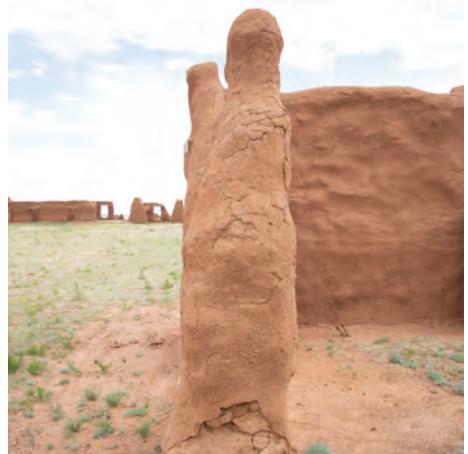
LEVEL 3

Wall unit, braced or unbraced, is leaning out of plane. If an imaginary original wall profile was drawn, the second third of the half of the wall would align with the edges of the stone foundation.

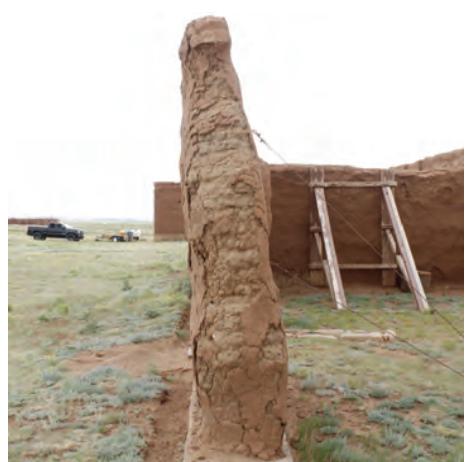
LEVEL 5

Wall unit, braced or unbraced, is out of plane and requires immediate structural repairs. If an imaginary original wall profile was drawn, the center line of the wall would align with the edges of the stone foundation.

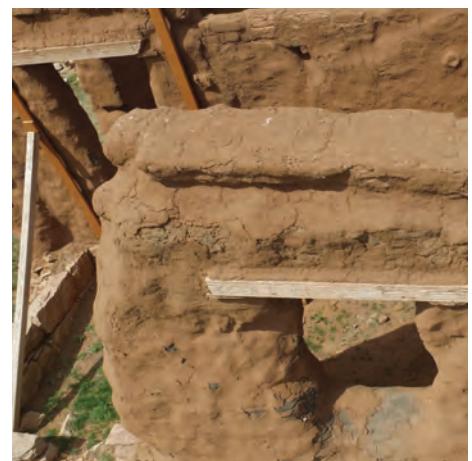
LEVEL 1

The surface of the shelter coat has many hairline cracks.

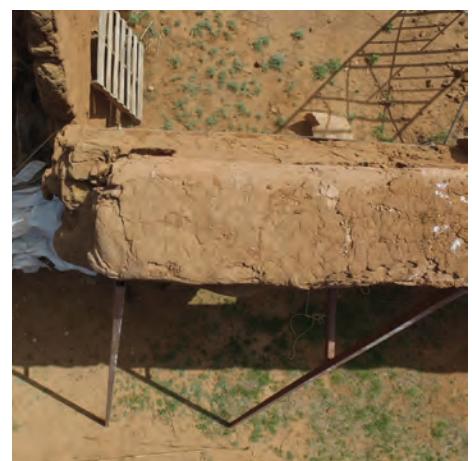
LEVEL 3

The surface of the shelter coat has several hairline cracks and a few wide cracks. Small patches of shelter coat loss might be present.

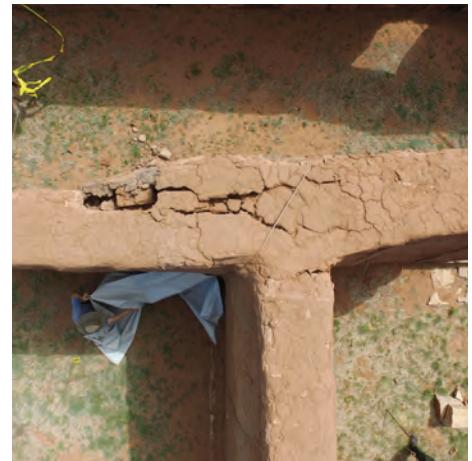
LEVEL 5

The shelter coat exhibits extensive hairline and wide cracks. These cracks are likely paired with shelter coat loss and displacement.

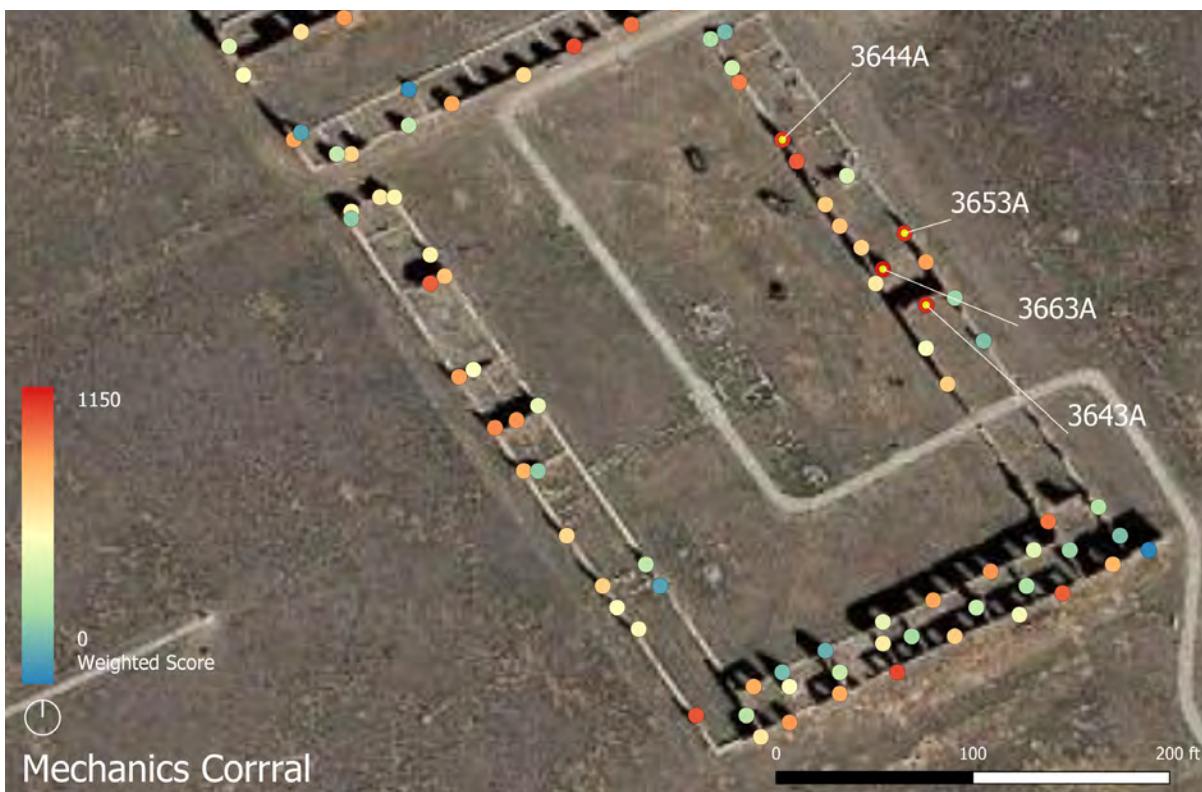
Figure 31- Composite, normalized and weighted RAS scores for the Mechanics' Corral (HS-36).

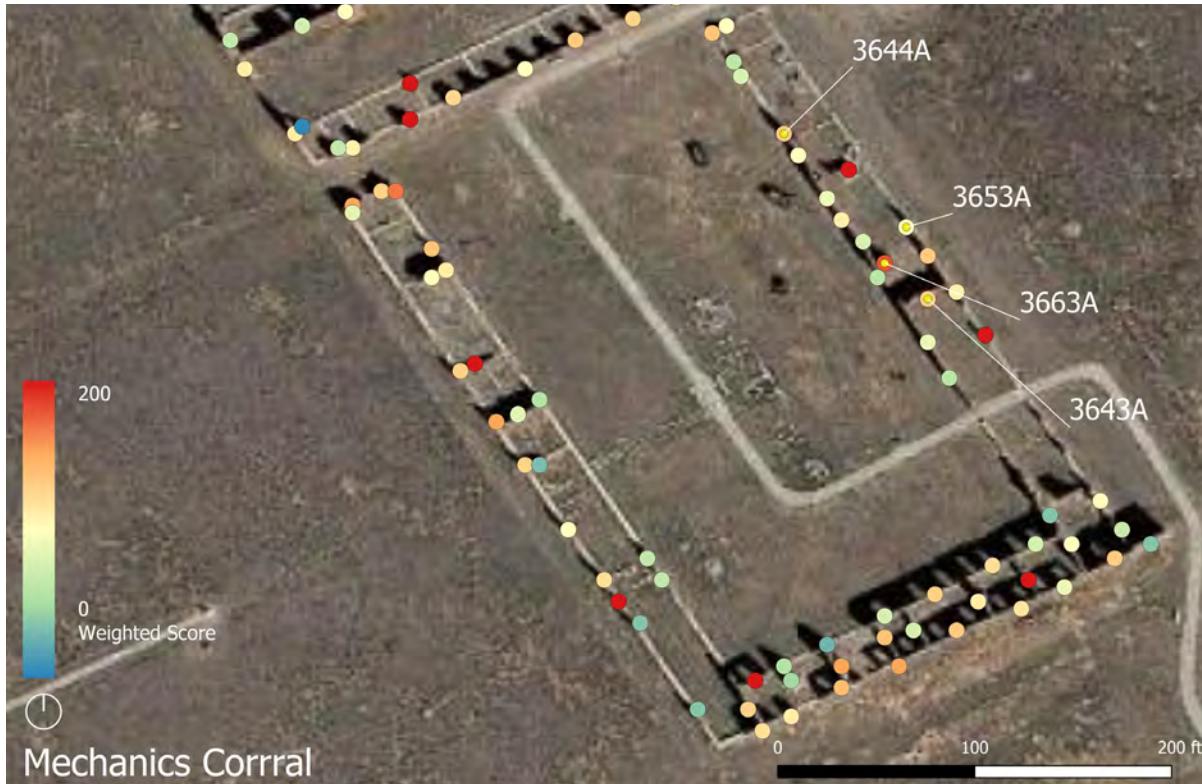
Figure 32- Normalized and weighted RAS scores for categories A & B of the Mechanics' Corral (HS-36).

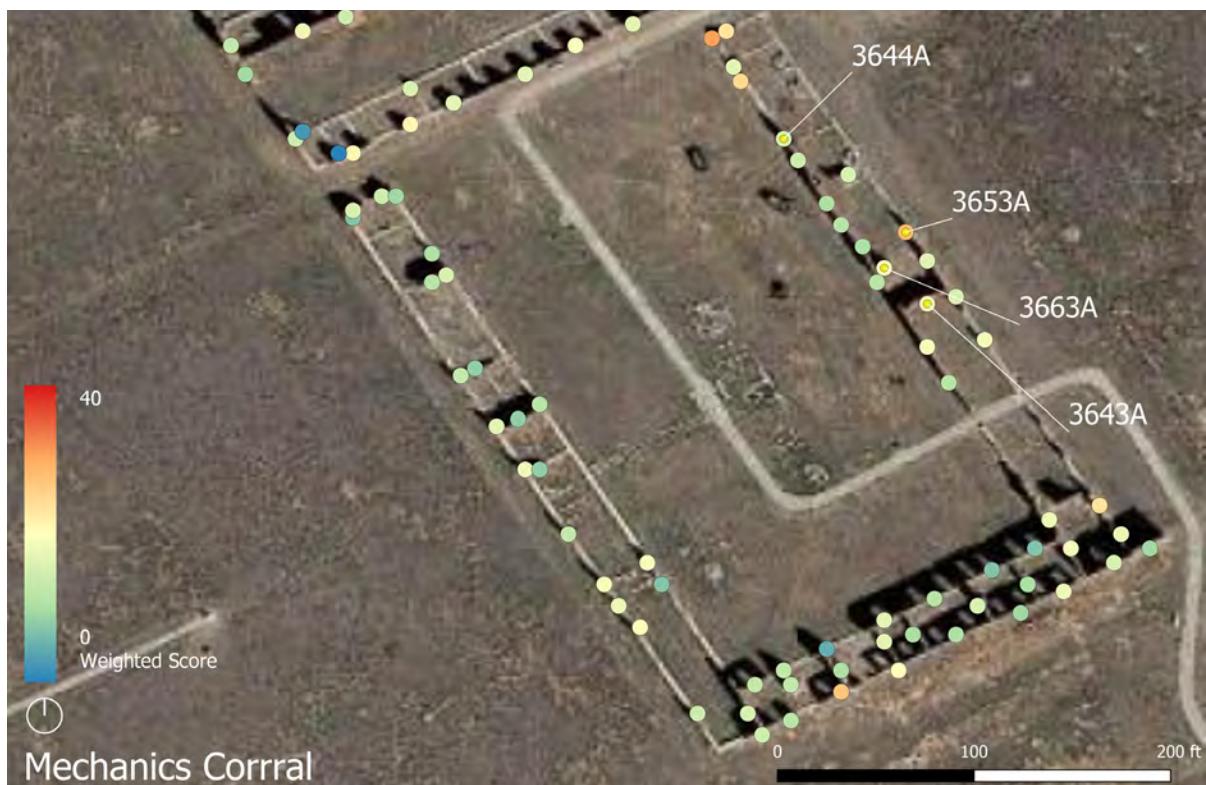
Figure 33- Normalized and weighted RAS scores for categories C - F of the Mechanics' Corral (HS-36).

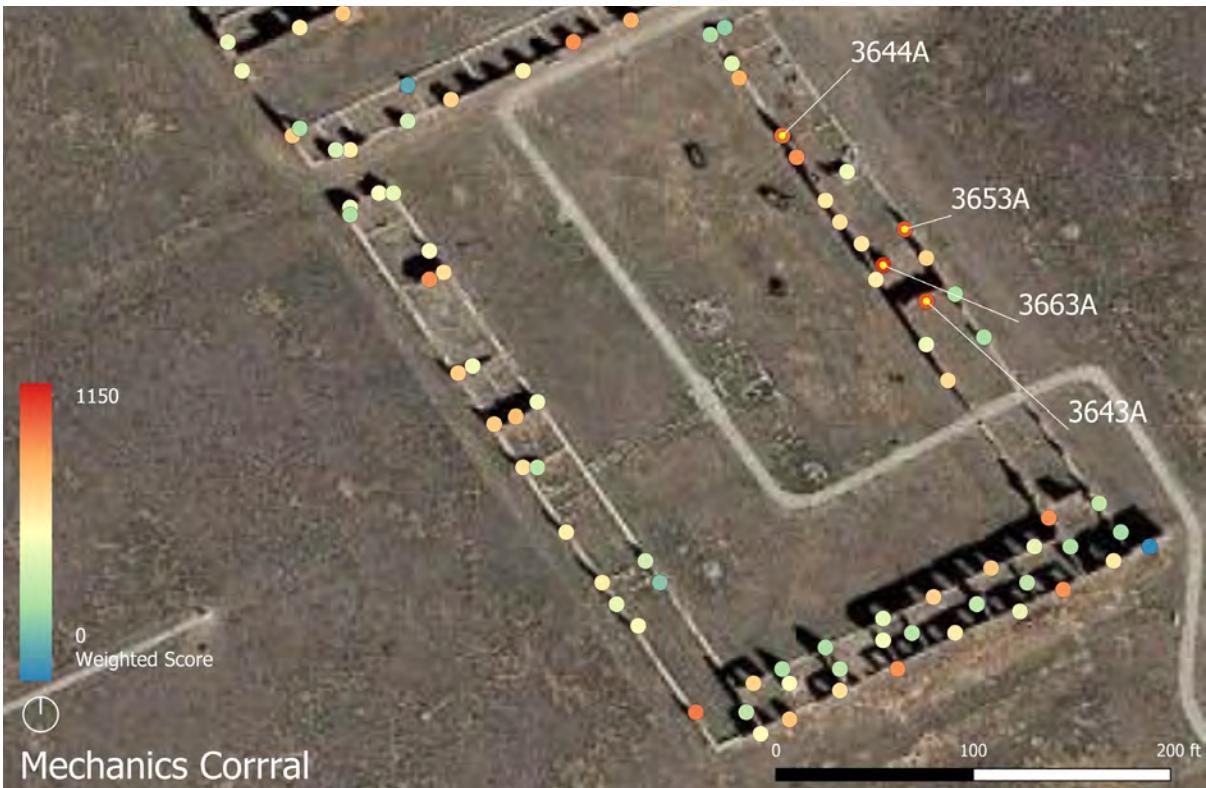
Figure 34- Normalized and weighted RAS scores for category G of the Mechanics' Corral (HS-36).

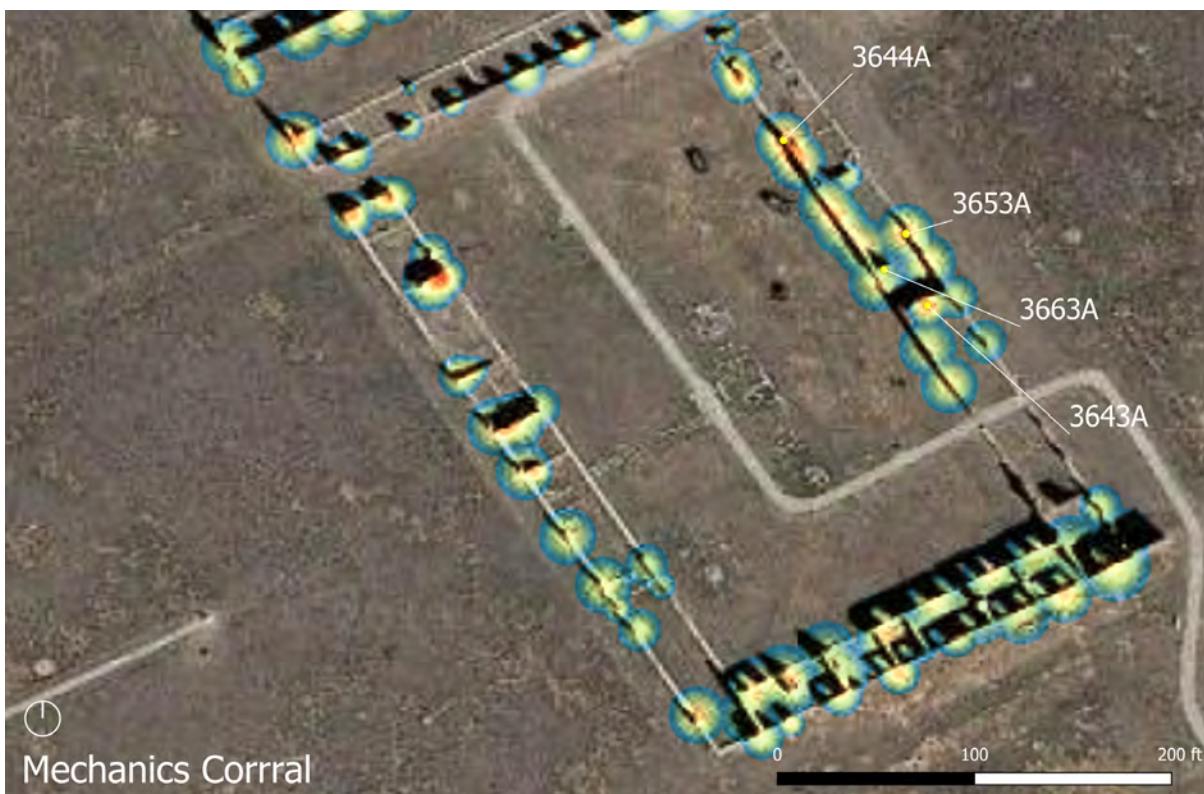
Figure 35- Composite results of the RAS plotted using wall sector height as a radius of 'risk impact.'

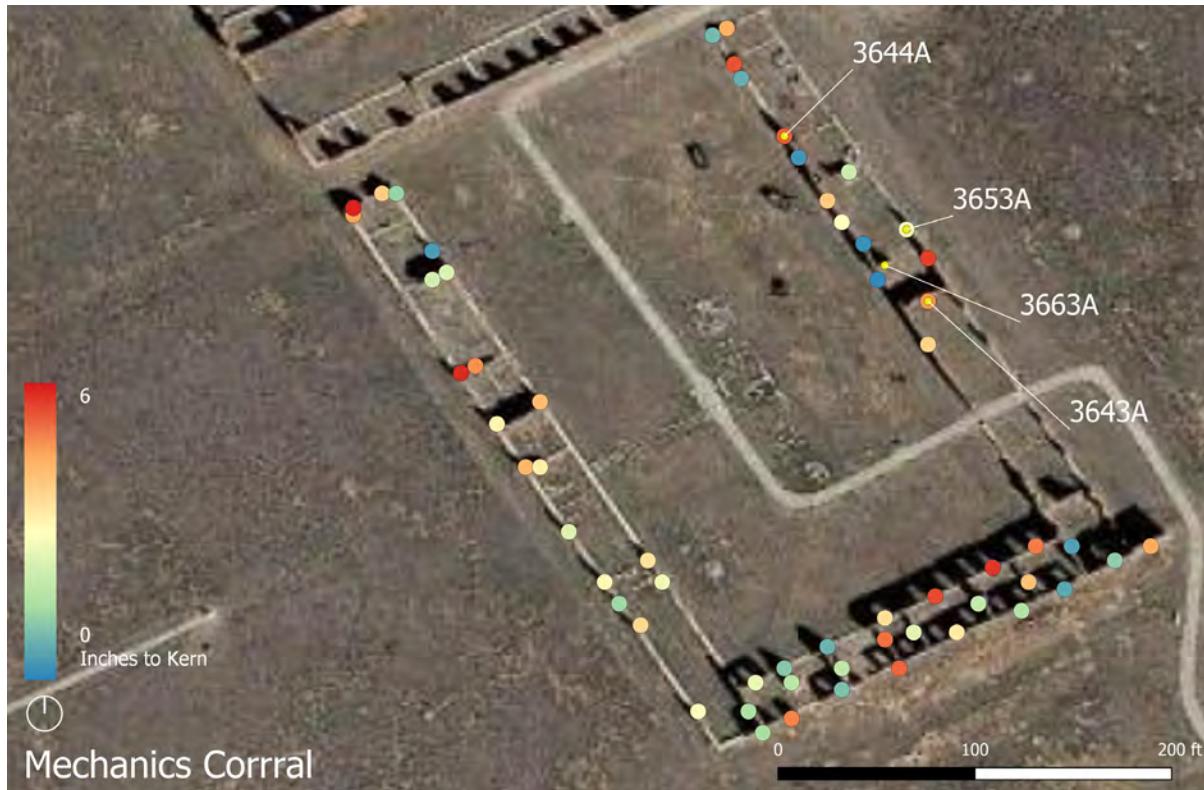
Figure 36- Results of structural analysis of wall profilometry data in "inches to kern", a measure of structural instability based on the geometry of the cross-section alone.
