Wind Turbine Common Failures and Solutions

Lessons Learned: Common Wind Turbine Bearing Failures, Costs & Solutions

Lead-time to drivetrain component failure and the impact of your O&M strategy

Understanding Uptower Generator Diagnostics & Repairs

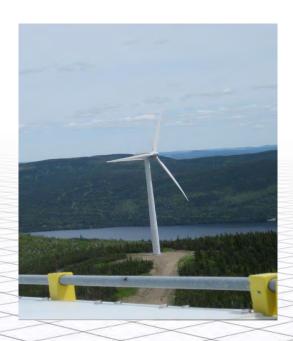
4.1 Electrical failure on rotor

Inspection requested by a customer

- Wind turbine tripping during high wind / full production
- Generator's rotor failure suspected

Solutions: Replace & solidify the rotor leads uptower Replace the Wye ring uptower

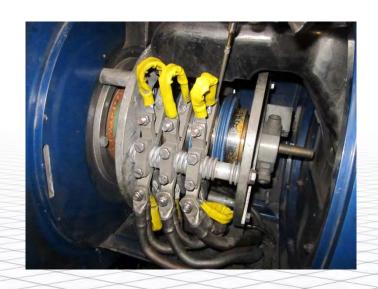
4.3 Unevenly worn slip ring

- Slip ring needed to be changed every 1-2 months
- Condition getting worst over time
- Uneven wear on the 3 rings and 3 brushes

- Steady runout of < 0,001 in after repair</p>
- Back to normal brush wear after 1 year of operation
