KRYTON CASE STUDY

Impala Platinum Mine Rustenburg, South Africa

Concrete Waterproofing, Rejuvenation and Crack Repair

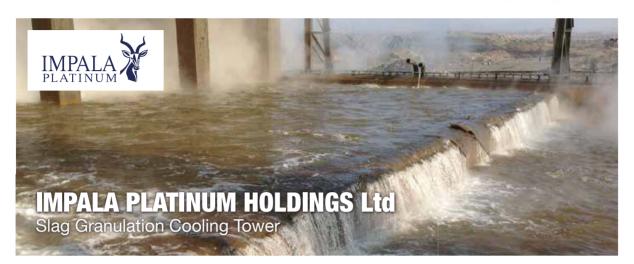
The Impala Platinum slag granulation cooling tower in Rustenburg had several flaws that were causing cracks and severe water leakage. Because of the nature of this process, the reservoir could not be emptied for this repair process as not only would it stagnate their smelting process but it would incur enormous labour and operational costs. Therefore, repairs would have to be to the negative

Sanika had to remove the unsuccessful membranes and other products from the structure to prepare it for the crack repair and waterproofing process. After preparing the surface Sanika had to act quickly with Krystol Plug as the water penetrating through the cracks was at a temp of over 80 C° (176 F°). After the Krystol Plug successfully stopped the flow of water Sanika employed the rest of the Krystol Crack Repair System followed by a coat of Krystol T1 & T2 to completely waterproof the reservoir.
