# HQDFM Design for Manufacture(DFM) Report

File name: 2026-06-23

Time: 2026-06-23 Layer count:2

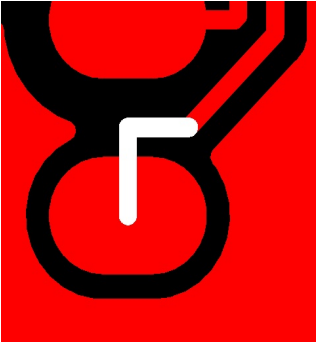
| ID | Check | Limits | Value | Issue | Image | Position | Qty | Level |
|---|---|---|---|---|---|---|---|---|
| 1 | Signal Integrity_Acute Angle Traces | -,,- | Error(s) detected | There is an acute angle connection mode in your design,which will affect the signal integrity of the product.it is recommended to adjust the acute angle posintion to arc or obtuse angle connection mode | | 166.34,-128.55 | 1 | Warning |

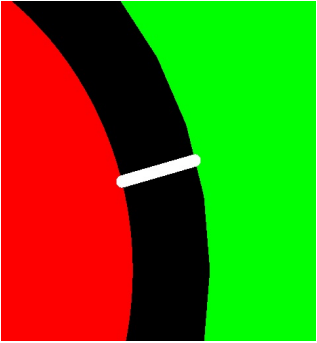
| ID | Check | Limits | Value | Issue | Image | Position | Qty | Level |
|---|---|---|---|---|---|---|---|---|
| 2 | Drill to Copper_NPTH-to-Copper | 8,10,12 | 0.25 mm | NPTH to copper spacing of 9.86mil was detected in your design. This could increase the risk of defects such as short circuits, which decrease manufacturing efficiency and yield, and affect the reliability of the boards. It is recommended to increase the spacing to at least 12 mil. | | 132.09,-131.70 | 32 | Warning |
