# HQDFM Design for Manufacture(DFM) Report

File name: 2026-06-21

Time: 2026-06-21 Layer count:2

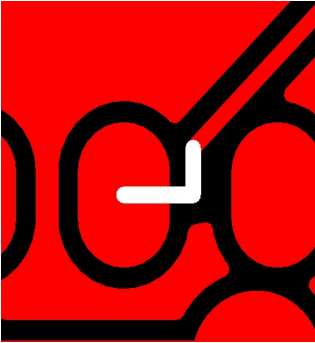
| ID | Check | Limits | Value | Issue | Image | Position | Qty | Level |
|---|---|---|---|---|---|---|---|---|
| 1 | Signal Integrity_Acute Angle Traces | -,,- | Error(s) detected | There is an acute angle connection mode in your design,which will affect the signal integrity of the product.it is recommended to adjust the acute angle position to arc or obtuse angle connection mode | | 147.45,-133.72 | 1 | Warning |
