Deployment of Aerial Robots after a major fire of an industrial hall with hazardous substances, a report

Hartmut Surmann¹, Dominik Slomma^{1,3}, Stefan Grobelny², Robert Grafe³

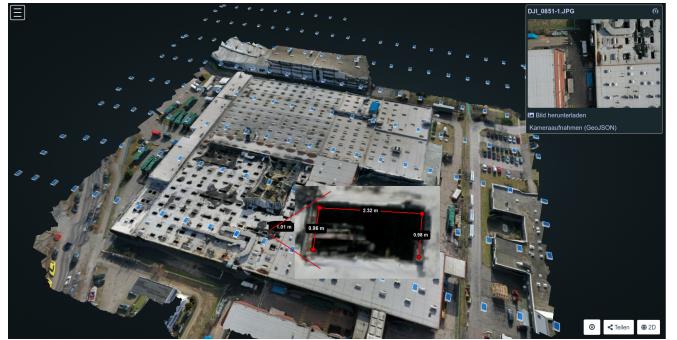
Fig. 3. Result of the first action is a georeferenced 3D point cloud. It is calculated out of 167 images acquired in a 12 minutes flight of the Mavic at a height of 45 meters. The calculation of the model in the RobLW needs 15 minutes. The measurements taken in the model are used to plan the second action.

by setting the overlap of the images. In this deployment, an overlap of 70% was set, generating 167 images from the UAV. These images were then processed using the WebODM tool. WebODM uses Structure from Motion (SfM) and Multi View Stereo (MVS) to create a scaled 3D point cloud that can be viewed in a web browser. Figure 3 shows the point cloud as well as the camera positions, in blue rectangles, over the terrain. By selecting a blue rectangle the image can be displayed in its original resolution (top right). Through the scaled point cloud, the openings of the burned roof hatches could be measured, which have a width of 1m and a length of 2.3m.

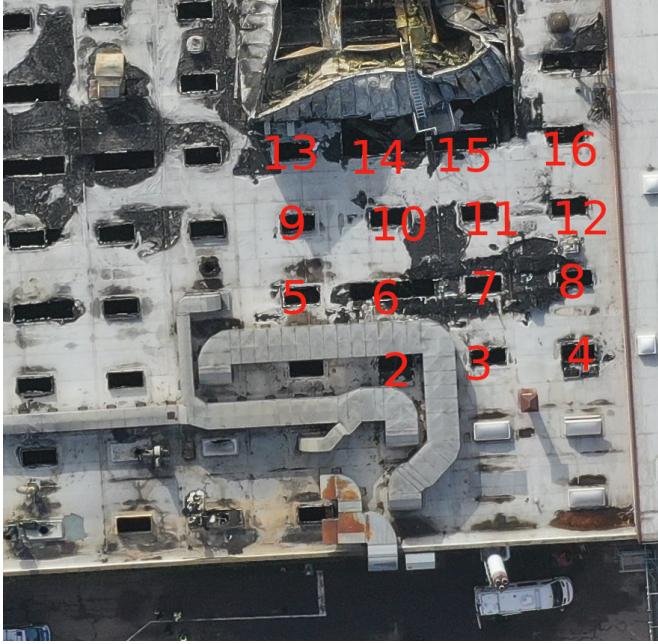
Fig. 6. Overview image after the initial meander mapping flight. The numbers indicate position of penetration points for the UAV (skylight windows) and therefore insight panorama 360 degree images. Bottom right is the position of the RobLW. The position of the operators were first at the RobLW and second at the neighbouring roof starting directly at the right sight of the image. The line at the right side is a wall which separates the halls. The part right from the line was not effected by the fire.

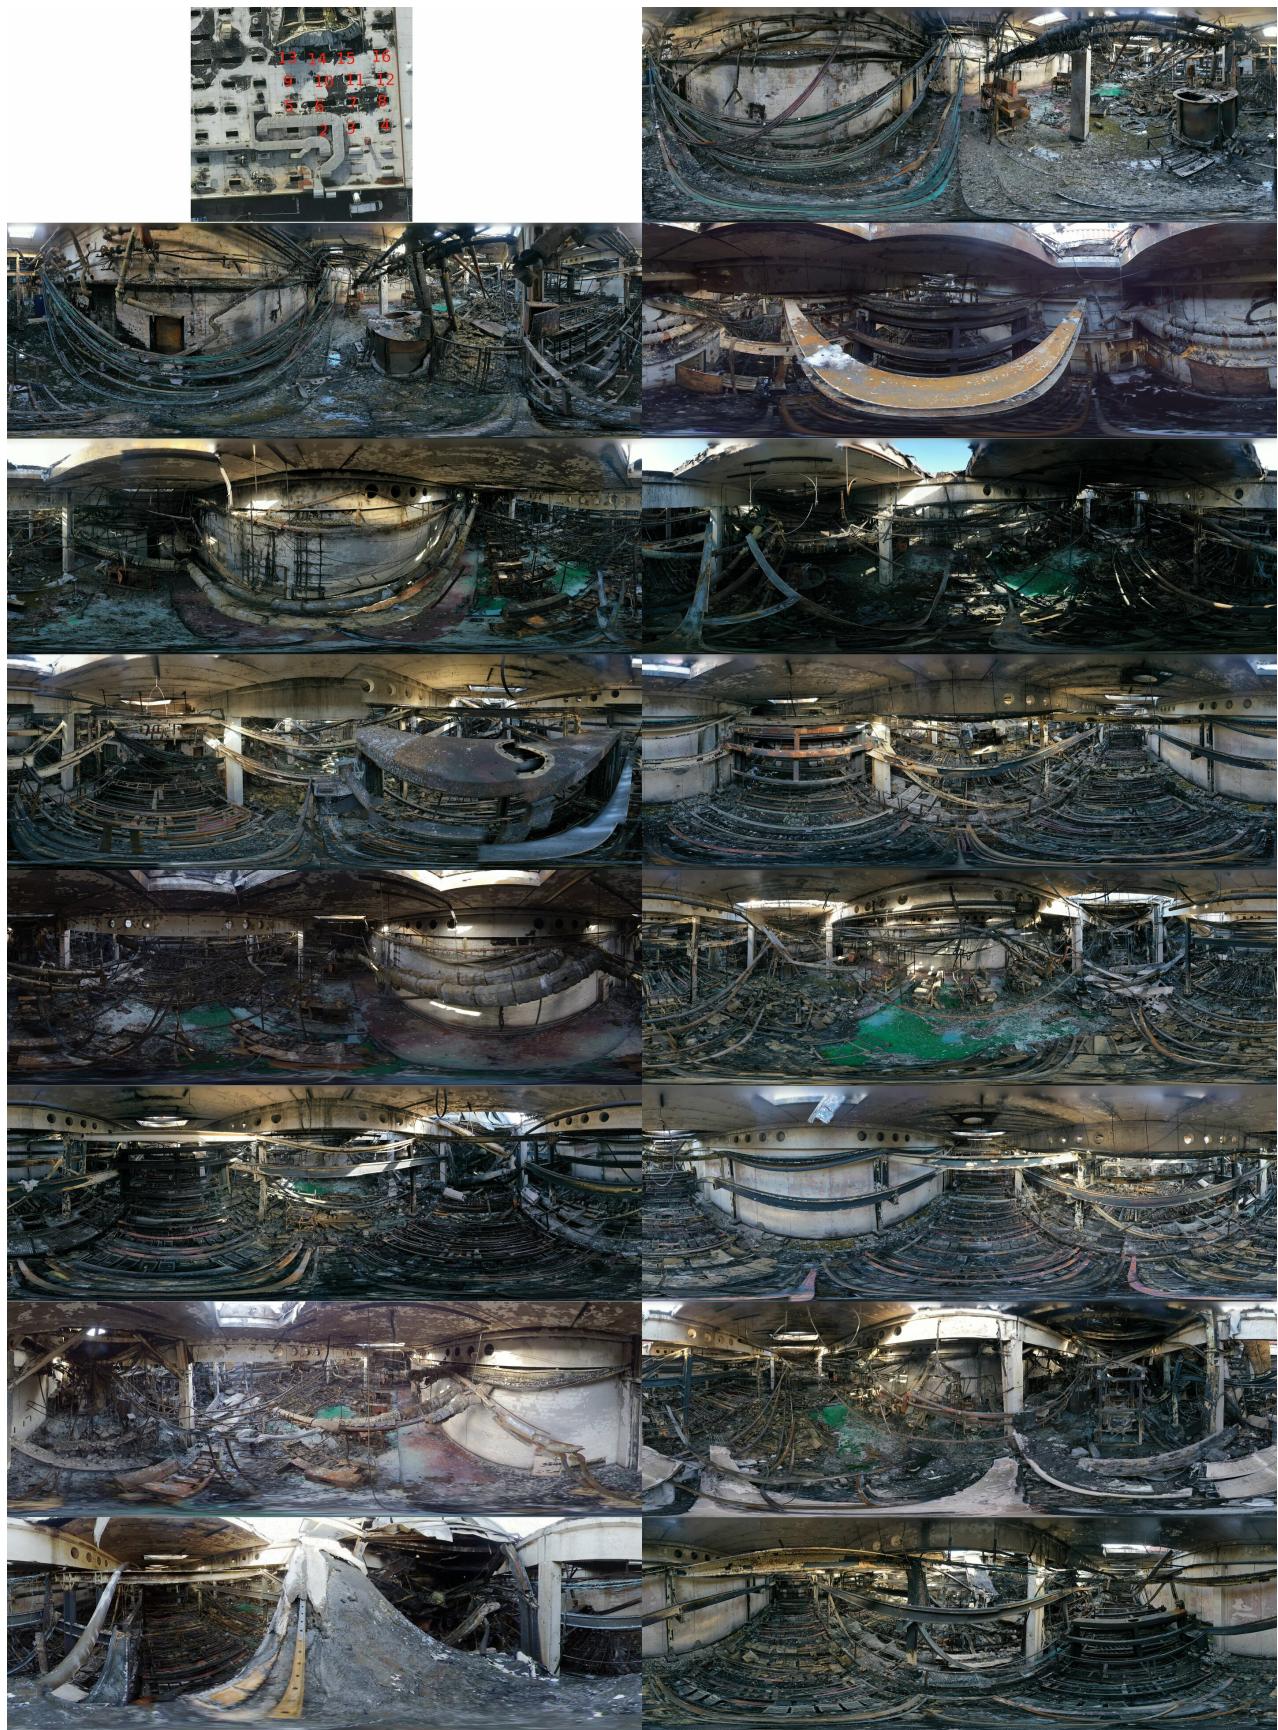
Fig. 12. 360 degree panorama images of the 15 positions (2 - 16).
