# Roehampton Library Retrofit - Technical Report

## Group 2

# Structural Appraisal for a Roehampton library existing structure

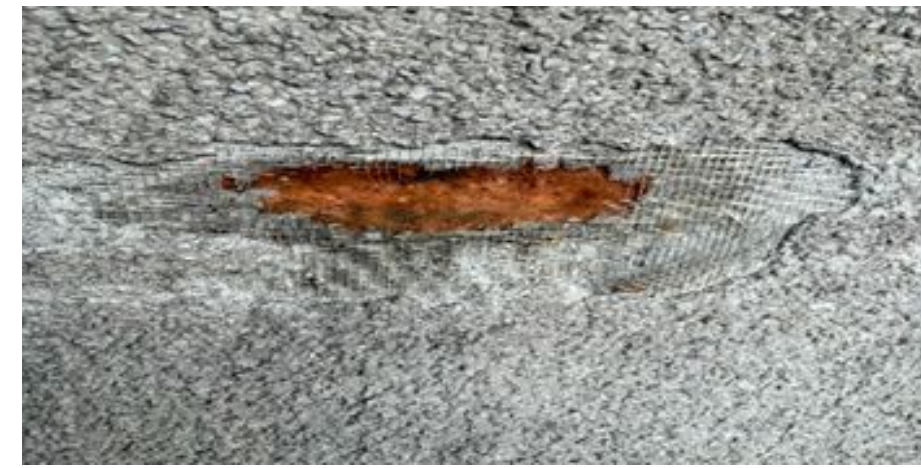
Dark streaks and uneven patches indicate that drainage is poor and moisture is building up. You can see specific areas where the surface is damaged and flaking, with some parts revealing the material underneath, which points to long-term weathering and possible moisture getting in. In some spots, you can find patch repairs and uneven finishes, hinting that previous maintenance efforts might not have worked well. (SSD Scotland, 2023)

Fig:Surface Damage

## 1. Surface Damage (BRE 2007)

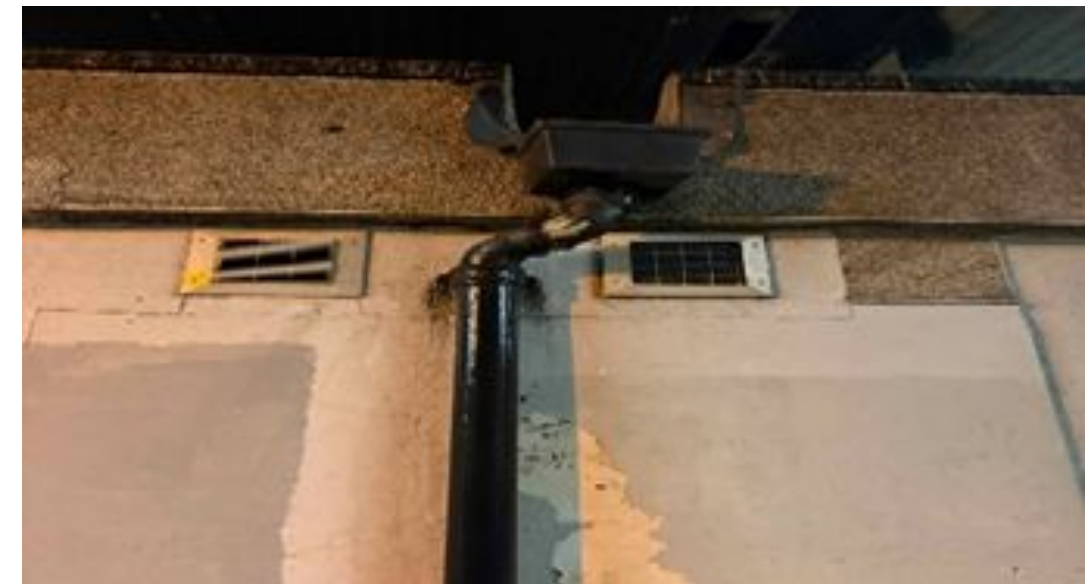
Around where pipes go through the walls, there are stains and damp spots, which could mean there's a leak or that the detailing isn't done properly. At the lower levels, there's a lot of dirt buildup and general wear from exposure and use.

Fig: pipe leaking and staining

## 2. Pipe Leakage & Staining (BSI 2009)

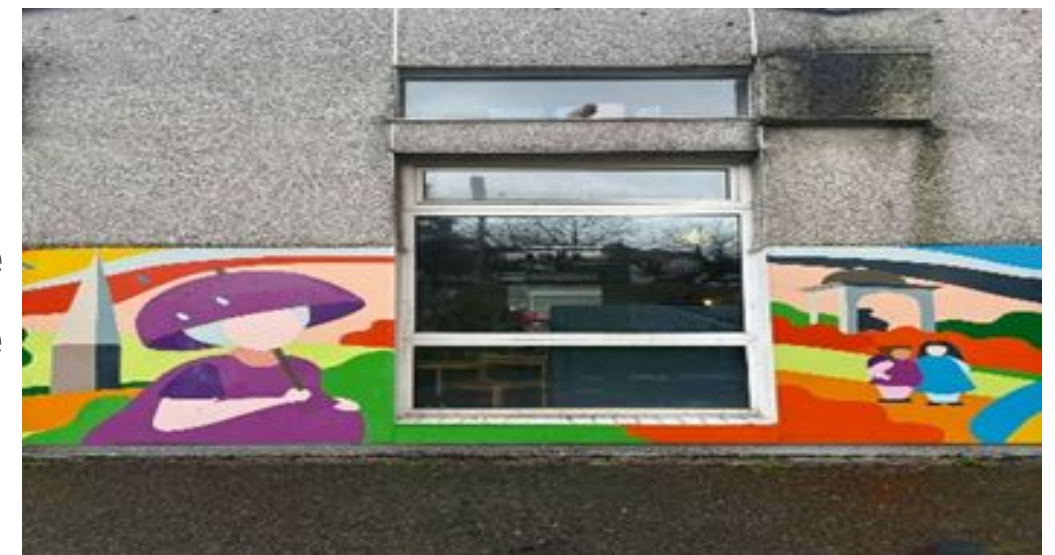
During the external survey we observed that the outer walls are clearly showing signs of wear and tear from being exposed to the environment for a long time. There are noticeable stains and discoloration all over the surface, especially under projections and around openings, which suggests that water has been running off there consistently over time.

Fig: Discoloration of wall

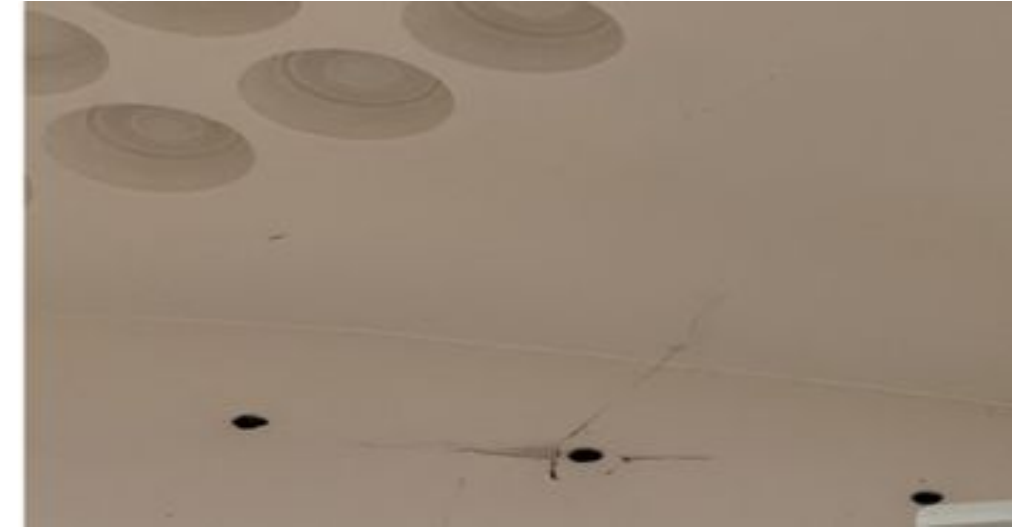
During the internal survey we observed that the internal inspection found multiple signs of damage and moisture problems inside the building. There are noticeable cracks and surface damage around the window openings, which could mean movement or wear overtime. Minor cracks can also be seen along joints and near fixings, hinting at localized stress or aging materials

Fig: Celling crack

## 5. Ceiling Crack (BSI 2004)

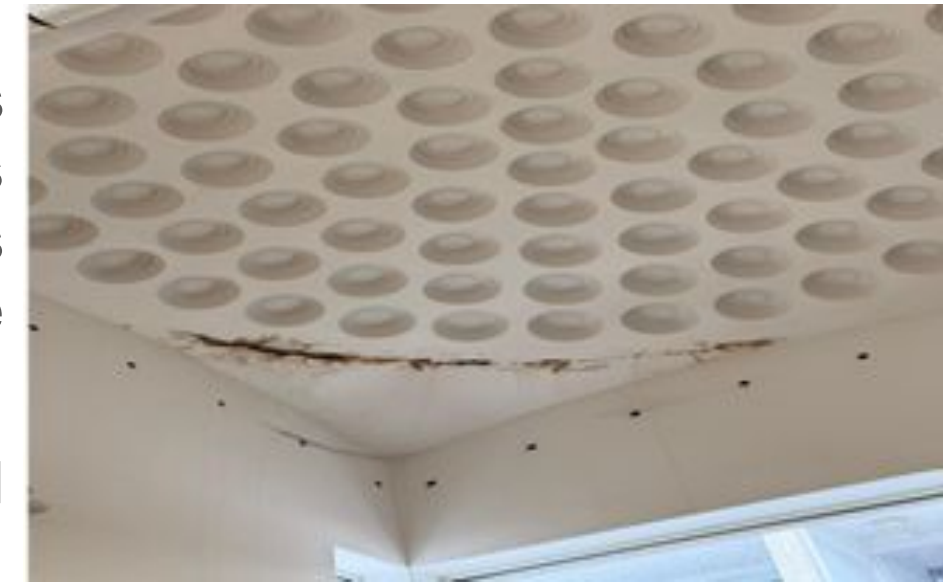
At the ceiling level, especially around the dome junctions, there are obvious signs of water stains and discoloration. Brown patches and streaks suggest that water is getting in, probably from the roof above. In some spots, the ceiling surface shows signs of damage and possible peeling, indicating it has been exposed to moisture for a long time.

Fig: Celling damage and mould

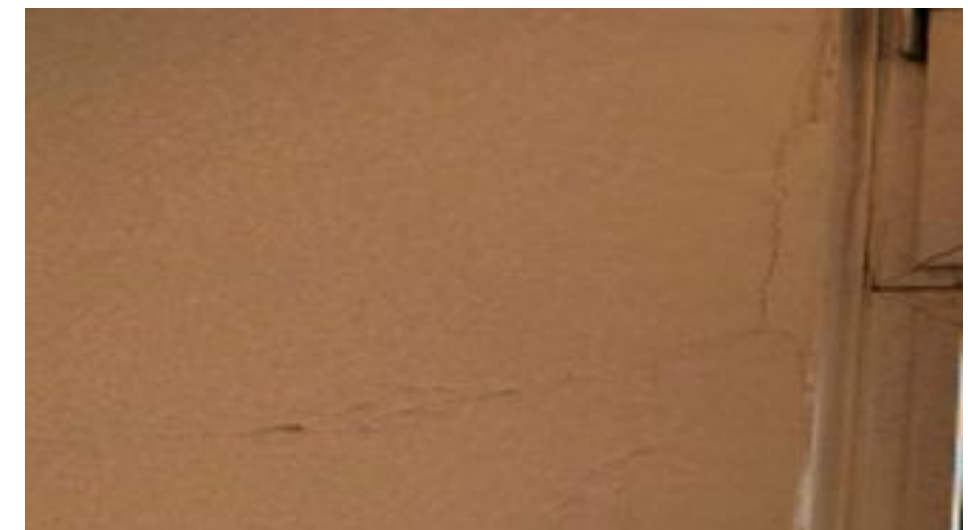
More cracks are visible on the internal wall surfaces, particularly near corners and around openings, which suggests minor structural or non-structural movement. There are small holes and exposed fixings, likely from past installations or maintenance work.

Fig: Peeling of paint
