**RE: Asbestos Inspection**

**5512 Owen Hill Rd, Tar Heel, North Carolina 28392**

**EI Project No: IHMO220083.00**

**ReBuild NC Batch ID: APP-09495, INSP-0012810**

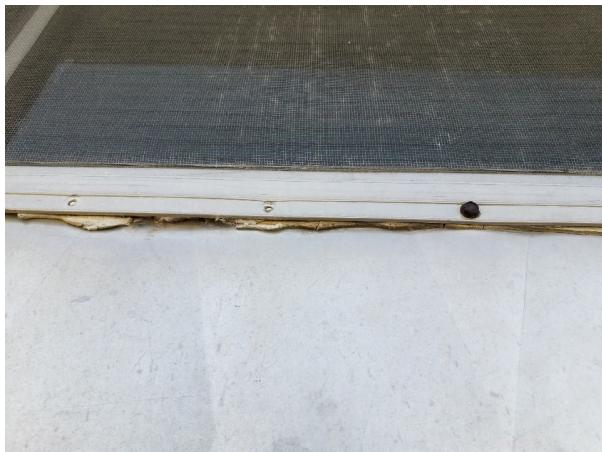
Material	Location	Asbestos Amount	Condition	Approximate Quantity
009 - Caulk, Window	Exterior	10% Chrysotile (Serpentine group)	Good	20 LF

009A, 009 - Caulk, Window, Side C, Main Floor

If the above identified materials containing >1 % asbestos are to be disturbed the owner must then adhere to all local, state and federal regulations regarding the removal and disposal of asbestos-containing materials (National Emission Standards for Hazardous Air Pollutants, Section 40 CFR Part 61.150). Any additional suspect materials identified outside of this survey should be presumed positive for ACM until further testing is completed.

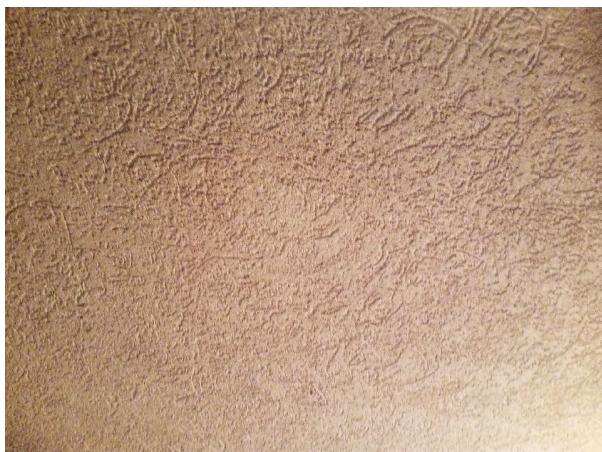
001A, 001 – Ceiling Tile, Bathroom 1, Main Floor

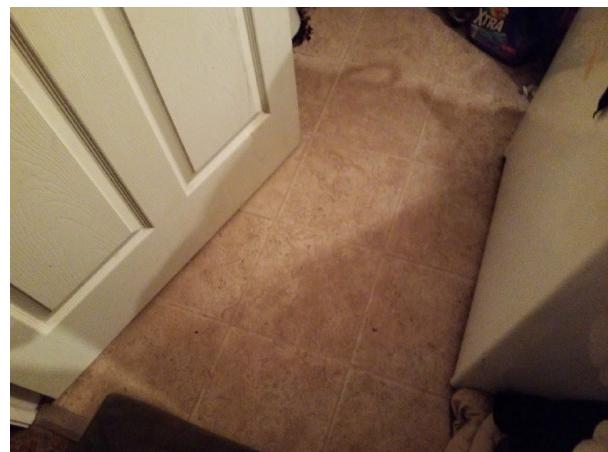
002A, 002 - Floor, Sheet Vinyl Paper Backing, Bathroom 1, Main Floor

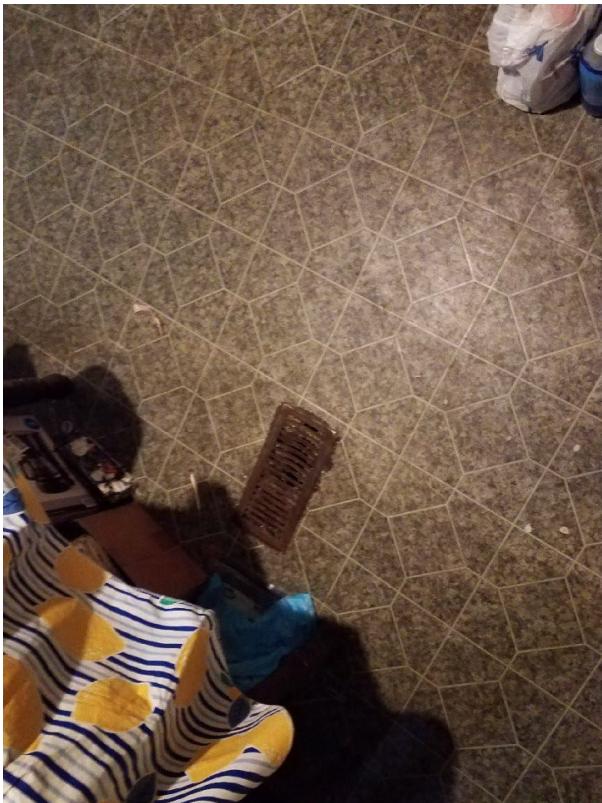
003A, 003 - Floor, Sheet Vinyl Paper Backing,  
Kitchen/ Dining Room, Main Floor

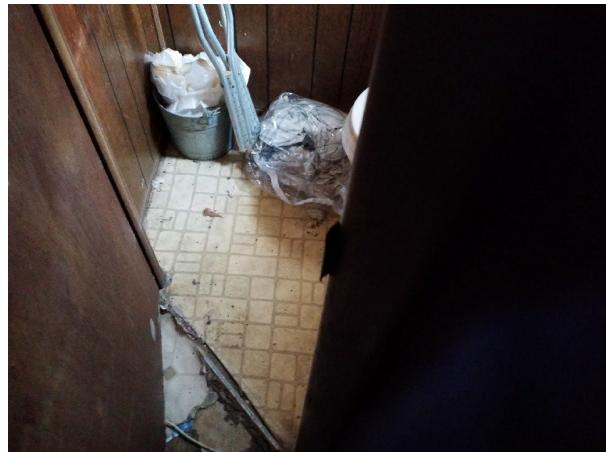
004A, 004 - Floor, Sheet Vinyl Paper Backing,  
Bathroom 2, Main Floor

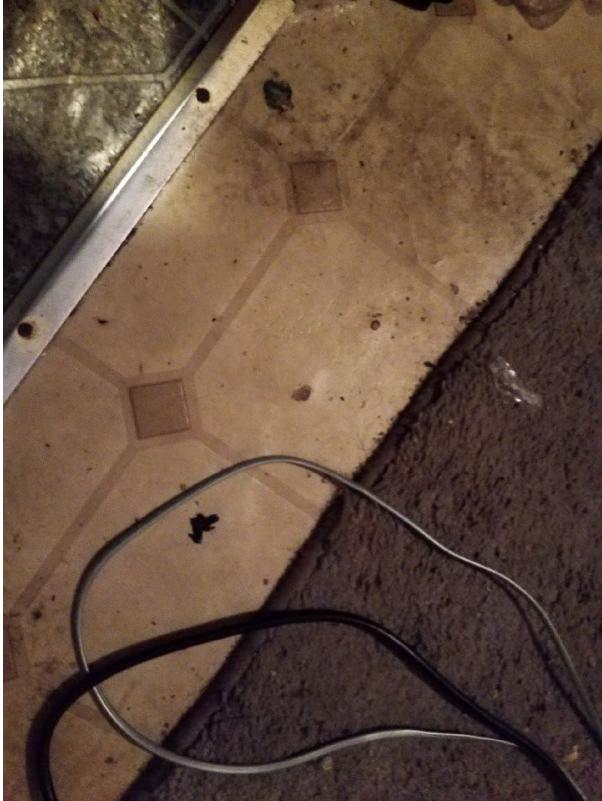
005A, 005 - Floor, Sheet Vinyl Paper Backing,  
Bedroom 3, Main Floor

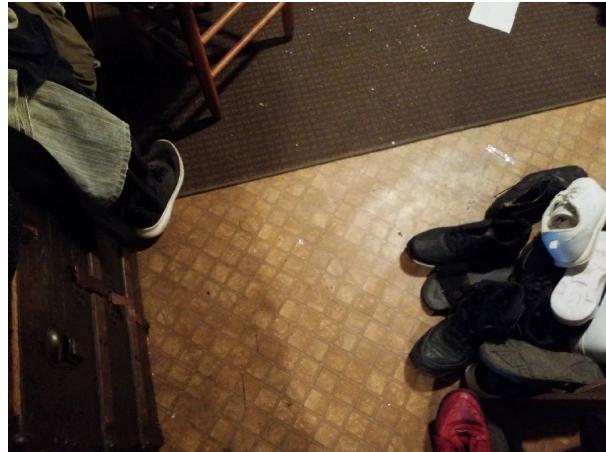
006A, 006 - Floor, Sheet Vinyl Paper Backing,  
Family Room, Main Floor

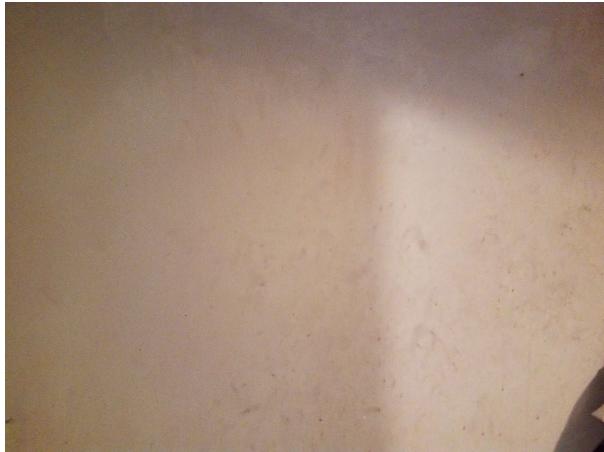
008A, 008 - Gypsum Wallboard, Family Room, Main Floor

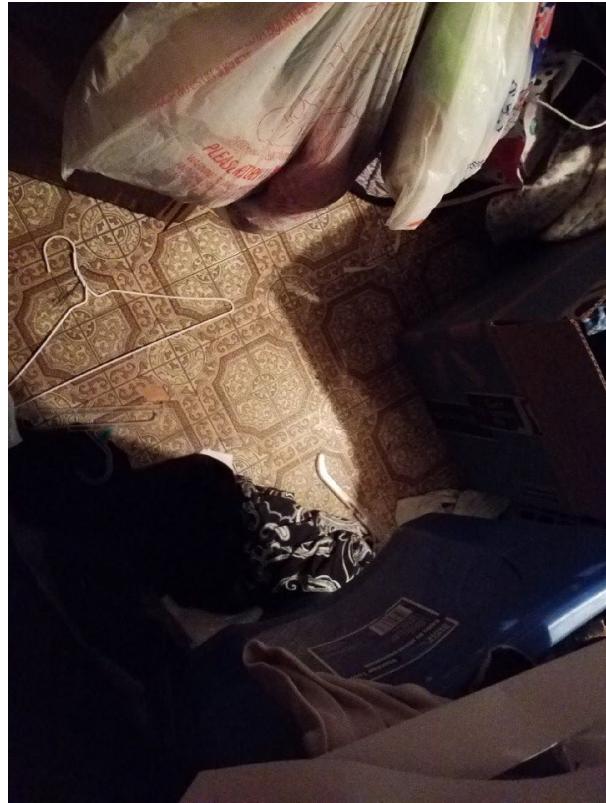
010A, 010 - Floor, Sheet Vinyl Paper Backing, Bedroom 1, Main Floor

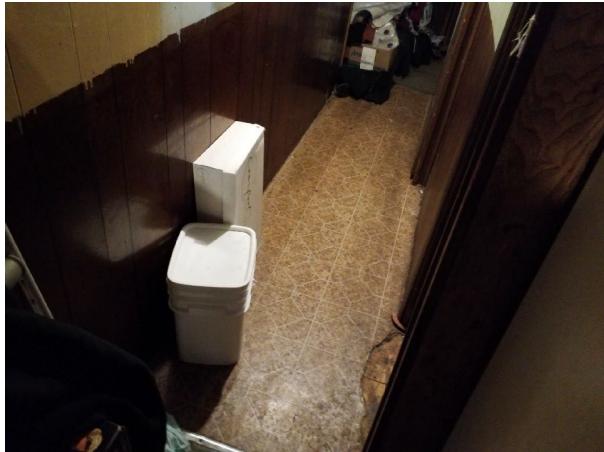
011A, 011 - Floor, Sheet Vinyl Paper Backing, Hallway, Main Floor
