May 16, 2022

**RE: Asbestos Inspection**  
**5512 Owen Hill Rd, Tar Heel, North Carolina 28392**  
**EI Project No: IHMO220083.00**  
**ReBuild NC Batch ID: APP-09495, INSP-0012810**

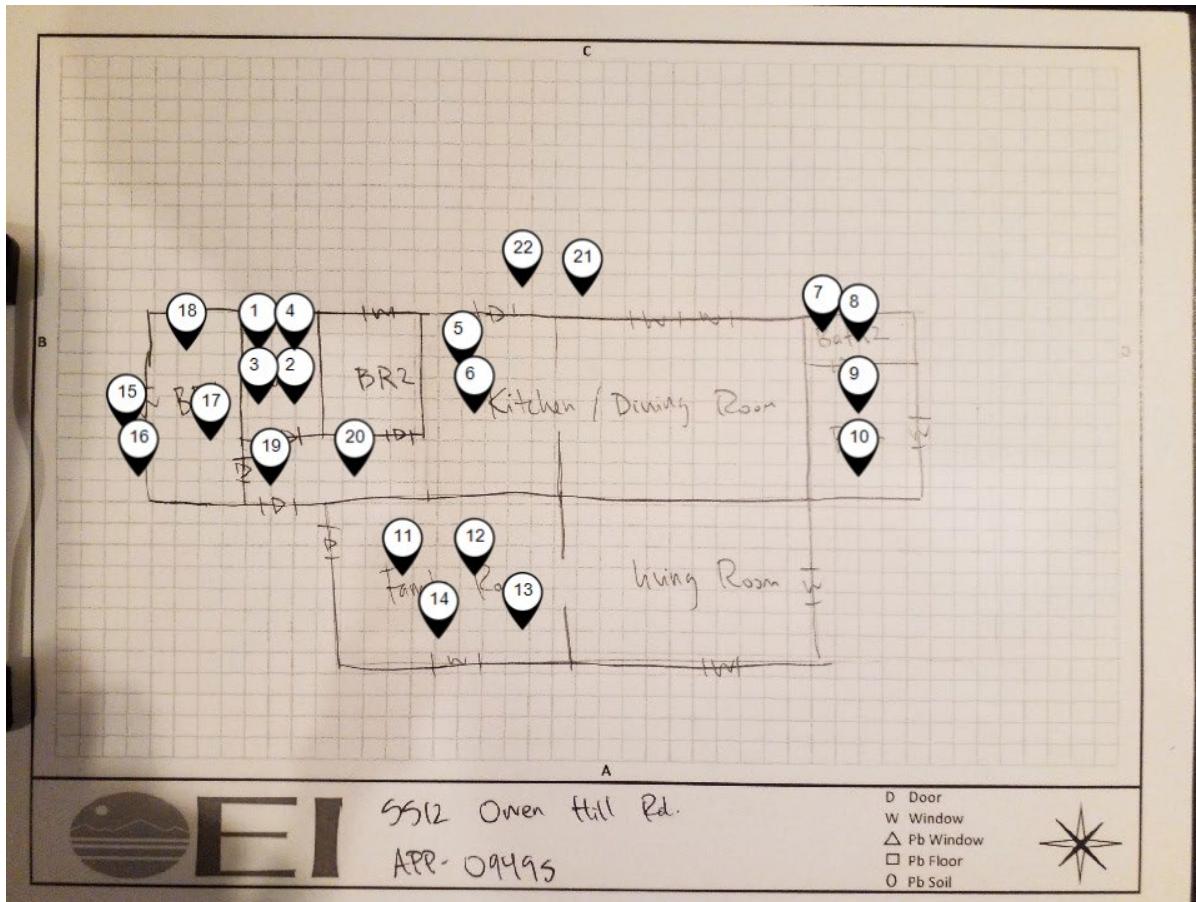
## APPENDIX C: SAMPLE LOCATION MAPS

Map ID	Sample ID	Space Name	Material	Lab Result	Analytical Result
7	004A	Bathroom 2	004 - Floor, Sheet Vinyl Paper Backing	Tested Negative by Lab (No Asbestos Detected)	N/A
8	004B	Bathroom 2	004 - Floor, Sheet Vinyl Paper Backing	Tested Negative by Lab (No Asbestos Detected)	N/A
9	005A	Bedroom 3	005 - Floor, Sheet Vinyl Paper Backing	Tested Negative by Lab (No Asbestos Detected)	N/A
10	005B	Bedroom 3	005 - Floor, Sheet Vinyl Paper Backing	Tested Negative by Lab (No Asbestos Detected)	N/A
11	006A	Family Room	006 - Floor, Sheet Vinyl Paper Backing	Tested Negative by Lab (No Asbestos Detected)	N/A
12	006B	Family Room	006 - Floor, Sheet Vinyl Paper Backing	Tested Negative by Lab (No Asbestos Detected)	N/A
13	008A	Family Room	008 - Gypsum Wallboard	Tested Negative by Lab (No Asbestos Detected)	N/A
14	008B	Family Room	008 - Gypsum Wallboard	Tested Negative by Lab (No Asbestos Detected)	N/A
15	009A	Side C	009 - Caulk, Window	Greater Than 1% Asbestos by Lab (ACM)	10% Chrysotile (Serpentine group)

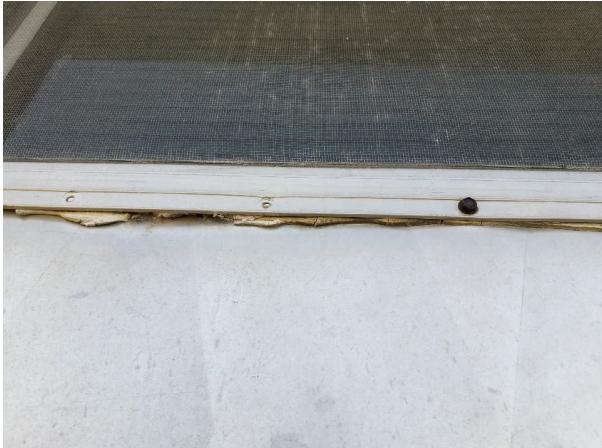
Material	Location	Asbestos Amount	Condition	Approximate Quantity
009 - Caulk, Window	Exterior	10% Chrysotile (Serpentine group)	Good	20 LF

009A, 009 - Caulk, Window, Side C, Main Floor

If the above identified materials containing >1 % asbestos are to be disturbed the owner must then adhere to all local, state and federal regulations regarding the removal and disposal of asbestos-containing materials (National Emission Standards for Hazardous Air Pollutants, Section 40 CFR Part 61.150). Any additional suspect materials identified outside of this survey should be presumed positive for ACM until further testing is completed.

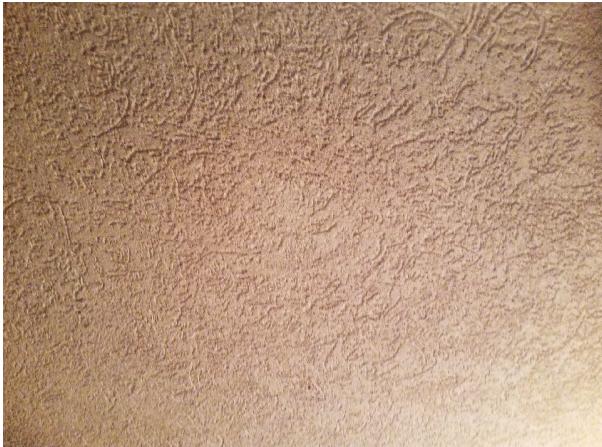
001A, 001 – Ceiling Tile, Bathroom 1, Main Floor

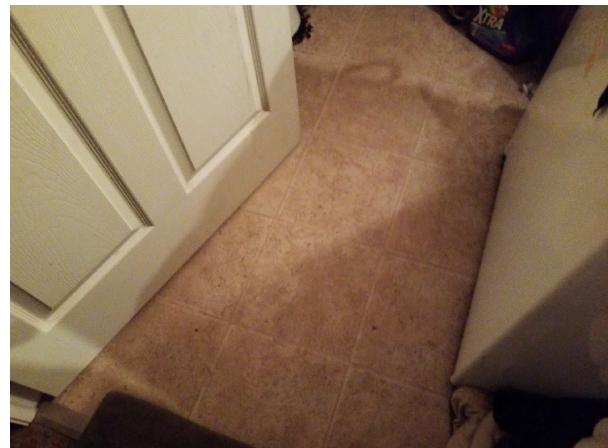
002A, 002 - Floor, Sheet Vinyl Paper Backing, Bathroom 1, Main Floor

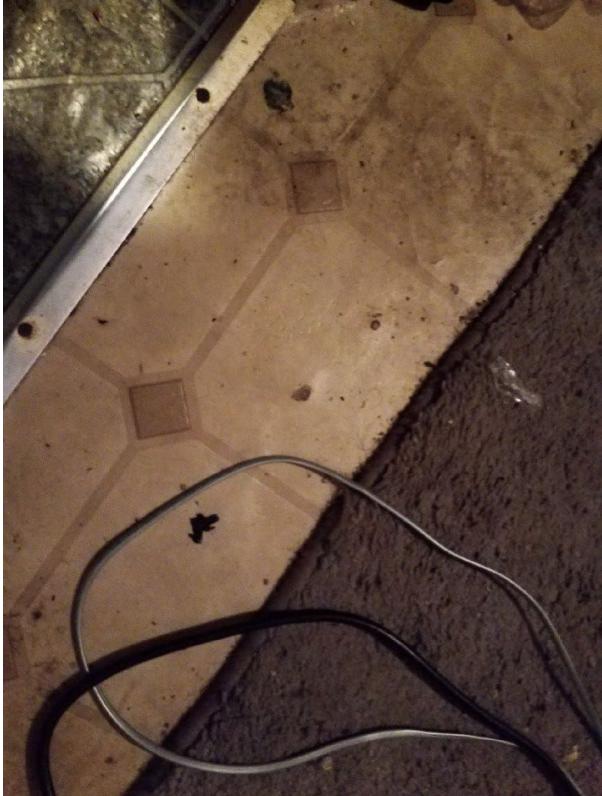
005A, 005 - Floor, Sheet Vinyl Paper Backing,  
Bedroom 3, Main Floor

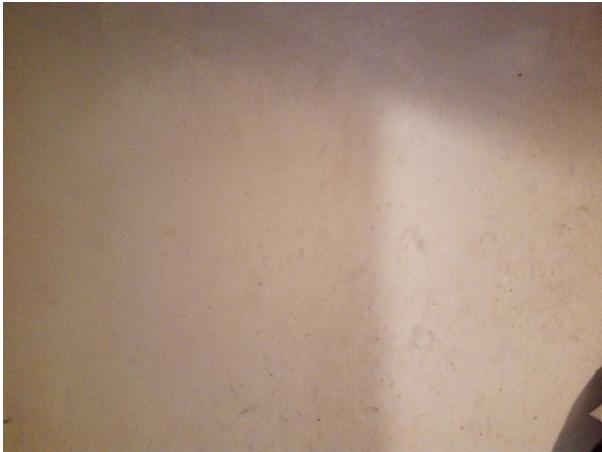
008A, 008 - Gypsum Wallboard, Family Room, Main Floor

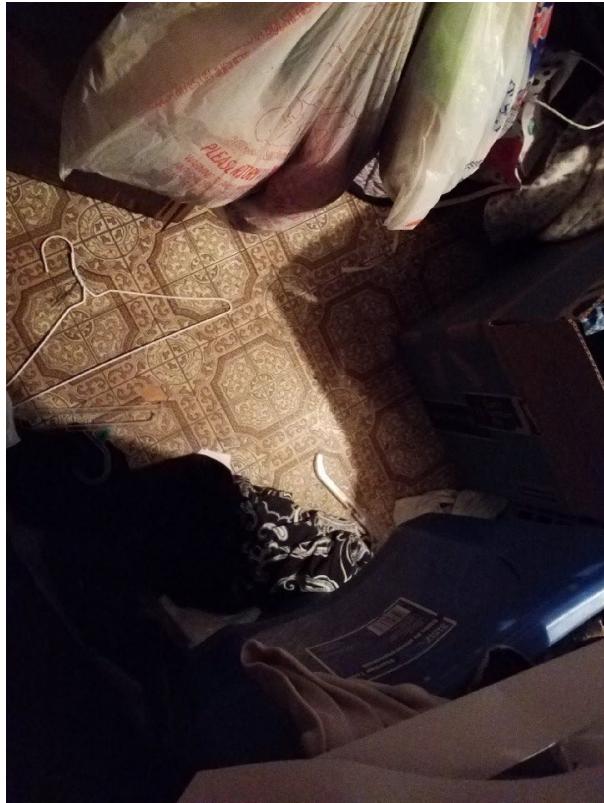
010A, 010 - Floor, Sheet Vinyl Paper Backing, Bedroom 1, Main Floor

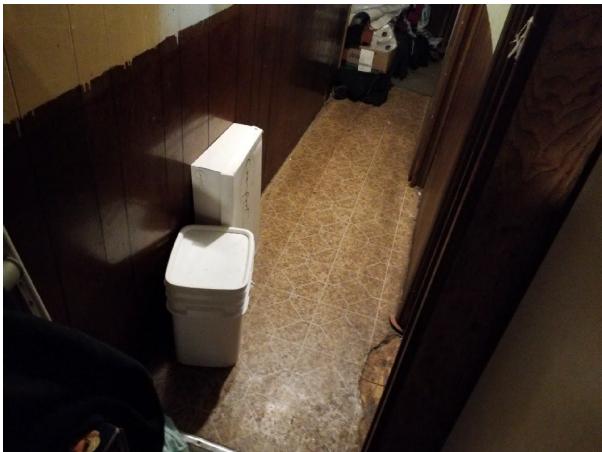
011A, 011 - Floor, Sheet Vinyl Paper Backing, Hallway, Main Floor

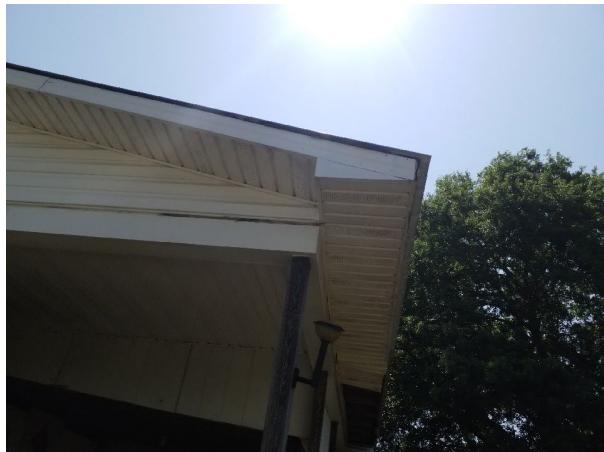
012A, 012 - Roofing, Composite Shingle, Side C, Main Floor
