# Inspection report, Final: PO003459

## KS106366-NAVY BLAZER: ALL I WISH FOR - JEWELRY

### 2nd inspection

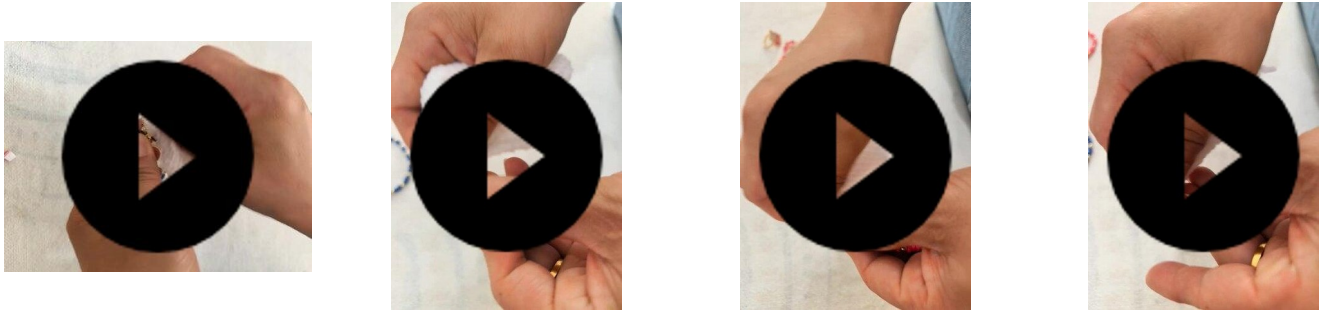
| 4.6 | Prove of color fastness test from supplier | OK |

| | After wiping with wet wipes, there was no obvious color fading in the bulk product, which is acceptable.<br>(Automatic translation) | |
