# Inspection report, Final: PO003423

## FA100017-BEIGE: BABY HAIRBRUSH SET

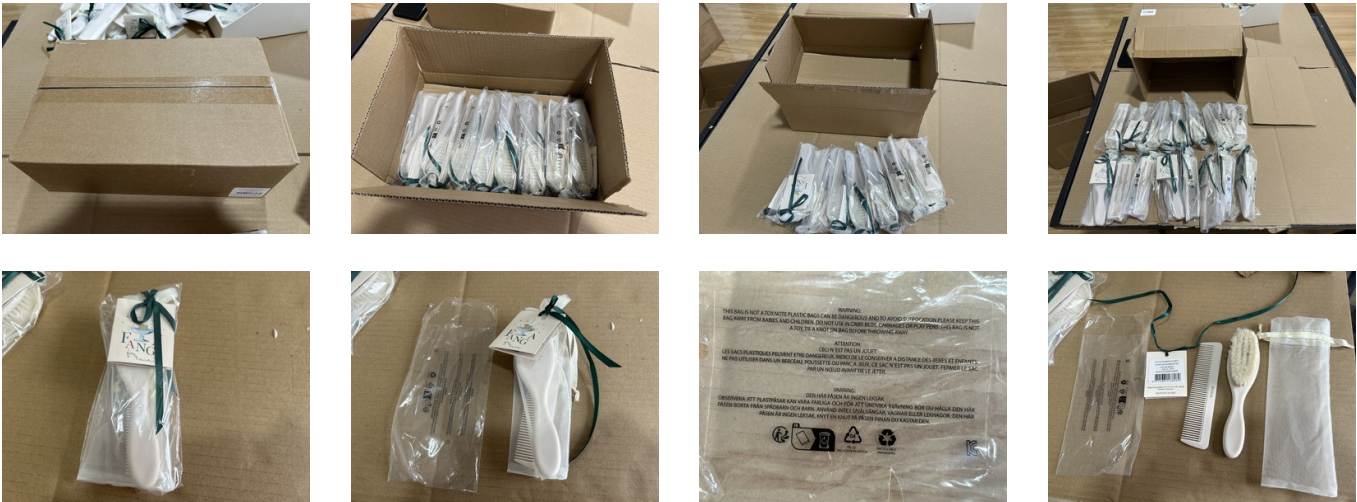
| 5.5 | Inner package ( polybag, sticker, tissue paper, silica gel etc) | OK |

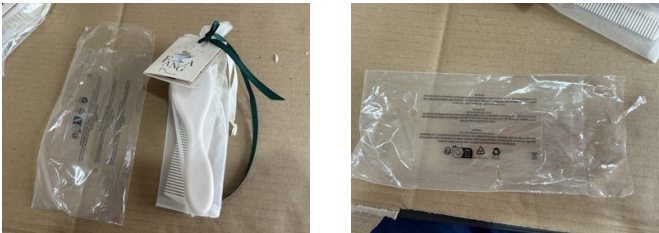
| 5.8 | Products are in polybags | OK |
