# Inspection report, Final: PO003632

## KS103368-SIROCCO: VALENTINES TUT SHOULDER BAG

### 2nd inspection

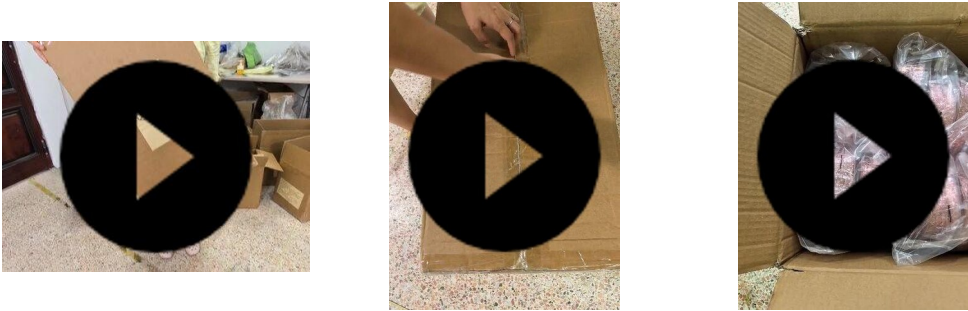
| 4.9 | 摔箱测试 | OK |

| | After the large-volume drop test, the cartons and the goods inside showed no damage, which is acceptable.<br>(Automatic translation) | |
