# Inspection report, Final: PO003632

## KS103368-SIROCCO: VALENTINES TUT SHOULDER BAG

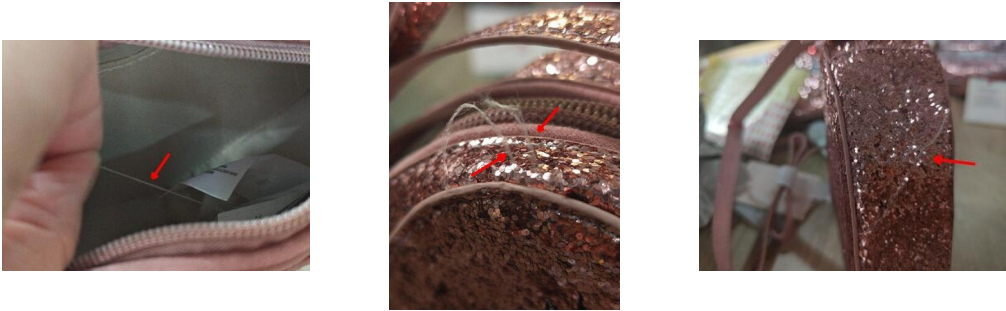
| 6 | W1 Threads, untrimmed. - | MINOR<br>Items affected: 1 |
